A Case Study on Repairing and NDT inspection of 3000 MT Ammonia Storage Tank Installed at GSFC Sikka Unit

Bindul A. Gohil

Gujarat State Fertilizers & Chemicals Ltd, Sikka Unit PO: Motikhavdi

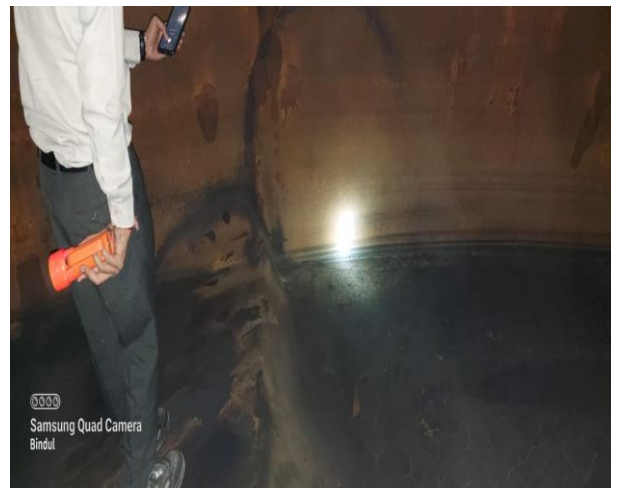
Fig 3. Visual Inspection

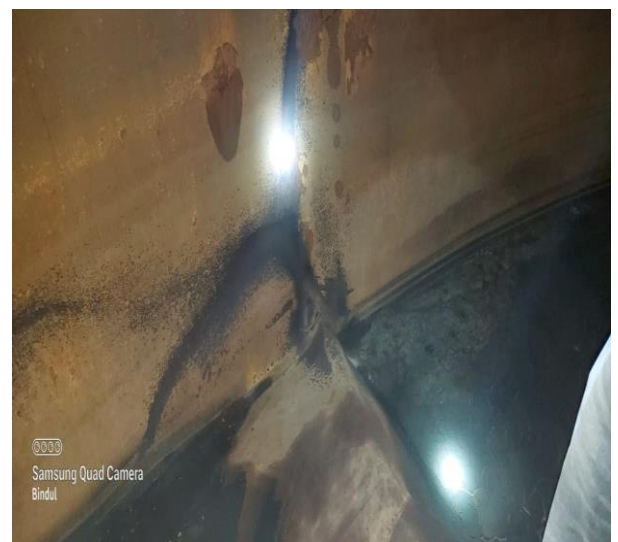
After completion of de commissioning activities, outer tank shell manhole cutting started with hot work permit. After cutting of outer tank shell manhole, it is required to check oxygen content inside the tank. After getting comfort condition inside (Annular space) the tank cutting of CUP manhole started. After opening of CUP manhole, it is necessary to check oxygen level again. If there is no any comfort working condition inside the tank, De humidifier with ID (Induce Draft) fan connected with the tank manhole and top roof manhole respectively. The oxygen level needs to be checked every day basis. After getting the comfort condition inside the tank, visual inspection started. While inspecting the tank from inside, it was observed that many cup bottom plates were bulged in convex shape from its original position (almost 50% of bottom) and also there was fracture from cup shell to cup bottom plate. The fracture/through cracks mentioned in Photos at figure No. 5/6.

Fig 4. Bulging and through crack at bottom

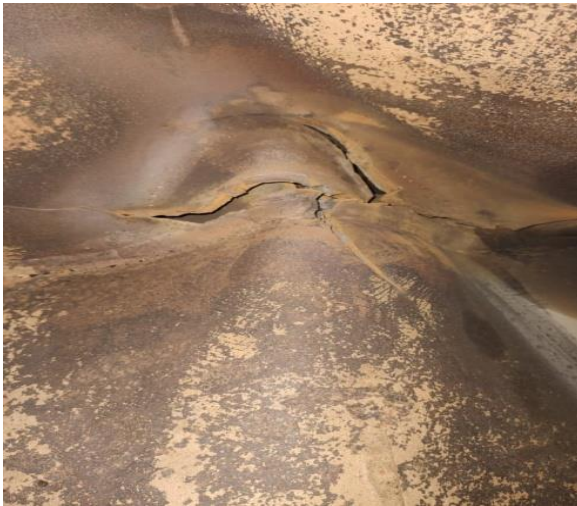
Fig 5. Through Crack at bottom

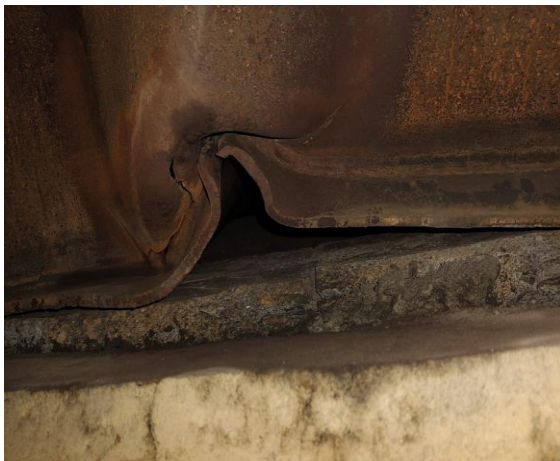
Fig 6. Fracture at Bottom to shell joint

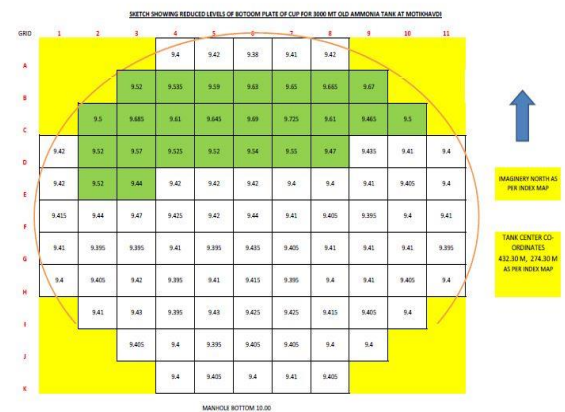
Fig 7. Measurement of bulge area

The green zone indicates bulge area inside bottom of tank.

- We have observed that approx. 270 M2 area including bottom & shell plates are in damaged condition and same had been replaced.
- The welding of bottom area is 180 Running meter & Shell area is 30 Running meter.

- Replacement of damaged bottom plates of CUP tank as per existing bottom plate layout with new plates (Overlap Joints).
- After completion of bottom plate & shell plate replacement 100 % DP test was carried out for following: (1) After back chipping and (2) After final welding (from inside).
- 100 % radiography as per API-620 Appendix-R was carried out for all but joints of tank shell & CUP shell plate joints.
- After completion of above repairing work, NDT inspection of bottom & shell portion of tank was carried out by inspection team and no any abnormalities found in bottom as well as shell.

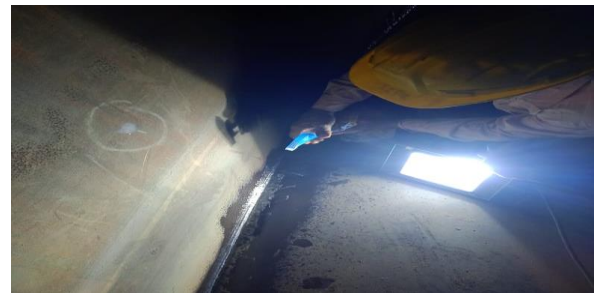
Fig 17. Diesel chalk test of bottom to shell joint

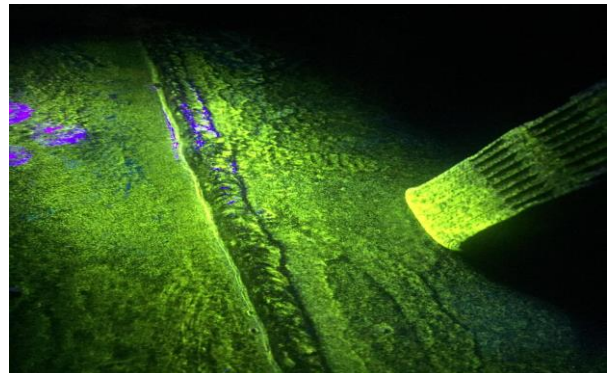
Fig 18. Wet Fluorescent magnetic particle test

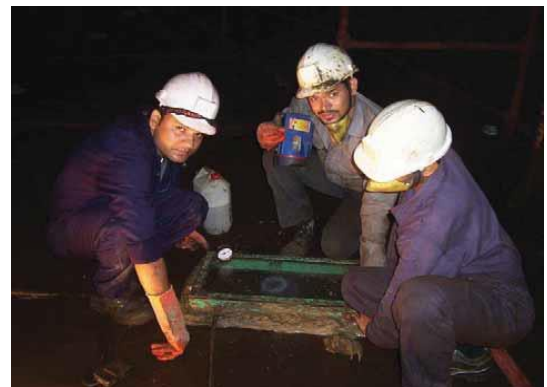
Fig 19. Vacuum Box testing
