Analysis and Prevention of Rust Issue in Automobile Industry

Abstract—Automobile vehicle bodies are prone to rust on exposure to long & short duration at normal atmospheric conditions due to design, material, and/or process related issues. In addition, sometime improper handling is also noted to be a factor resulting in major rusting on automobile body. In this study, two case studies were performed on car bodies that experienced severe corrosion during service. The first case study was performed on rusting at fire wall area and the second one on inner hood. The root cause analysis was performed with the help of fishbone diagram. Two major causes were identified as the potential source causing rusting of car body. These are: 1) Rusting resulting from stagnant liquid owing to the absence of drain hole (i.e. Design related issue) and 2) Process related issue caused by over coating thickness, Improper Backing of ED & low DFT of paint. Containment action & Permanent actions were taken to mitigate the rusting problem on car body by drilling drain holes at appropriate location to prevent liquid from stagnating at corroded area and properly maintaining GPL of Zn in ED bath, increasing pa

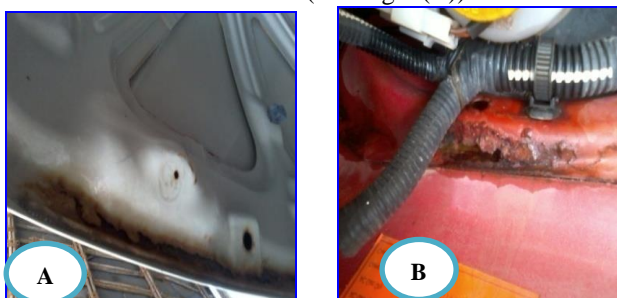
In this study, two major cases were identified and studied. These are: (a) Case of non-uniform corrosion on fire wall area (See Fig. 1(A)) and (b) uniform corrosion on inner section of the hood (See Fig. 1(B)).

Fig. 1: a) Non-uniform rust on fire wall, and b) Uniform rust on inner side of the Hood.

To determine the root cause of corrosion on fire wall, a fishbone diagram was constructed. Several potential factors were considered to determine to root cause of rusting on fire wall area. These factors are: i) Contributions for human factors like unskilled operator performed painting, change of manpower during the process etc., ii) Machine related factors, such as use of wrong machine, use of wrong spraying gun, wrong program, improper current applied, iii) Methods such as pH and concentration of ED bath not maintained to desired value, use of improper mixture of thinner and paint, poor baking, overheating and current not maintained properly in the ED bath, and iv) Design related factors resulting in water stagnation, sharp edges or area more prone to physical damage etc. After considering all these factors, it is observed that the fire wall area is prone to rust due to direct contact of water over an extended period of time. This occurred because of the uneven shape around the wall area resulting in water being remaining stagnant for long duration. In addition, wiper water which uses NaOH (part of Soap solution) with higher pH up to 9~10 is also considered a contributing factor to increase the corrosion rate of fire wall area. Therefore, the solution of this problem was resolved by drilling drain hole at appropriate locations to allow the water and soap solution to flow without remaining stagnant for long duration. In addition, non-conductive Mastic sealant was applied on the fire wall area before painting to prevent corrosion of steel body. After the application of sealant, salt spray test and acceleration tests were performed. No evidence of rust was observed after the completion these test (Fig. 3a). The corrective action is implemented in service and the rusting issue on the fire wall area is resolved.

In this case, multiple causes played role in formation of rust. These are: huge contact area, less effectiveness of grain hole, and improper design resulting in inadequate painting & coating inside the area.

In Case A, the root cause of corrosion is primarily attributed to design factors that resulted in stagnant water at the fire wall area. To avoid the corrosion and to reduce the corrosion rate, nonconductive material (Mastic Sealant) was applied on fire wall area before painting. The Mastic sealant reduced direct contact of OH^- and H^+ ion with the steel body and thus helped in reducing the rate of corrosion. After the application of sealant, vehicle was tested at accelerated corrosion test and salt spray test.

In Case B, to avoid corrosion between reinforcement and the hood skin panel, a hole was drilled to drain the excess amount of ED and water that remained stagnant in that area. So during heating (Backing) ED, the part was dried properly and subsequently produced corrosion resistance film. To provide additional corrosion resistance, a part of the hood skin was covered with Mastic sealer to prevent erosion of paint. Salt spray and accelerated corrosion tests showed no evidence of rust on inner hood area after applying sealant to it.

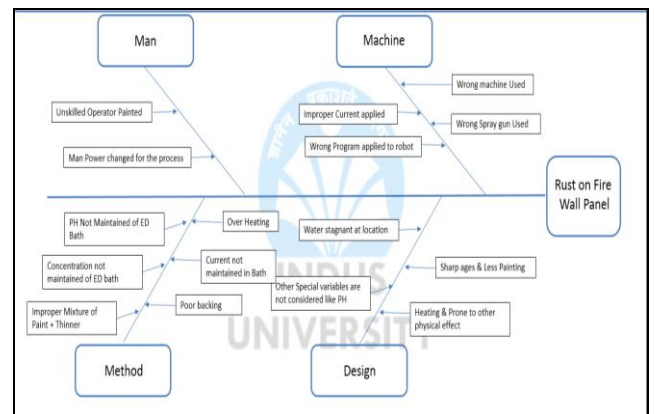
Fig. 2: Fishbone diagram to determine the root cause for corrosion.

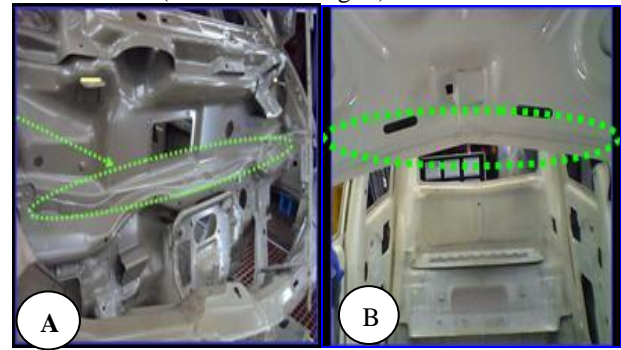
Therefore, as a counter measure, white mastic sealant was applied between panel skin and reinforcement panel. In addition, the drain hole location was changed to eliminate the occurrence of stagnant water and soap solution in the area. Subsequently, salt spray and accelerated tests were performed on the hood assembly. Both of these tests showed no evidence of rust in inner hood area (Fig. 3b).

Both tests showed no evidence of white or red rust at the fire wall area (Shown in the Fig. 3).

Fig. 3: a) Fire wall after 120 hrs salt spray test, and b) Hood inner after 120 hrs salt spray test. No rust observed.
