# Analysis Of Mechanical Seal Leakabge in Crudeoil Transfer Pump

Stephen Victor And Emeka Okafor

Department Of Petroleum And Gas Engineering, University Of Port Harcourt

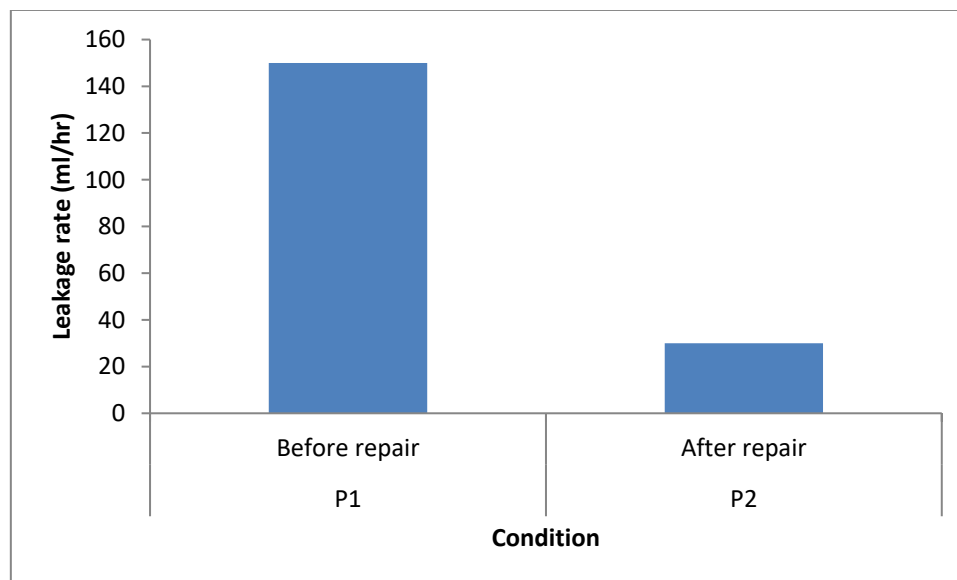
**Figure 1: Leakage rate (ml/hr) before and after repair**

As shown in Figure 1, the leakage rate prior to repair stood at 150 ml/hr, which indicated a severe loss of fluid. This high leakage level was categorized as critical, suggesting potential issues such as degraded seals, worn gaskets, or misalignment in the pump assembly. Such excessive leakage not only leads to significant operational inefficiency and increased energy consumption but may also pose safety and environmental risks depending on the nature of the fluid being pumped.

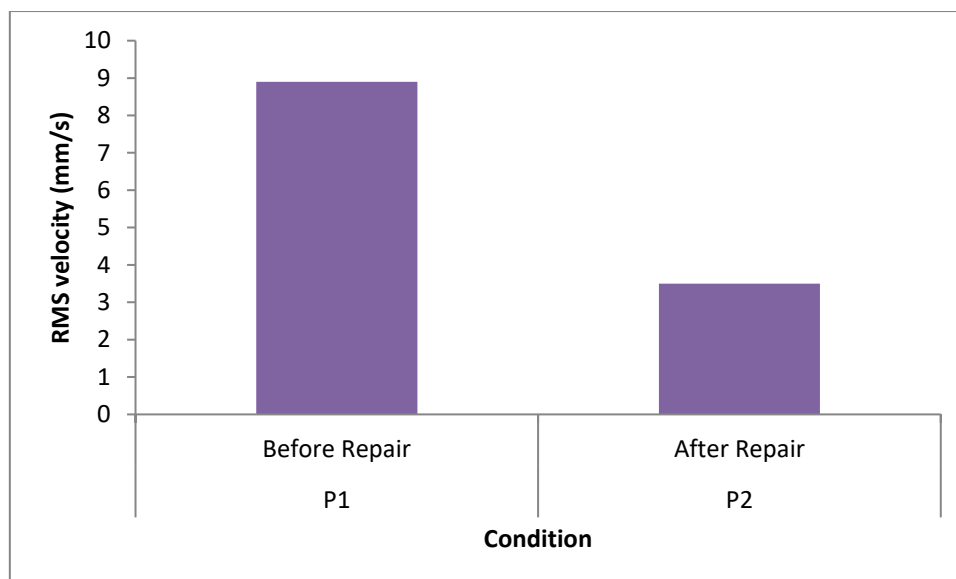
Figure 2: RMS velocities (mm/s) before and after repair

As illustrated in Figure 2, the RMS velocity prior to repair was 8.9 mm/s. This high vibration amplitude indicated significant mechanical distress, that fell into the unsatisfactory or high vibration zone according to ISO 10816-3 guidelines for group 2 machines (medium-sized rotating equipment) (Rao,2016). Such elevated vibration levels are typically associated with mechanical faults including rotor imbalance, shaft misalignment, bearing defects, or structural looseness. Following the repair works, the RMS velocity reduced markedly to 3.5 mm/s, placing the pump firmly within the good or acceptable operating range. The substantial drop in vibration amplitude is clearly visible in Figure 2, highlighting the effectiveness of the maintenance activities in restoring the pump's dynamic stability

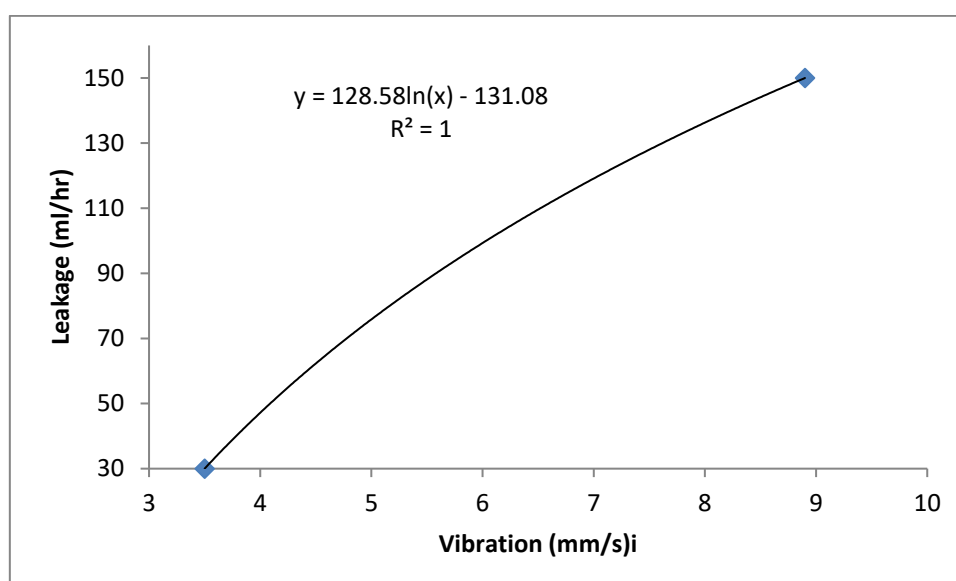
Figure 3: Vibration versus Leakage Rate

As illustrated in Figure 3, a strong positive relationship exists between vibration amplitude and leakage rate. Prior to repair, the pump operated at a high leakage rate of 150 ml/hr and a correspondingly high RMS velocity of 8.9 mm/s. This simultaneous occurrence of elevated vibration and leakage suggested that the underlying mechanical faults (such as misalignment, bearing wear, seal degradation, or internal clearances) were contributing to both symptoms. Following the repair works, both parameters improved significantly, with the leakage rate reducing to 30 ml/hr and the RMS velocity reducing to 3.5 mm/s. The movement from the upper-right quadrant (high vibration-high leakage) to the lower-left quadrant (low vibration-low leakage) in Figure 3 clearly demonstrated the effectiveness of the maintenance intervention in addressing the root causes affecting both vibration and sealing performance.

However, the data points yielded an apparent strong linear correlation. The percentage reductions were previously calculated where leakage rate reduction: was 80% and RMS velocity reduction: was approximately 61%. Moreso, figure 3 showed that vibration and leakage rate were directly proportional in this pump system. This relationship showed that higher mechanical vibration typically accelerated seal and gasket degradation, which led to increased internal leakage. Conversely, excessive leakage could sometimes contribute to hydraulic instability, which further increases vibration levels.

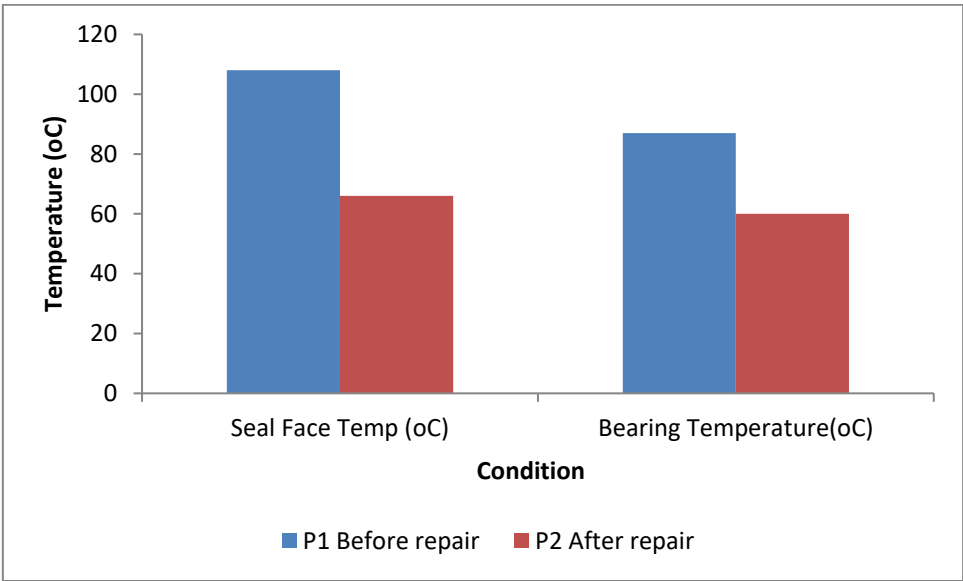
Figure 4: Temperature measurements of critical components of the crude oil transfer pump

As illustrated in Figure 4, the pump operated under severe thermal stress prior to repair. The mechanical seal face temperature reached 108°C, while the bearing temperature was recorded at 87°C. These elevated temperatures are of particular concern for a crude oil transfer pump, where the fluid’s high viscosity and potential for abrasives could exacerbate frictional heat generation. Such high thermal loading often resulted from misalignment, worn bearings, degraded mechanical seals, or insufficient lubrication conditions that were evidently present before the intervention.

After the repair works, a significant improvement in thermal performance was evident. The seal face temperature decreased to 66°C, and the bearing temperature dropped to 60°C. This substantial reduction brings both critical components well within safe and recommended operating temperature ranges for centrifugal pumps handling crude oil.

Furthermore, figure 4 clearly demonstrated the effectiveness of the repair in mitigating thermal distress. The marked decrease in seal face temperature is especially important because mechanical seals are highly sensitive to heat. Excessive temperatures could cause thermal distortion of the seal faces, vaporization of the lubricating film, and premature seal failure issues that commonly lead to increased leakage in crude oil service as observed in Table 1.

The reduction in bearing temperature from 87°C to 60°C also indicated improved lubrication conditions and reduced internal friction. Lower bearing temperatures minimize the risk of lubricant oxidation and extend bearing service life significantly (Harris and Kotzalas, 2007). This thermal improvement correlated strongly with the reductions observed in leakage rate (80%) and vibration level (61%). The combined effect suggested that the repair successfully resolved underlying mechanical issues such as shaft misalignment, bearing wear, and seal degradation. In the context of crude oil transfer pumps, where reliability is critical due to continuous operation and hazardous fluid properties, such improvements are vital for operational safety, environmental protection, and cost efficiency. The results presented in Figure 4 reinforce the value of multi-parameter condition monitoring (vibration, leakage, and temperature) in predictive maintenance strategies for critical rotating equipment in the oil and gas industry.

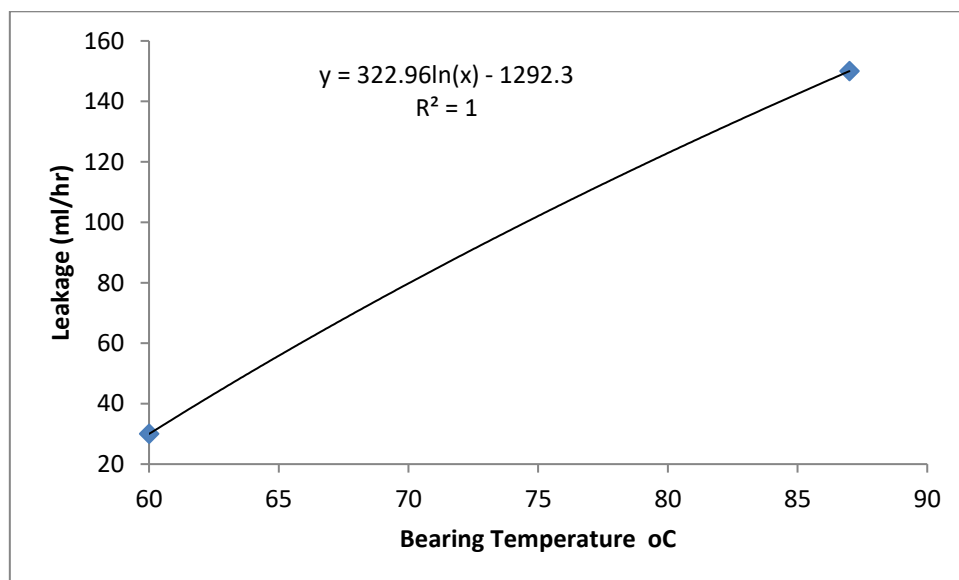
Figure 5: Bearing Temperature (°C) versus Leakage Rate

As shown in Figure 5, a strong positive correlation existed between bearing temperature and leakage rate. Before repair, the pump exhibited a high leakage rate of 150 ml/hr corresponding to an elevated bearing temperature of 87°C. This combination indicated that excessive internal leakage was accompanied by increased frictional losses and heat generation within the bearing assembly. High leakage could lead to loss of lubrication film, increased radial loads, and consequent rise in bearing temperature.

Following the repair intervention, both parameters improved markedly, with leakage reducing to 30 ml/hr and bearing temperature reducing to 60°C. The downward shift observed in Figure 5 demonstrated that the maintenance activities effectively restored proper bearing clearance, alignment, and lubrication conditions, thereby reducing both heat generation and fluid loss simultaneously.

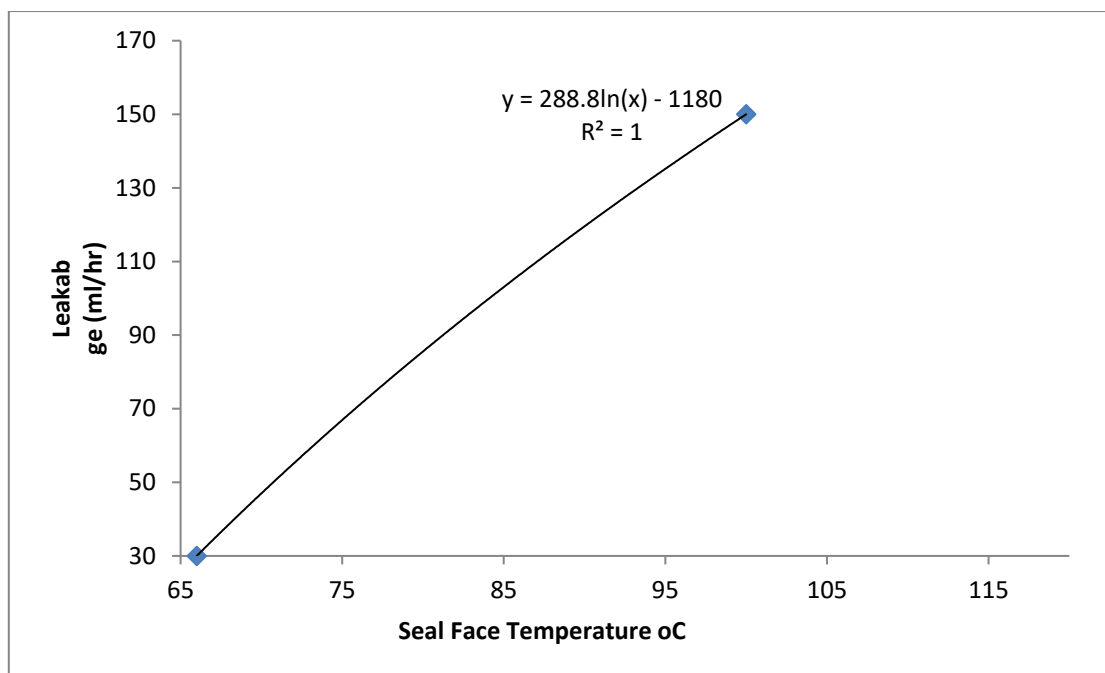
**Figure 6: Seal Face Temperature (°C) versus Leakage Rate**

Figure 6 revealed an even stronger relationship between seal face temperature and leakage rate. Prior to repair, the mechanical seal face operated at a critically high temperature of 108°C while the pump experienced a leakage rate of 150 ml/hr.

Such elevated seal face temperatures are known to cause thermal distortion, warping of seal faces, and degradation of the lubricating film, which directly contributed to increased leakage, a common failure mode in crude oil transfer pumps (John , 2019). High temperatures create uneven thermal expansion across the seal faces, leading to coning or warping. This distortion disrupts the critical hydrodynamic lubricating film, resulting in direct face contact, accelerated wear, and higher leakage rates. In crude oil applications, where fluids often contain abrasives and operate under demanding conditions, this failure mechanism is particularly prevalent and could rapidly escalate operational risks.

After repair, the seal face temperature decreased to 66°C alongside the substantial reduction in leakage to 30 ml/hr. This significant improvement, clearly visible in Figure 6, indicated successful restoration of the mechanical seal's integrity, proper face loading, and cooling conditions.

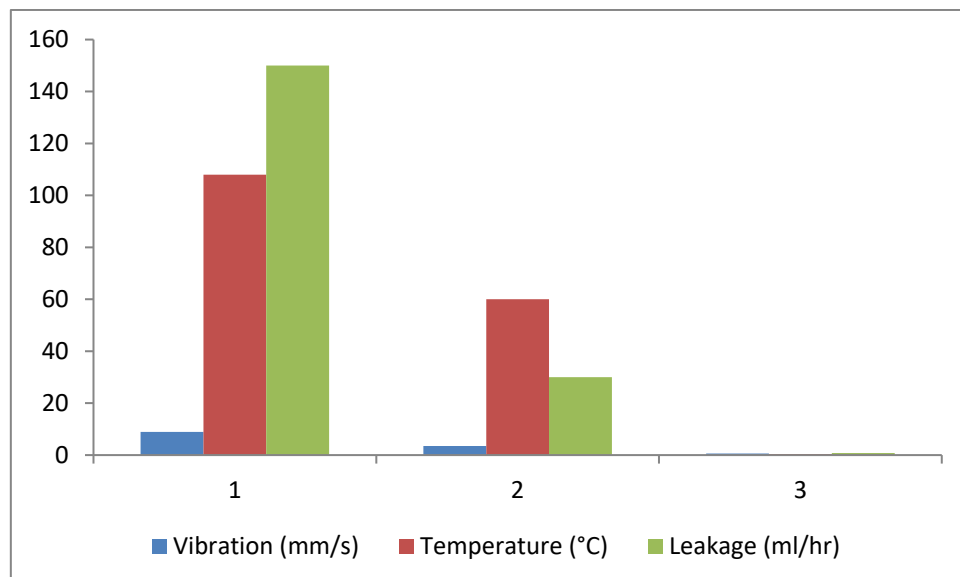
**Figure 7: Comparative analysis of parameters before and after correction**

As illustrated in Figure 7, all three critical parameters showed remarkable improvement following the repair intervention. Before repair, the pump exhibited high vibration of 8.9 mm/s, elevated seal face temperature of

108°C, and critical leakage rate of 150 ml/hr. These values indicated poor mechanical condition, characterized by excessive dynamic forces, thermal stress, and fluid loss. After the repair, the parameters improved significantly to 3.5 mm/s for vibration, 60°C for temperature, and 30 ml/hr for leakage rate. The graphical comparison in Figure 7 clearly highlighted the magnitude of improvement achieved.

Figure 7 provided compelling visual evidence of the holistic success of the repair intervention. The most significant improvement was recorded in leakage rate (80%), followed by vibration (60.7%) and temperature (42%). This variation in improvement levels indicated that while the repair effectively addressed the primary failure mechanisms, the response of individual components differed. The simultaneous reduction across all three parameters confirmed that the repair successfully resolved the common root causes, primarily shaft misalignment, bearing wear, and mechanical seal degradation. The substantial decrease in leakage rate reflects restored sealing integrity, while reductions in vibration and temperature indicated improved mechanical stability and reduced internal friction.
