Black Spot Management in NH 208 (Madurai-Virudhunagar Districts): A Case Study of Tamilnadu

C. Vigneshkumar

M.E, Department of Civil Engineering, K.L.N College of Information Technology
Madurai, TN, India

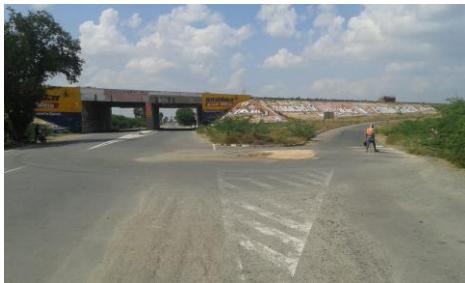
a) T.Kallupatti road: 0.5 km-NH 208

Fig 1 (a) shows the following deficiencies on the existing stretch under investigation:

- i. The curve is deficient of berms.
- ii. Sight/stopping distance is obstructed by encroachments.

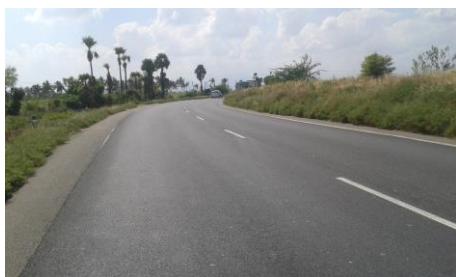
a) Ammapatty road: 19 km-NH 208

Fig 2 (a) shows the following deficiencies on the existing stretch under investigation:

- i. The existing horizontal curve is not standard.
- ii. The encroachments causing obstruction to the driver to have sufficient sight/stopping distance.

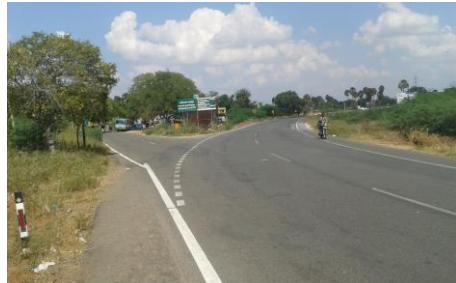
a) Alagapuri Junction: 32 km-NH 208

Fig 3 (a) shows the following deficiencies on the existing stretch under investigation:

- i. The existing curve is not standard.
- ii. The feeder road is almost joining the national highway at the vertex of the curve causing accidents.

- i. The existing non-standard curve requires improvement. Depending on the availability of land, improvement of curve should be taken up. Being a NH minimum radius of the curve as 360 mts is suggested.

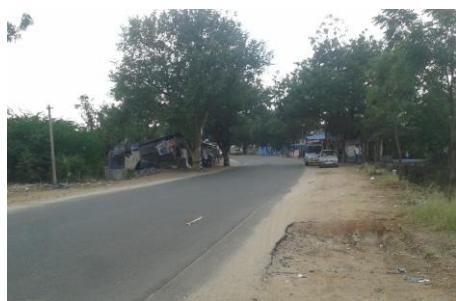
a) Nathampatti road: 35 km-NH 208

Fig 4 (a) shows the following deficiencies on the existing stretch under investigation:

- i. The shops are causing obstruction to the driver to have sufficient sight/stopping distance.

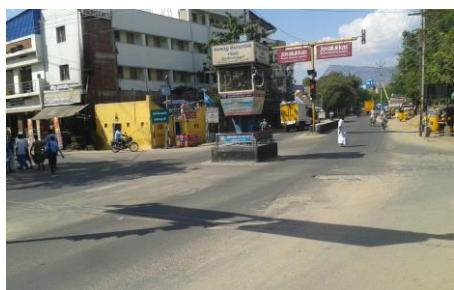
a) Srivilliputtur Junction 1: 50 km-NH 208

Fig 5 (a) shows the following deficiencies on the existing stretch under investigation:

- i. Congested junction

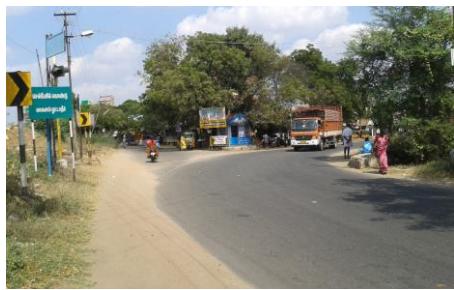
a) Srivilliputtur Junction 2: 52 km-NH 208

Fig 6 (a) shows the following deficiencies on the existing stretch under investigation:

- i. The existing curve is not standard.
- ii. The feeder road is almost joining the national highway at the vertex of the curve causing accidents.

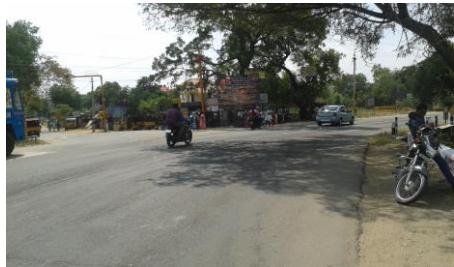
a) Vanniyampatti Junction: 56 km-NH 208

Fig 7 (a) shows the following deficiencies on the existing stretch under investigation:

- i. The existing curve is not standard.
- ii. The feeder road is almost joining the national highway at the vertex of the curve causing accidents.

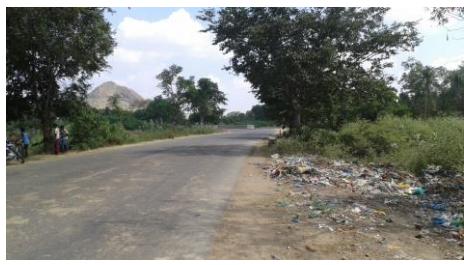
a) Devathanam road: 90 km-NH 208

Fig 8 (a) shows the following deficiencies on the existing stretch under investigation:

- i. The existing horizontal curve is not standard.
- ii. The encroachments causing obstruction to the driver to have sufficient sight/stopping distance.
