Experimental Investigation and Finite Element Analysis for Solving Pumps Resonance Problem

Sami A. A. El-Shaikh

Mechanical & Electrical Research Institute,
National Water Research Center, Ministry of Water Resources & Irrigation,
Delta Barrage, Egypt

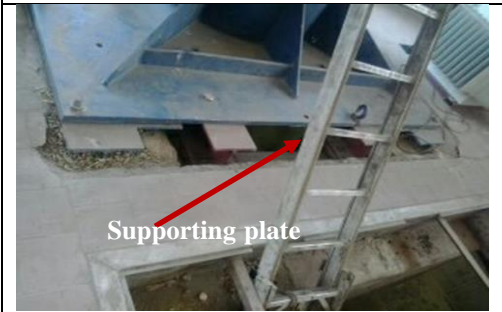
Figure (2-a) Stiffeners and Supporting Plates

- The use of support steel beam which is smaller than recommended in addition to the inappropriate positions/numbers of stiffeners and supporting plates for the motor base **Figure (2)**. This would normally result in weak supporting positions for the motor base.
- The bolts that connect the pump base and the foundation are not integrated properly, as shown in **Figure (3)**.
- Improper fixation of the motor soleplates due to missing or lose bolts. In **Figure (4)**, the motor three soleplates were fixed from two sides instead of four as recommended by the standards design.

So, the user must have to follow the foundation design recommended by the manufacturer, as shown in **Table [2]** for dimensions and in **Figure (10)** for adding stiffeners. Complete description and dimension for this design will be prepared. The new design will increase the foundation stiffness by adding two cross beams at the middle of the manufacturer foundation as described in the figure below, as shown in **Figure (10)**. The new base should be fixed properly from four sides.

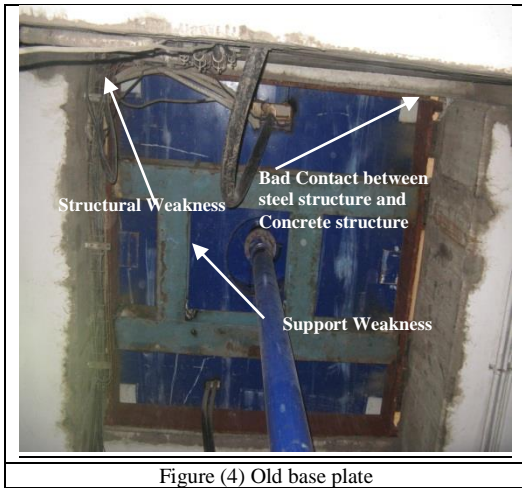
These problems in the existing foundation have contributed to the pump vibration, foundation and its old base plate is as shown in **Figure (4)**.

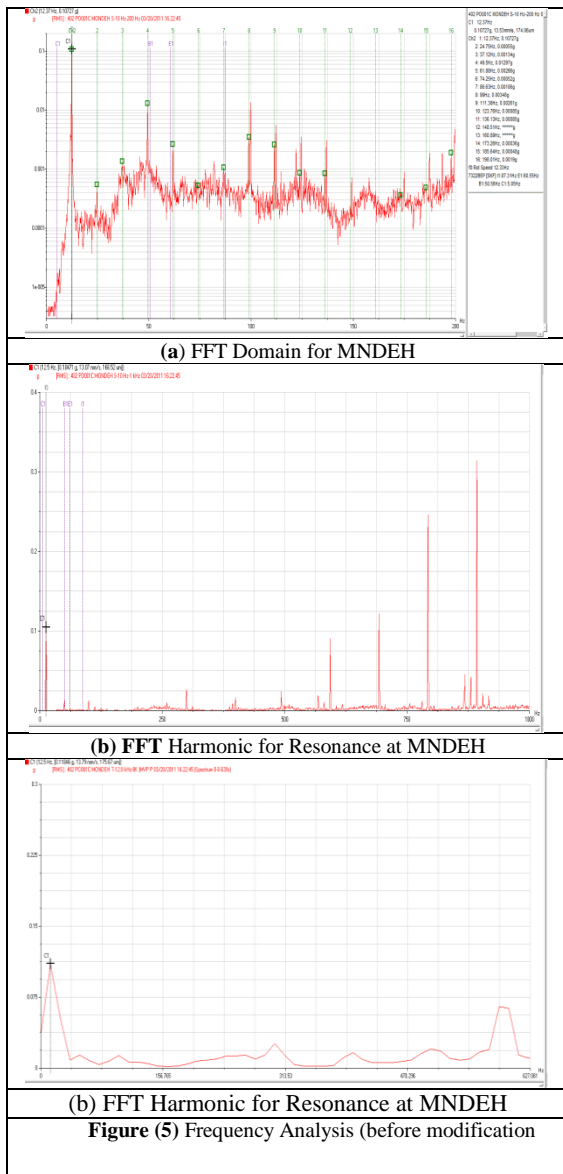
Frequency analysis was done to determine high frequencies unwanted, frequencies for each element in the pump system, and to know problem at any frequencies. Frequency spectrum analysis indicated that there were vibration peaks at motor running speed ($1X \approx 12.4\text{Hz}$) and its harmonics in the vertical and horizontal directions. It is obviously noticed that the maximum vibration amplitude reached 13.5 mm/sec at 12.5 Hz as shown in **Figure (5-a)**, its harmonics as shown in **Figure (5-b)**, and peaks with high amplitude at low frequency as shown in **Figure (5-c)**. These high levels of vibration are in the “not permissible

zone” of ISO 10816-3 indicating a resonance problem. It is not safe and dangerous to operate at this condition. Normally weakness in foundation causes this observed resonance problems.

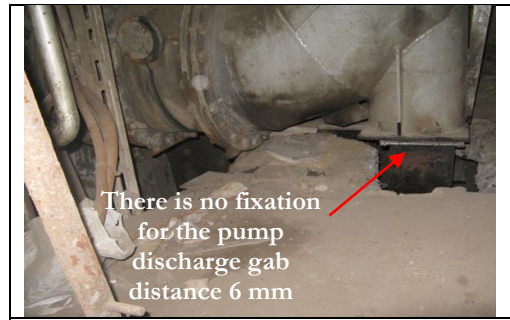
(a) There is no fixation for the pump discharge gab distance 6 mm

Proper maintenance work was carried out by the user to improve the pump concrete foundation to provide good fixation for motor soleplates. Work included: the fixation for the pump discharge gab, **Figure (6-a)**; increase fixation at the base of the pump, (**Figure (6-b)**) and modification of the foundation as shown in **Figure (7)**. Finally, dynamic

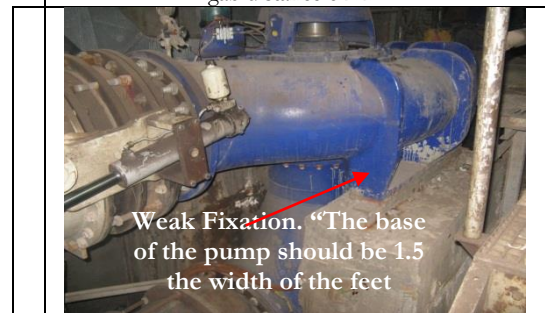
(b) Weak fixation. The base of the pump should be 1.5 the width of the feet

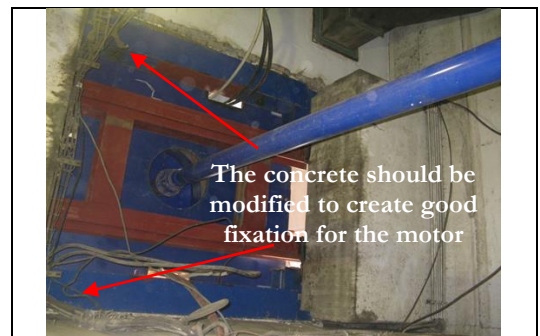
Figure (7) The concrete should be modified to create good fixation for the motor soleplates in both sides

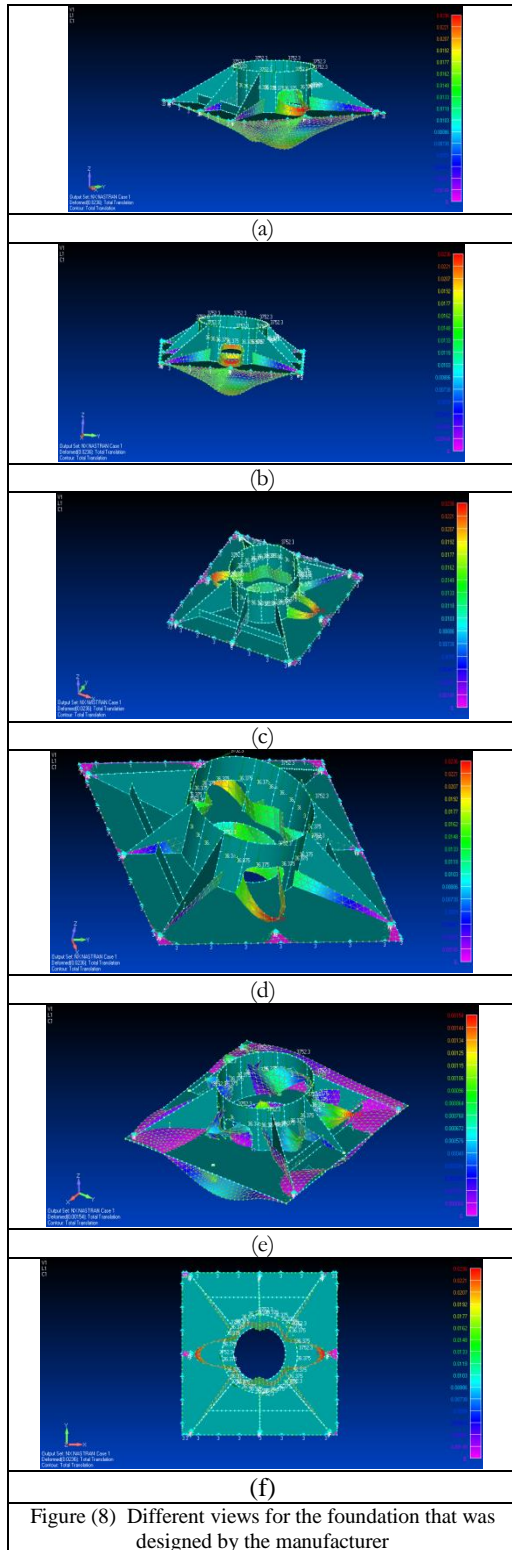
The finite element analysis for the manufacturer base design indicates that the maximum deformation occurs at the middle of the base where there is no support for the base. On the other hand this design provides a rigid supporting for all sides of the base.

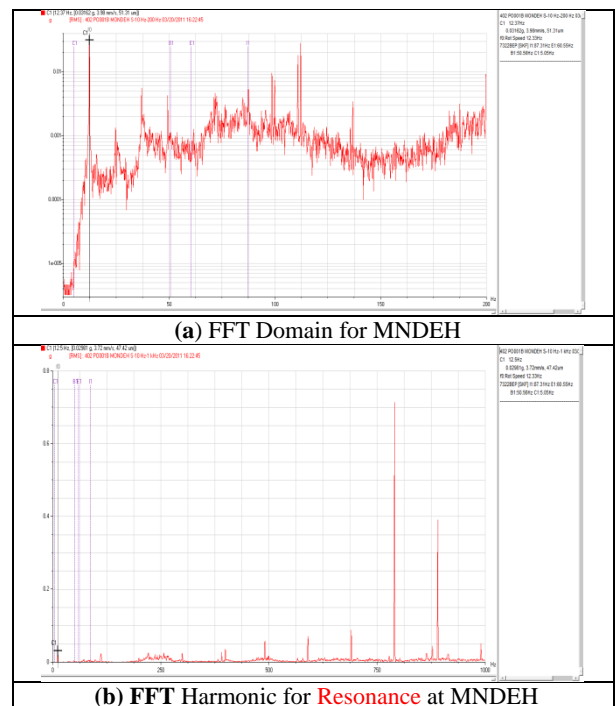
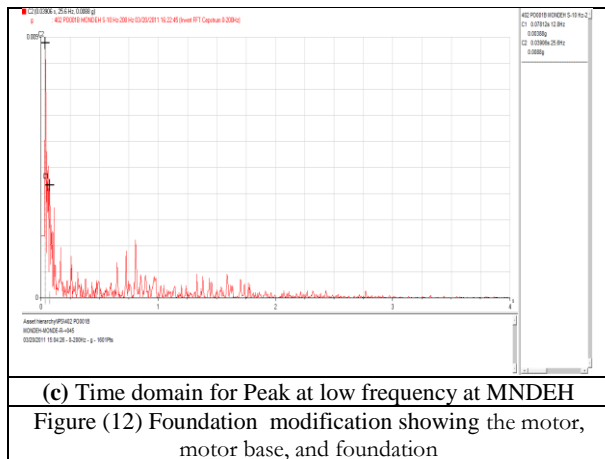
Frequency spectrum analysis indicated that no vibration peaks were found at motor running speed (1RPM, 12.5Hz), reached to 3.98 mm/sec, as shown in Figure (13-a), no harmonics as shown in Figure (13-b), and no peaks with high amplitude at low frequency as shown in Figure (13-c).
