Experimental Study on Repair Methods of Corroded Long Span Cables

S. Daniel Raj

Department of structural engineering
Nadar Saraswathi college of engineering and technology
Theni , Tamilnadu

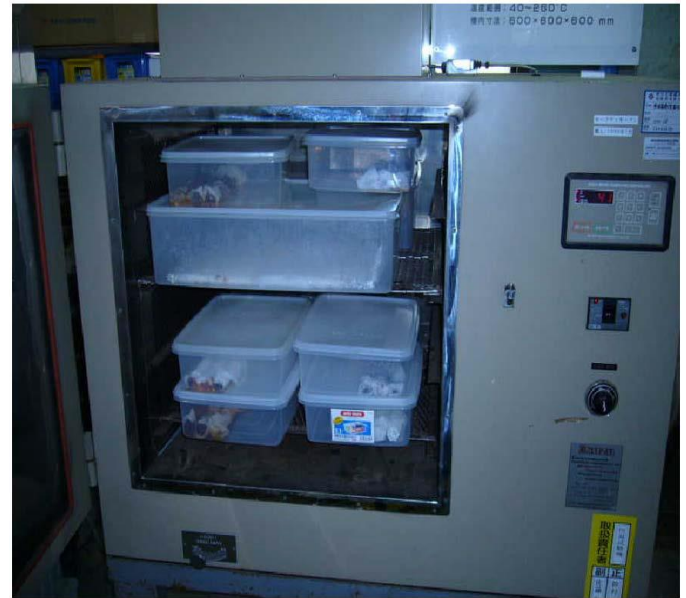
Fig 1: test strands in oven

Fig. 1 shows the appearance of the test strands 15 months after the initiation of the corrosion acceleration test. The strand was

Dismantled at the same time and the corrosion conditions of both the surface wires and inside wires are also shown in Fig. 1. In Case A-1, the surface wires were heavily corroded, especially at the points where the gauze was attached to the wires. In Case A-2, steel rust came out from the coating defect of the surface wires. In Case A-3, the surface wires were covered with a white zinc corrosion product. In Cases A-1 to A-3, the inside wires were covered overall with steel rust, which was heavy at the connection lines of the adjacent wires.

In Case A-4, the oil became partly solid, producing a mixed State of steel rust and solid oil. In Case A-5, no damage was Observed on the surface and the inside wires except for light steel corrosion at the connection lines of the adjacent wires. In Case A-6, although a white zinc corrosion product was observed, the paste was still healthy and steel rust was not observed on the surface wires. Steel rust appeared on the inside wires; however, it was lighter than in Case A-3. In Case A-7, although there was very light steel rust on the wires, the wires were basically healthy. That the mass loss of the surface wires in the repaired cases (A-2 to A-7) is much less than in the unrepaired wire (Case A-1). Among the repair methods, the dehumidification method (Case A-7) was the most effective, followed by the epoxy resin paint and filling (Case A-5), the zinc powder paste (Case A-6), and the zinc-rich and epoxy resin paint (Cases A-2 and A-3). The oil filling (Case A-4) was not as effective as the other repair methods because the oil became solid and lost resistance against corrosion. the surface wires with 450 g/m² (Fig.4). Fig. 5 also indicates that

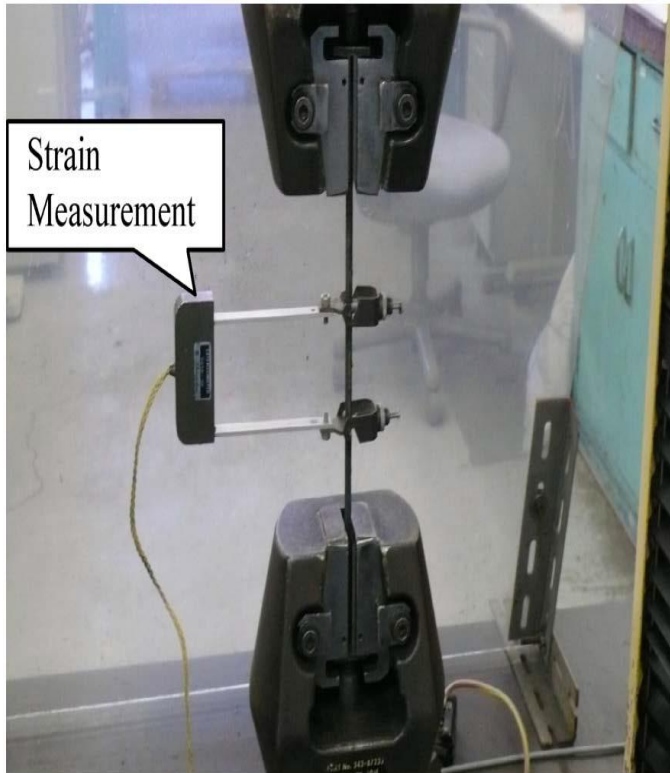
Fig 2: test strands

The surface wires of the unrepaired specimens (Case A-1), the inside wires of the unrepaired specimens (Case A-1), the surface wires with dehumidification (Case A-7), and the epoxy-filled surface wires (Case A-7). There are three specimens in each case. It is understood from Fig. 2 that the tensile strength of the surface wires in dehumidification Case A-7 was almost the same as in the original wire, whereas that of the surface wires of unrepaired Case A-1 was lower than in Case A-7 by about 75 MPa. The tensile strength of the surface wires of epoxy-filled Case A-5 and that of the inside wires of unrepaired Case A-1 are also nearly the same as the original strength. Fig. 3 shows the elongation of the same tested wires. Elongation of the surface wires of unrepaired Case A-1 was much less than in dehumidification Case A-7 and epoxy-filled Case A-5. It was found by these tension tests that corrosion significantly reduces the tensile strength and elongation of wires and proper repair is useful in preventing the reduction of the mechanical properties of cables.

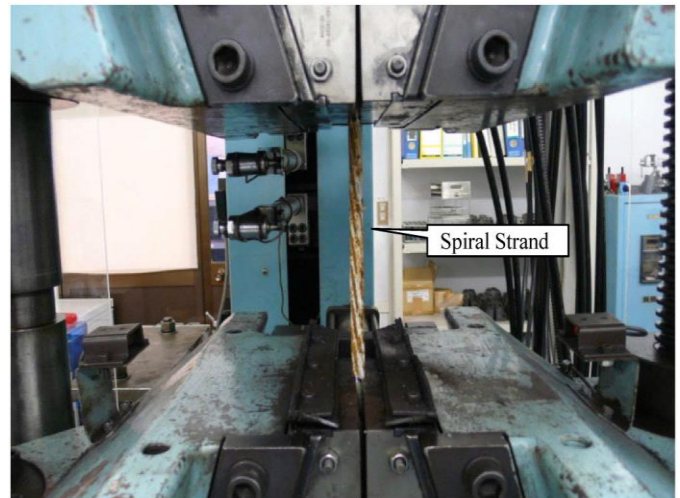
Fig 4: testing of spiral strands

The appearance of the test cable 40 days after initiation of the test. The strand was dismantled at the same time, and the corrosion conditions of the surface wires and inside wires are also shown in Fig. the wires were covered with white zinc corrosion and steel rust at the surface. In Case B-2, the surface looked healthy; however, there was some zinc rust inside. In Case B-3, the surface and inside wires were locally covered with steel rust. In Case B-4, the oil became partly solid and produced a mixed state of steel rust and solid oil on the surface wires. In Case B-5, no damage was observed on the surface and the inside wires except a small amount of zinc corrosion. In Case B-6, although the white zinc corrosion product was observed, the paste was still healthy and the steel rust was light. In Case B-7, although there was very light steel rust on the inside wires, they were basically healthy.

The mass loss rate owing to corrosion of the spiral strands with the six repair methods. The mass loss rate of the strands owing to corrosion decreased sharply with time for the first 4 months. At that time, the corroded strands were repaired. After the initial 4 months, the spiral strand without

repair continued to corrode. On the other hand, the corrosion did not progress further for the spiral strands, which were repaired by all of the six methods. These tension tests results show that although corrosion significantly reduces tensile strength proper repair is useful in preventing the reduction of the mechanical properties of cables.
