Failure Analysis of an Exhaust Valve Spring Failed in Automotive Diesel Engine

Shivarama K
Department of Metallurgy,
Stumpp Schuele and Somappa Springs Private Ltd.,
Bangalore, India.

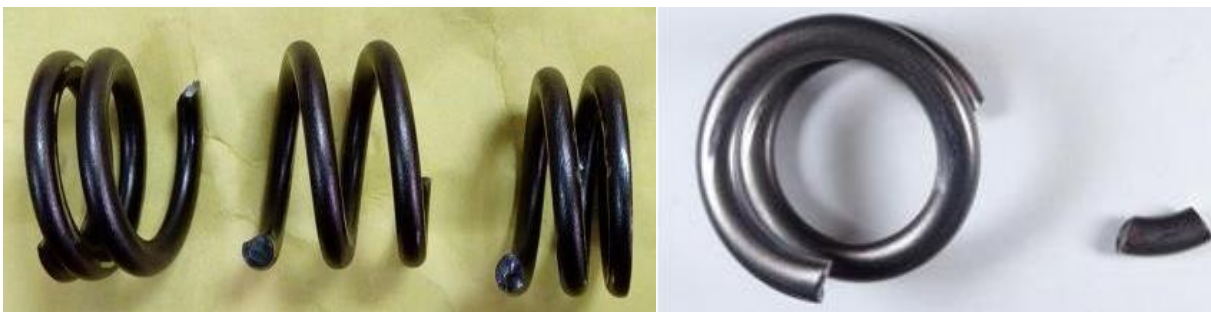
In the present case, the failed spring was failed in the field, which was assembled in a diesel engine of heavy commercial heavy vehicle. The engine has operated for 930 working hours when the spring failure occurs. The breakages occurred at multiple locations of the spring as shown in Figure 1 and 2. The oil hardened and tempered wire used for manufacturing the particular failed spring having the tensile strength of 2050 N/mm² with percentage reduction in area of 46%. The material grade of high performance spring steel wire used to manufacture the spring is Cr-Si-V with oval cross section, which measures 4.36X3.35 mm.

Fig. 1 and 2. The broken exhaust valve spring in the diesel engine and multiple fracture faces

As shown in figure 1-2, the exhaust valve spring has failed at multiple locations, specifically at 2.5th coil from both the end of the spring. The fracture faces are cut from the failed portion of the spring as shown in figure 3, cleaned and observed under optical microscope. The failure mode clearly indicates typical fatigue in nature and which has initiated from the surface in between the spring inner diameter and outer diameter and further propagated towards core, figure 4-5. Closer look at the fracture surface reveals the presence of some foreign particle at fatigue origin point and radiating ridges emanating from this point suggest fatigue failure caused by cyclic loading during the service [7]. At the fatigue origin, spring surface found to be free from any of the possible mechanical damages, tool marks or any material surface defects like crack or laps as mentioned in 2.1 and 2.2 above.

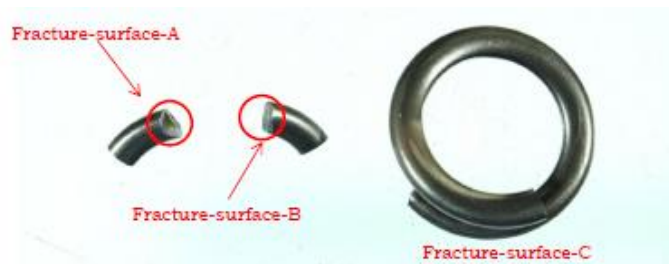
Fig.3. Fracture faces removed from the failed spring

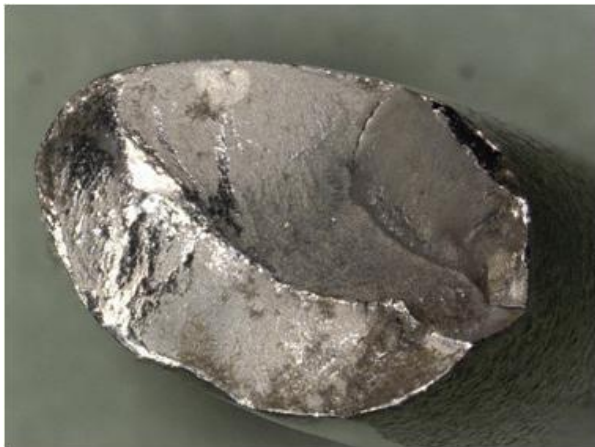
Fig. 4. Fracture face A at 10X

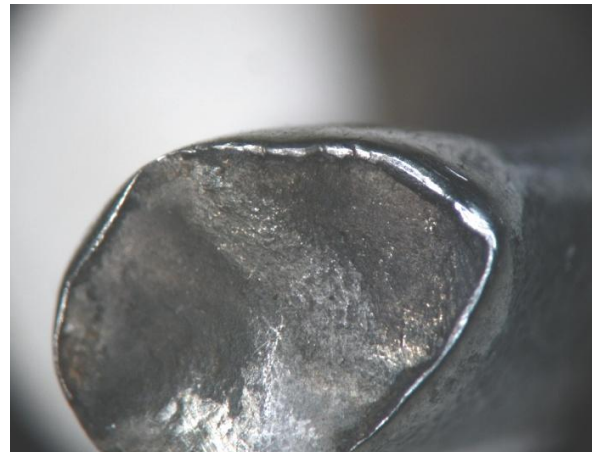
Fig. 5. Fracture face B at 10X

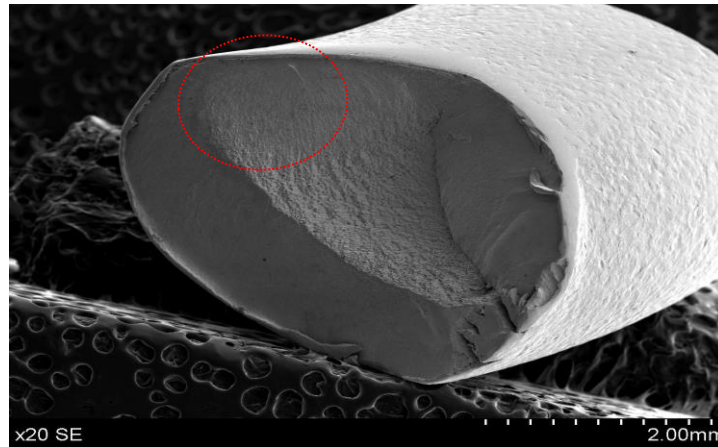
The fracture specimens are cleaned ultrasonically to remove the contaminations, there after scanning electron microscope (SEM) was used to examine the detailed features of the fracture surface [8]. Refer figure 6, a crescent shaped region on the fracture face where fracture originated and clear beach marks and further crack propagation are visible, which are typical fatigue failure characteristics. About 117 μm beneath from the spring surface, non-metallic inclusion, which carried from basic steel was observed. The non-metallic inclusion measured with size of 26.1 μm x 3.58 μm and EDAX analysis confirms the presence of Silicate type non-metallic inclusion, Refer figure 7-9.

Fig.6.Fracture face with crescent shaped region at fatigue origin

Visual and macroscopic examination of fractured valve spring revealed that the failure is typical fatigue in nature, which has initiated from the surface. A crescent shaped region on the fracture face where fracture originated and clear beach marks and further crack propagation are visible, which are typical fatigue failure characteristics [7]. The macroscopic examination also reveals that, the spring surface found to be free from any harmful mechanical damages, tool marks, surface crack or any other mechanical or material defects, which could be carried from manufacturing, assembly or any external impacts and these factors are not contributed spring failure.

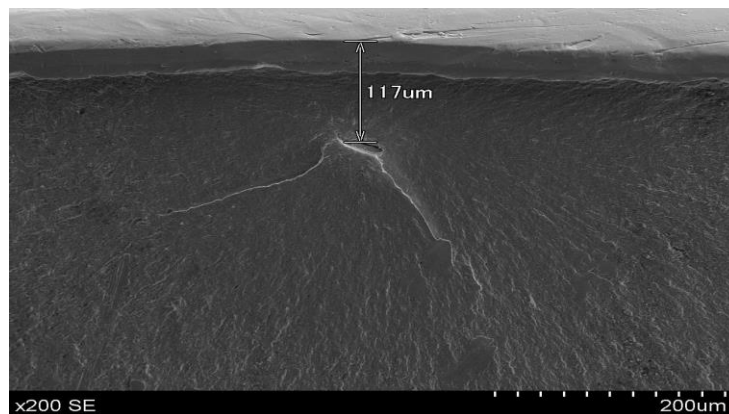
Fig.7.Presence of non-metallic inclusion at fatigue origin

Scanning electron microscope analysis reveals the presence of a non-metallic inclusion about 117 μm beneath the surface and fatigue has initiated from the same location and further propagated towards core. The non-metallic inclusion measures 26.1 μm X 3.58 μm in size. Energy dispersion analysis (EDAX) analysis reveals that the composition of non-metallic inclusion is of Silicate type. Silicate type non-metallic inclusion assumed residues of Silicon, carried from steel making process, where Silicon being used as alloying element and as a deoxidizer [3].

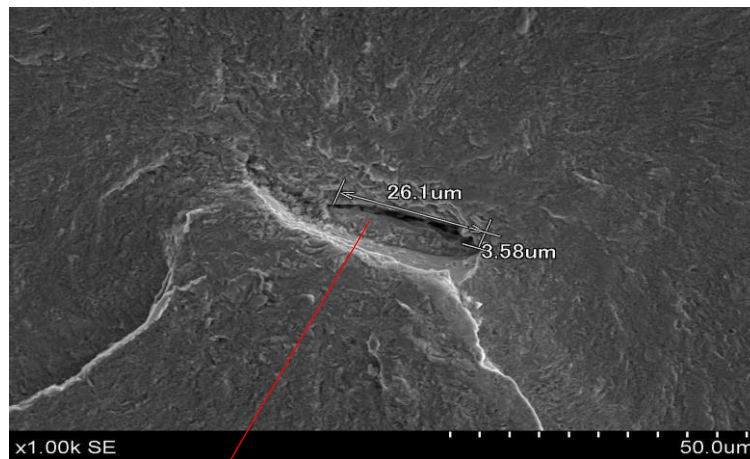
Fig.8, Inclusion size measures as 26.1 μm x 3.58 μm

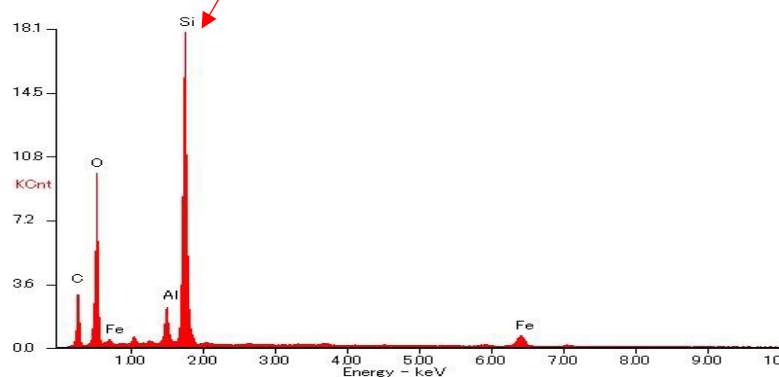
Fig.9.EDAX analysis confirms the Silicate type inclusion

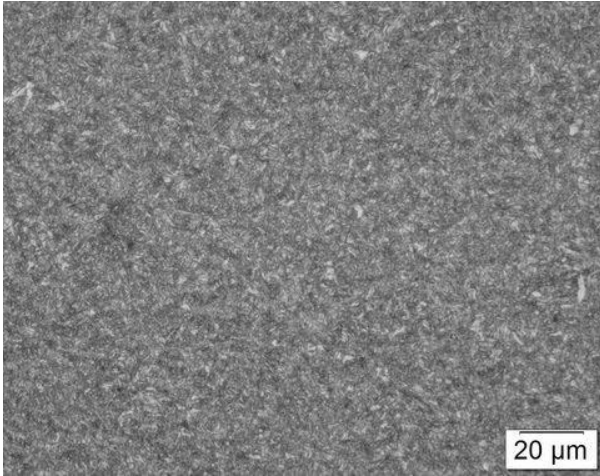
A specimen was cut from the failed spring (near the fracture surface), polished and etched using 4% Nital as standard metallography techniques to reveal microstructures. The microstructure revealed as fine tempered martensite and there is no decarburization, see figure 10-11.

Fig.10.Fine Tempered Martensite (X500)

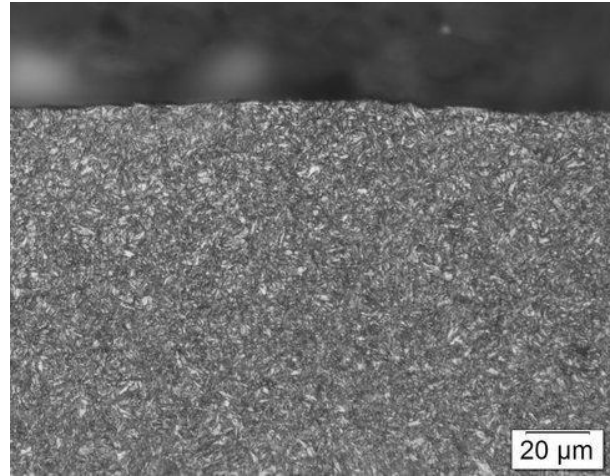
Fig.11.No decarburized layer on the surface

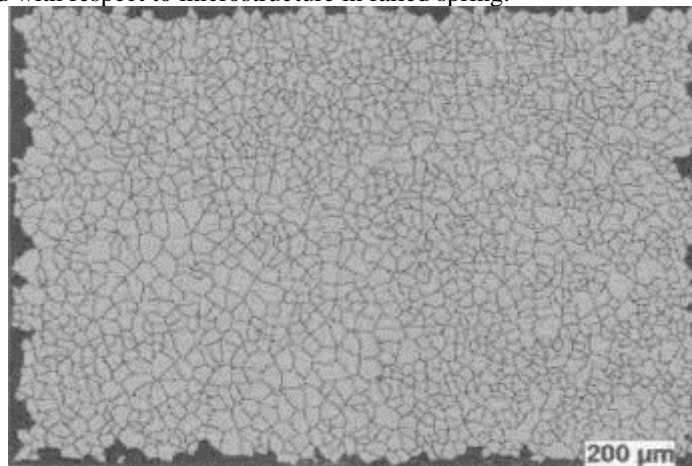
Prior Austenite grain size also analyzed near the fracture face of the spring and it measures as 7.9, see figure 12. The test method followed for measuring the grain size is IS 4748:2009, ISO 643.

Fig.11.Prior Austenite grain size measures as 7.9

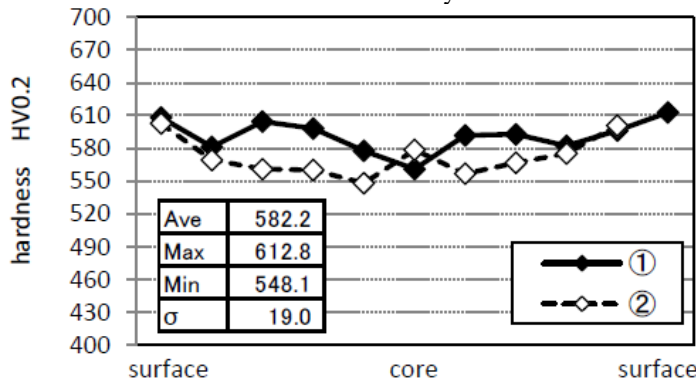
A hardness survey was made across the cross section of the metallographically prepared sample of the failed spring. The sample showed average hardness value of 582 HV, which is the acceptable criterion for the spring steel. Figure 12-13 shows the graphical representation of cross sectional hardness survey.

Fig.12.Cross sectional hardness survey

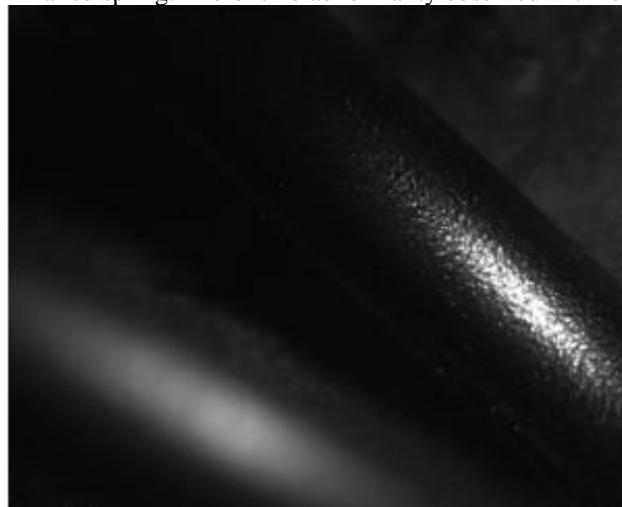
Shot peening coverage on failed spring was observed under optical microscope at 10x magnification. Figure 14 shows the uniformly distributed shot peening coverage on spring surface.

Fig.14.Good shot peening coverage on failed spring

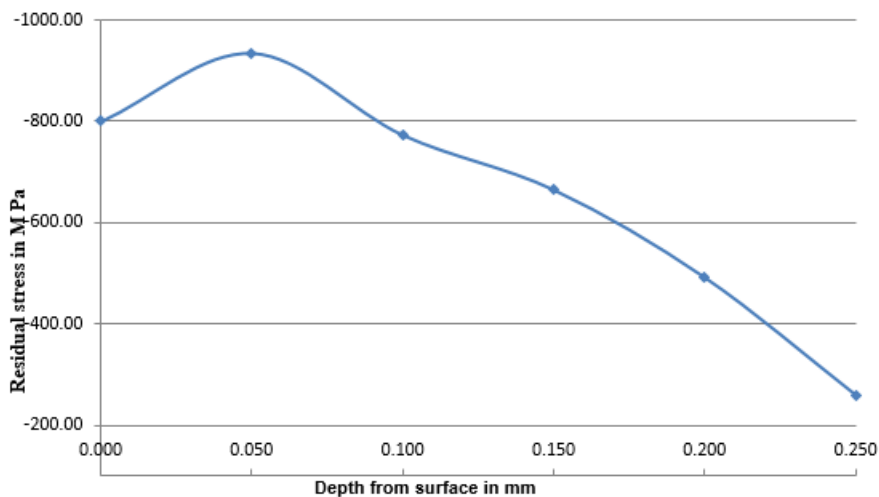
Quantitatively to confirm the effect of shot peening on failed spring, compressive residual stress was analyzed using X-ray diffraction method. Surface compressive residual stress was measured as -800 M Pa on the surface and maximum compressive residual stress was measured as -935 M Pa at 50 μm depth from the surface. Figure 15 shows the graphical representation of compressive residual stress profile in failed spring. There is no abnormality observed with respect to residual stress profile.

Fig. 15. Compressive residual stress profile in failed spring
