# Failure Analysis of Engine Valve Spring

Yogesh Mahajan, D. V. Moghe, D. R. Peshwe  
Department of Metallurgical and Materials Engineering,  
Visvesvaraya National Institute of Technology, Nagpur,  
Maharashtra, India

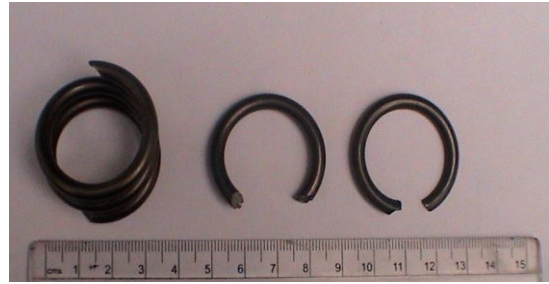
The failed engine valve spring material is demonstrated in fig. 2. The detailed metallurgical investigations were carried out on the fractured spring sample which included visual examination, optical microscopy, scanning electron microscopy and X-ray mapping.

Fig.2 Broken Engine valve spring

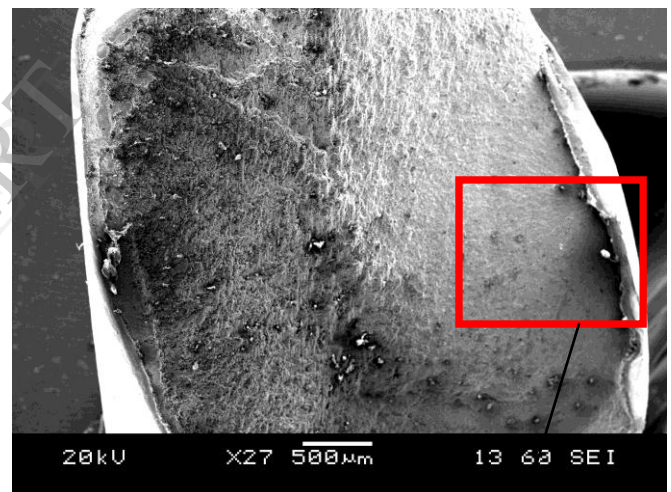
Visual examination of the spring sample revealed a generally smooth surface without any apparent indication of cracks at the outer surface. Engine valve spring, end ground at both the ends fractured at two locations - 3<sup>rd</sup> coil from top and bottom. However, the fractured portion of the sample revealed a brighter shiny surface typical of brittle fracture and is shown in fig. 3. It shows a chevron pattern radiating away from the origin of the crack as indicated in Fig. 4. The other end of the spring sample also revealed the fine grained fracture as demonstrated in Fig. 5.

Fig.3 SEM photograph of fractured surface. Selected area is magnified in SEM image no.4

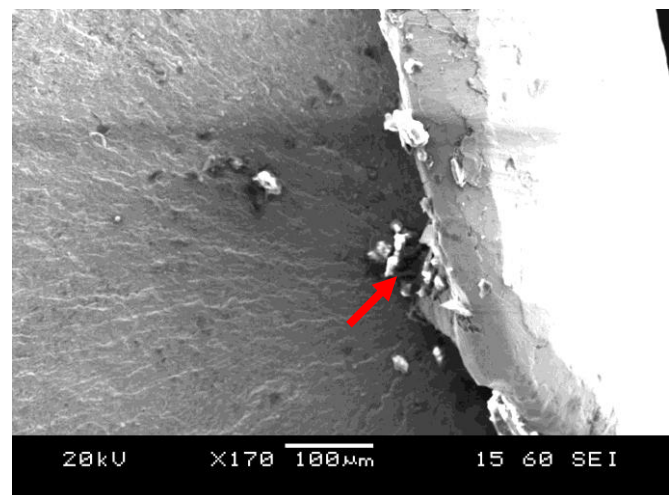
Fig.4 Magnified view of SEM image fig.4 indicating chevron pattern and origin of the crack

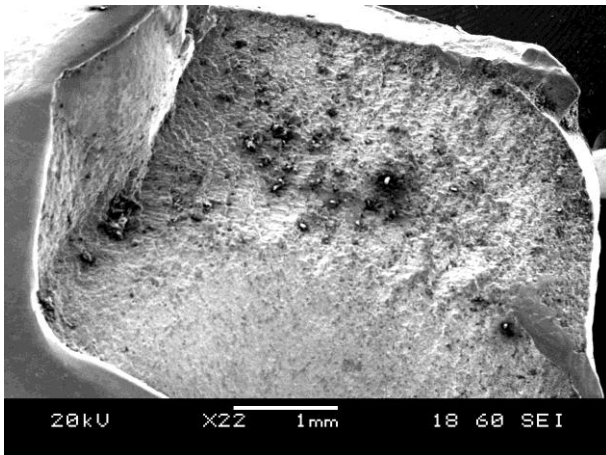
Fig.5 SEM photograph of fractured surface of other end of the spring sample

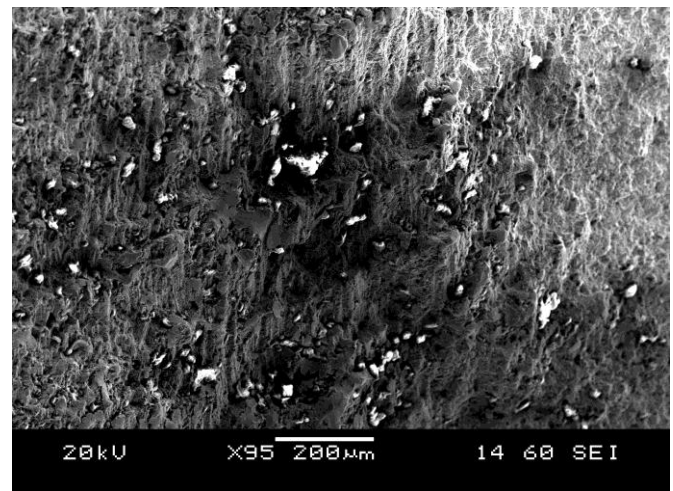
Fig.7 SEM photograph of fractured surface

Different fractured surfaces are shown in fig.7 and fig.8. Examination of the fractured surface exhibited the familiar fibrous fracture typical of a high strength spring material as shown in fig.7. It can also be deduced that the material is a fine-grained component. At some locations, fractured surface as indicated in fig. 8 exhibits a combination fractured mode of ductile and brittle fracture. Fractured surface shows the dimple fracture surface characteristic of the ductile metal as well as cleavage fracture surface characteristic of the brittle metal.

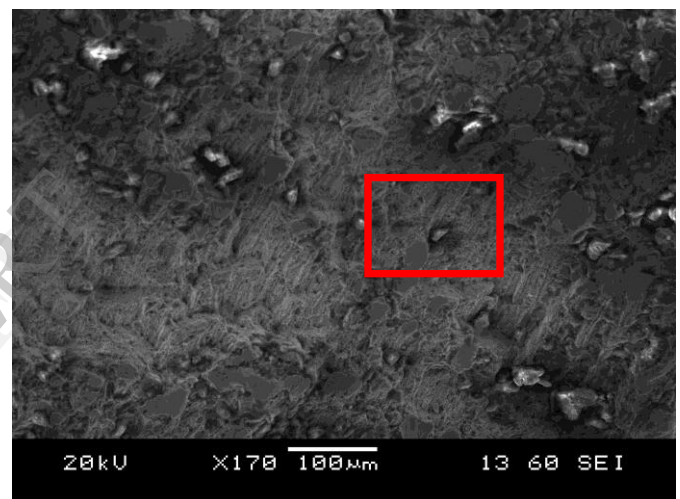
Fig.8 SEM photograph of fractured surface

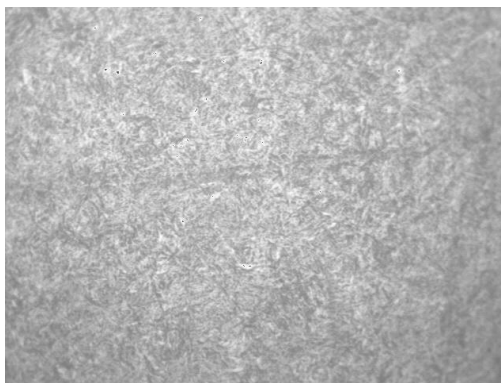
Fig.6 Optical microstructure at 500X of the sample revealing tempered martensite

For metallographic inspection, spring samples are mounted in longitudinal as well as in transverse direction and analyzed. The optical microscopy of the spring sample revealed a normal hardened and tempered structure typical of high strength spring steel, as shown in fig.6. It shows tempered martensite in the structure.

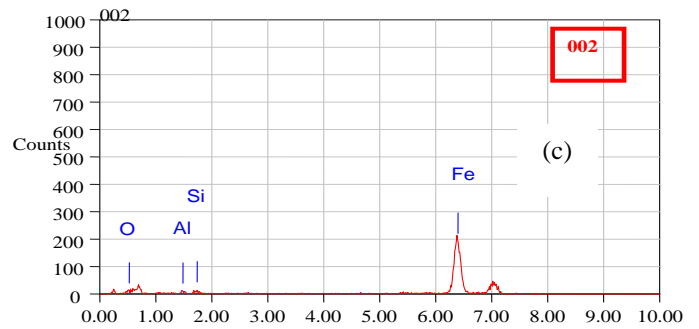
The red marked region in the Fig.8 is magnified to 3000X and shown in Fig. 9a. After analyzing, the size of the entrapped particle observed is about 10 - 20 μm size. The white regions in the fractured surface are the distinguished non metallic inclusion particles in the matrix. The EDAX analysis of the entrapped inclusion shows the presence of major constituent elements such as Silicon (25 at%), Aluminium, Magnesium and Oxygen. The adjacent portion of the entrapped particle was also analyzed by elemental image analysis. It shows intense peak of iron and small peaks for the Silicon (1.5at%), Aluminium and Oxygen. This can be seen from the EDAX graph Fig. 9b-9c.

Fig.9 Magnified view of the region shown in fig.7 indicating non metallic inclusion (a) with the EDAX spectrum taken from the inclusion region (b) and near by region (c)

The ZAF Method Standardless Quantitative Analysis indicates the presence of Silicon is about 15-25at%, Oxygen about 35-40at% and Magnesium about 15at% at the non metallic inclusion area while in the rest portion, Silicon is about 1.5 at% and Oxygen about 5 at%. The size of the non metallic particle observed is about 10-20 μm.

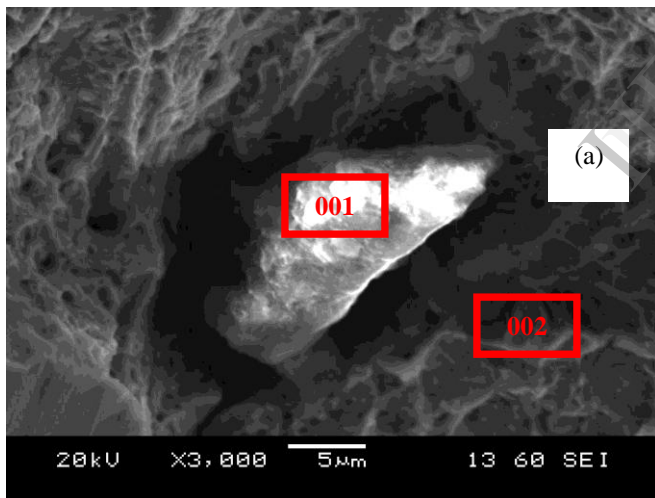
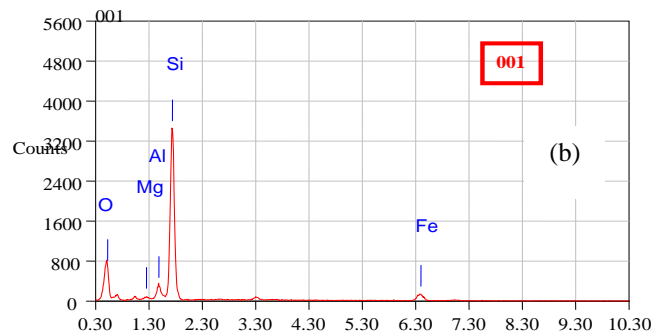
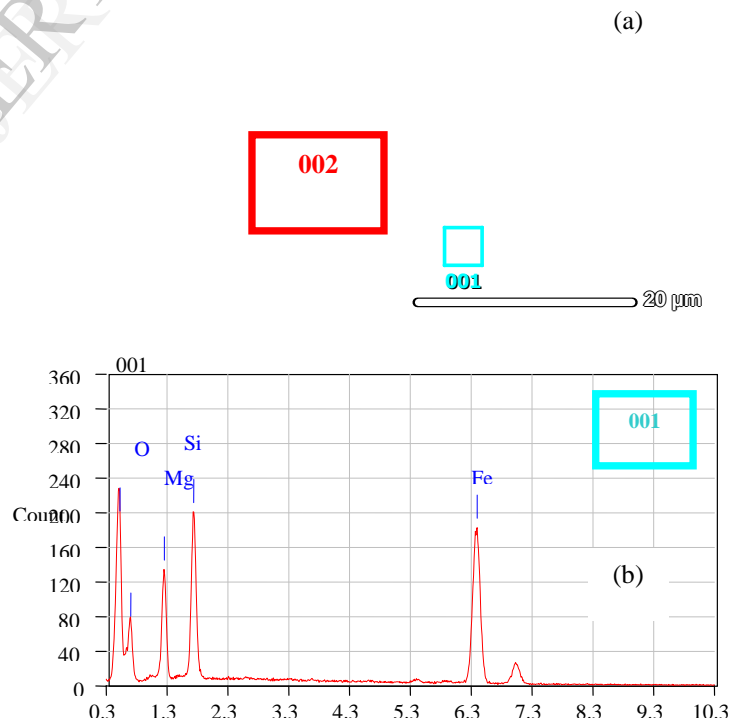
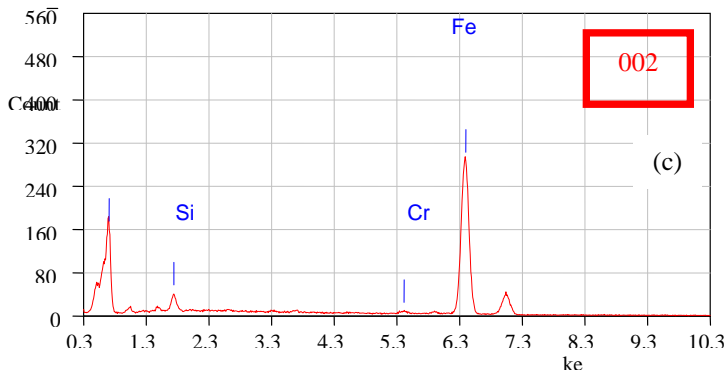
Similarly, other SEM photographs are also analyzed and shown in the figure 9 and 10 with EDAX analysis. It shows elongated dimples at the shear lips. SEM images as indicated in fig.9a, 10a, 11a and 11b of fractured surface shows inclusion matrix interface decohesion. The intensity of silicon, Aluminium, Magnesium and Oxygen peak is more on the entrapped particle than the adjacent area. SEM images of fractured surface as in fig.11a shows inclusion protruding out from the matrix. The selected area is magnified at 3700X. It clearly shows the matrix interface decohesion as indicated in fig.11b. The intensity of silicon, Aluminium and oxygen peak is more on the entrapped particle than the adjacent area. This shows the presence of Silicon, Aluminium, Calcium Oxygen, and Magnesium as major constituents in the inclusion.

Fig.10 SEM photograph at 2200X of the fractured surface indicating non metallic inclusion (a) with the EDAX spectrum taken from the inclusion region (b) and adjacent area (c).

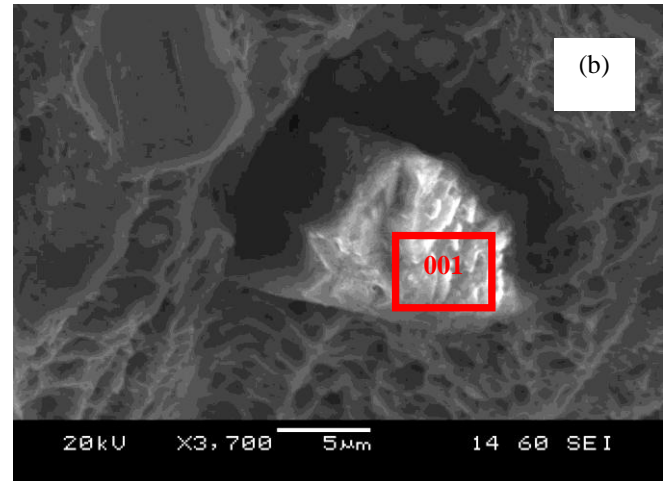
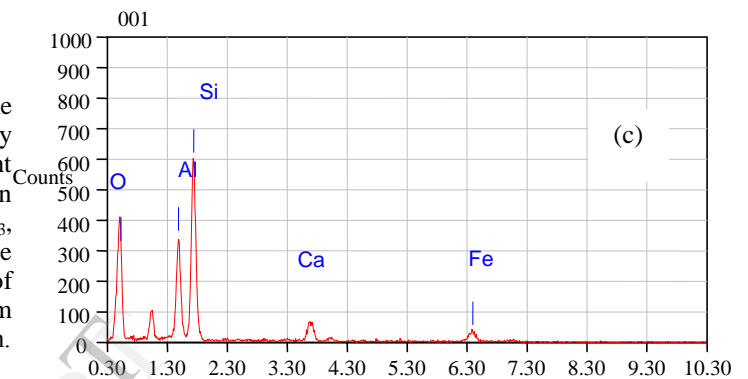
Fig.11 SEM photograph of the fractured surface indicating non metallic inclusion at 650X (a), Magnified view of the non metallic inclusion at 3700X (b) with the EDAX spectrum taken from the inclusion region (c)

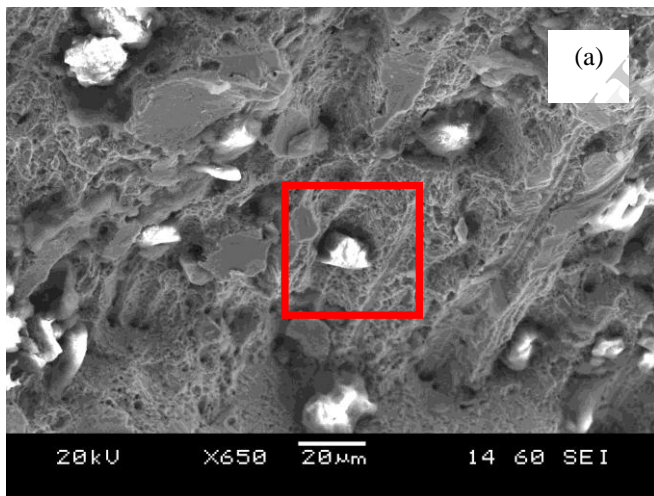
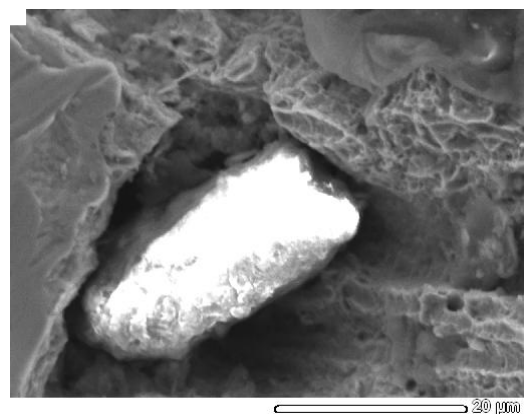
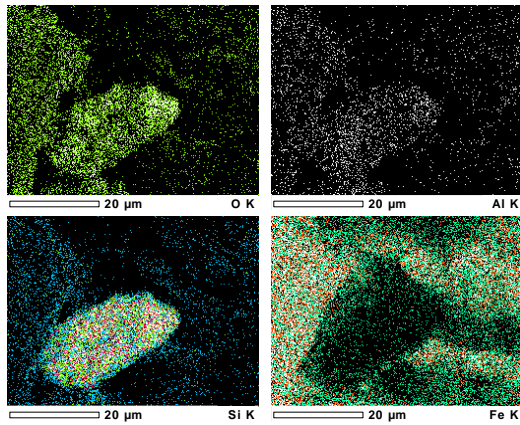
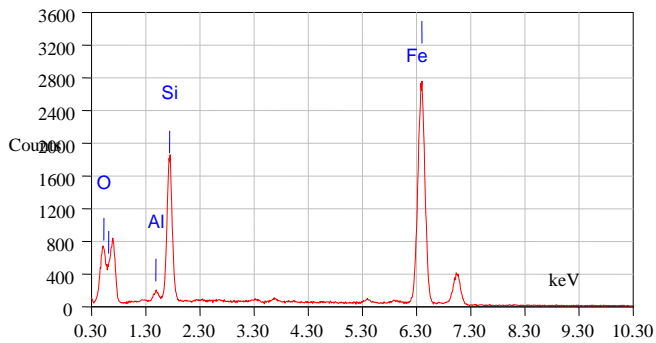
In addition to examining the fracture and the surface of the material, the inclusions were examined by Elemental X-ray Image analysis. It gives colour pixels equal to the element concentration. The location of silicon, aluminium and oxygen elements are shown in the Fig. 12. Inclusions of SiO<sub>2</sub>, Al<sub>2</sub>O<sub>3</sub>, MgO-Al<sub>2</sub>O<sub>3</sub> are known to cause breakage of valve springs. The analysis suggests that these are the non-metallic particles of oxides of Silicon (i.e SiO<sub>2</sub>), Aluminium (i.e Al<sub>2</sub>O<sub>3</sub>), Calcium (CaO) and Magnesium (MgO) with the size of about 10-20 µm.

From the above observations we can conclude that the presence of hard, non deformable, 10-20 µm size inclusions are the potential sites for the crack initiation and subsequent failure.

Fig.12 SEM photograph at 2300X with the X-ray Mapping and EDAX analysis
