# Hintze Ribeiro Bridge Collapse: Mistakes & Lessons Learned

Fabricio Gaspar  
Coimbra higher institute of engineering  
Department of civil engineering

Individual article for obtaining credit in the discipline of Structural Analysis  
Supervisor: Eng. João Paulo Martins Gouveia

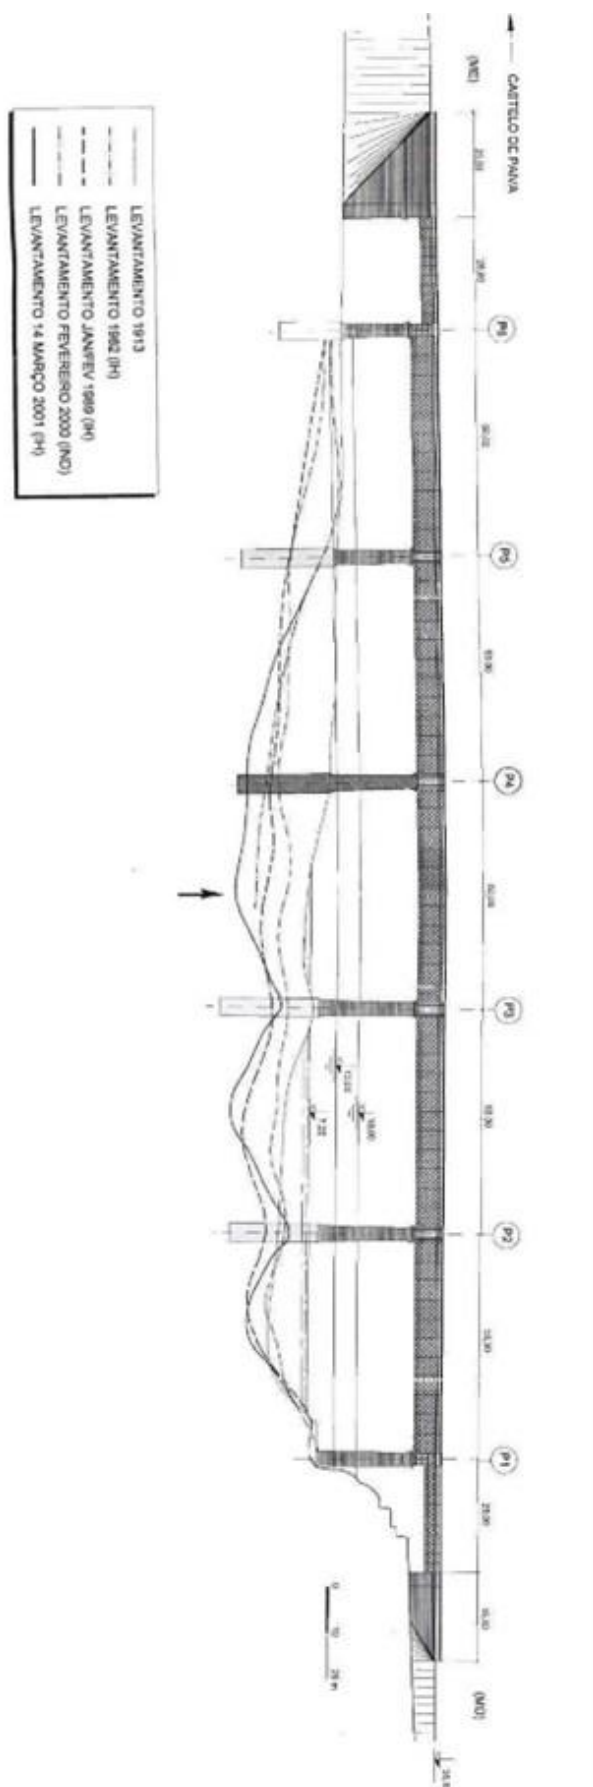
Figure 3.  
 Longitudinal diagram of the old Hintze Ribeiro Bridge over the Douro River, in Entre-os-Rios, and evolution of the riverbed level in this section between 1913 and 2001.

Figure 3 shows a longitudinal diagram of the old Hintze Ribeiro Bridge, which illustrates the evolution of the riverbed level in the bridge section between 1913 and 2001. The morphological changes that occurred in the area will be discussed in greater detail in the following sections.

From the analysis of the results obtained by various surveys and geotechnical soundings carried out, it is possible to conclude that "in the area where pillar P4 was installed, the lowering of the riverbed was greater than that observed near the other pillars of the bridge, to such an extent that it reached the level of the base of the foundation box".

Comparing the results of the surveys carried out in 1986 and 2001, it is possible to prove the existence of this process. However, "it is noted that, in the case of pillar P2, the evolution between the situations detected at the two inspection times is not very relevant. The same is true on the right side of pillar P3, that is, on the side facing pillar P2. On the other hand, on the face of pillar P3 belonging to the gap between pillars P3 and P4, between those two dates, there was a very significant localized erosion of the rockfill, with its elevation next to the face of the pillar having dropped between 7 and 9 meters".

The analysis of Figure 1 allows us to observe the evolution of the riverbed level in the bridge section between 1913 and 2000. It is possible to verify the sharp decrease in the height of alluvial material above the base of the pillars' caissons, especially in pillar P4. Between the years of 1913 and 1982, no bathymetric surveys of the riverbed were carried out, which presents a significant time lapse in data collection. Although the behavior over this period is not known, it is plausible to consider that the lowering of the riverbed "it worsened sometime between 1913 and 1982, a time that probably coincided with the construction of the Douro River dams and the increase in the amount of sand extracted, and therefore this worsening was a consequence of these factors".

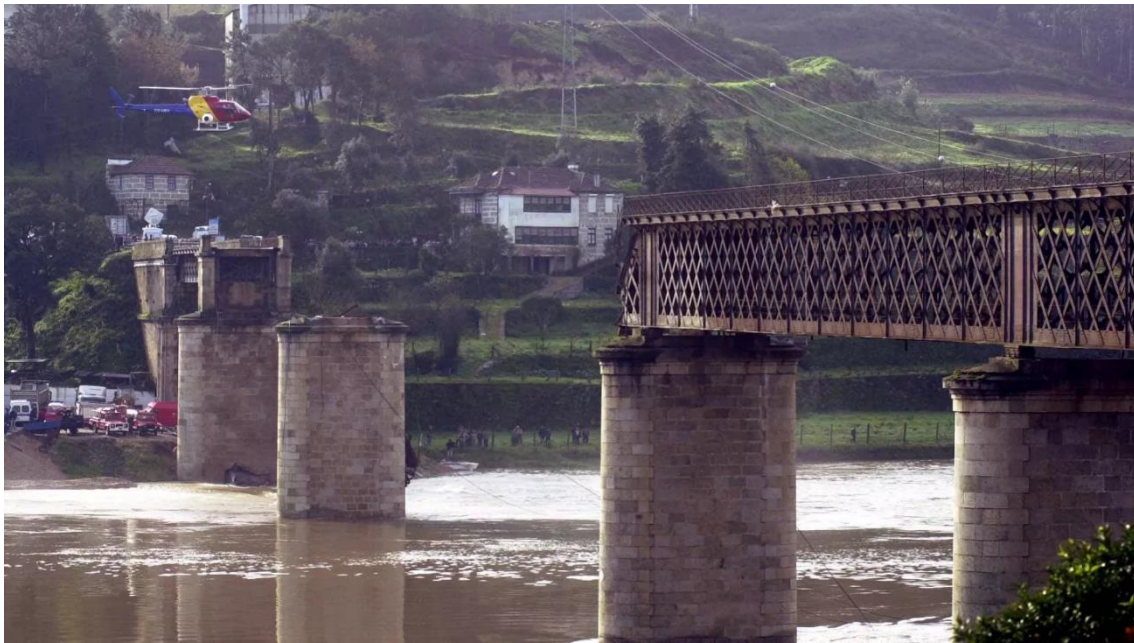
From an engineering perspective, it is important to understand the structure's failure mechanism in order to analyze the event. "The failure of the deck occurred in the sections close to pillars P3 and P5, as there were forces incompatible with its resistance capacity resulting from the yielding of pillar P4, since the deck was now supported by these two pillars and, therefore, with a span twice as large as the initial one (approximately quadrupling the values of the forces developed), in addition to the dynamic effect developed by the sudden disappearance of pillar P4."

The rupture mechanism presented in the report as being the most likely, despite all the difficulty in characterizing it, is the following: “The base of pillar P4 must have rotated around an axis that is roughly perpendicular to the direction that the pillar is now facing after the collapse (approximately 30° upstream in relation to the axis of the bridge, towards pillar P3). This rotation must have been caused by the fact that the rounded edge furthest north (upstream area) settled, which caused the pillar to lose its balance. After the aforementioned rotation began during the collapse process, the pillar rotated on its own axis, with its right-hand side (north) coming to rest on the riverbed”. It is also mentioned that “in the initial stages of the collapse of the pillar, it fractured into two large portions, which may have been caused by some opposition to the collapse that developed at the connection to the deck. The remaining fractures that the pillar presents must have occurred when it settled on the presumably undulating riverbed”.

Figure 4 – Hintze Ribeiro Bridge with high flow after the pillar fell

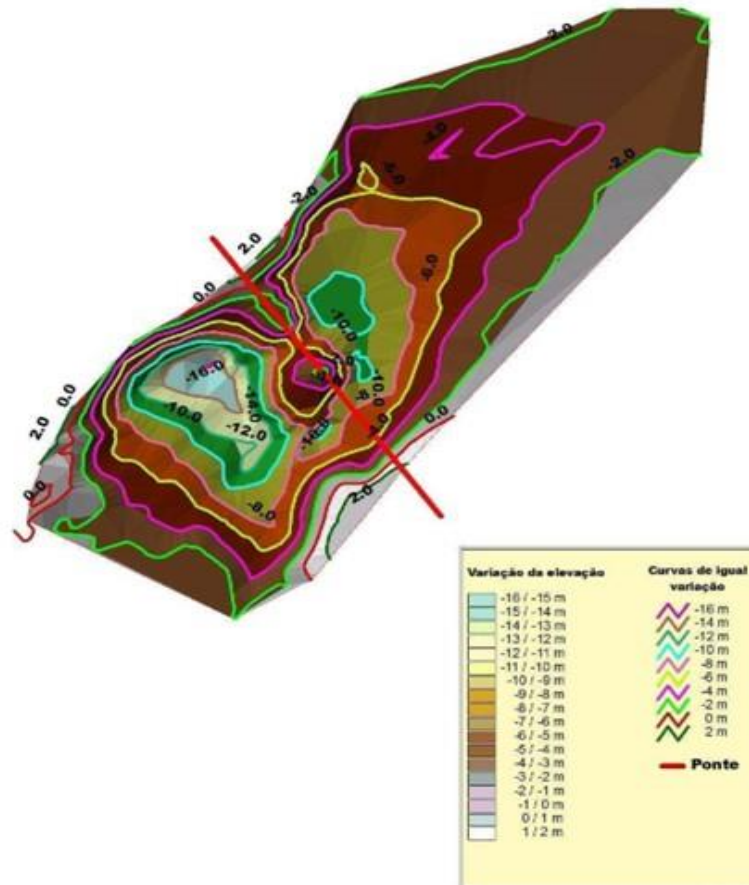
Figure 5 shows the presence of deep waters both upstream and downstream of the bridge, using a plan of the area, presented with distorted scales. The depth values indicated correspond to the variations observed between the survey carried out in 1982 and the subsequent survey carried out in 2001, after the accident, by the Hydrographic Institute.

Figure 5 – Change in depths in the area of the Entre-os-Rios Bridge comparing the surveys of the Hydrographic Institute between April 2001 and 1982. Plan with distorted scale (VELOSO GOMES ET AL. 2001).

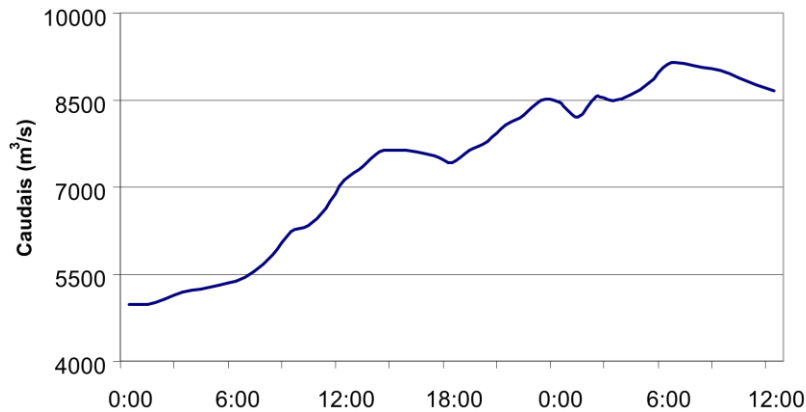
It is stated, based on the flow rates presented above, that “it is in fact the persistence of the flow rate that occurred in the hydrological year of 00/01, reflected in the average value of the average daily flow rate – 104% and 52% higher than those of 89/90 and 95/96, respectively – that explains the radical lowering of the riverbed near pillar P4. In the same sense, it is also worth noting the greatness of the minimum value of the average daily flow rate, much higher than that of any other hydrological year analysed, which means that there were no calm periods that would allow the replacement of some of the solid material eroded on the days with the highest flow rates”. However, it is important to note that up until the date of the bridge collapse, there had already been five floods that year, which had never been seen since the hydrological year of 1727/1728.

Figure 6 shows the flood hydrograph corresponding to the average hourly flows between midnight on 4 March and 12 noon on 5 March 2001.

Figure 6 – Flood hydrograph corresponding to the collapse of the bridge.  
The flow rates indicated refer to 4 and 5 March 2001.
