Investigating Failure in A Pipe Connectors

Abstract: The aim of this project was to investigate and evaluate corrosion using sample analysis and computer modelling for the causes of failure on specimens which had similar behavior and nature of failures, used in petroleum industry. A nipple-connector reducer made from malleable cast iron and 90 degrees elbow made from carbon steel A25 grade B used to carry liquid and gas in a petro chemical company located in Bahrain was used as sample.

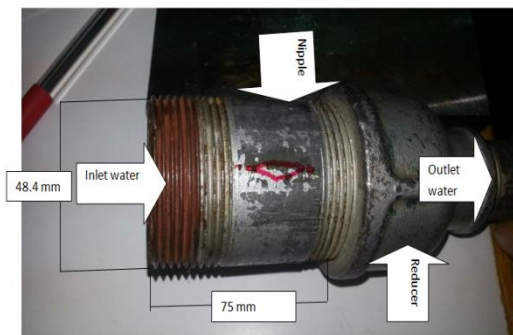
Figure 4: Sample nipple connector assembly

According to the geometry of pipe nipple-connector reducer assembly shown in figure 4, the inlet velocity at the reducer of the nipple measured by flow probe is equal to 0.0018117 m/s and the temperature assumed is higher than 28 °C at the same point.

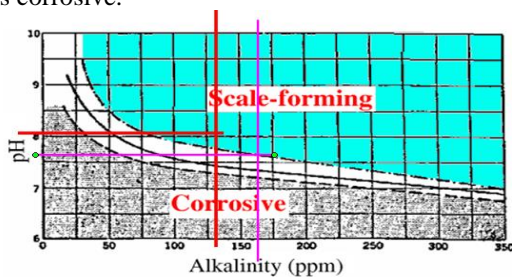
Figure 5: Baylis graph

Baylis graph (Figure 5) was used to evaluate the stability of water in both standards, the red lines in the graph shows the result of Bahrain water quality and pink lines for US standards. It shows that the water in Bahrain have a lower alkalinity and higher pH value, thus the measure of stability is visible in blue zone which means, the water is not corrosive but does have excessive amounts of alkalinity present, which will cause the formation of time scale in the lines of flow. Thus forming a coating of calcium or magnesium carbonate on the inside wall of the pipe leading to pipe clog. Thus combining results from table 1 and figure 5, Bahraini water with high level of sodium chloride,

hardness and scales increase the conductivity of water and causes corrosion.

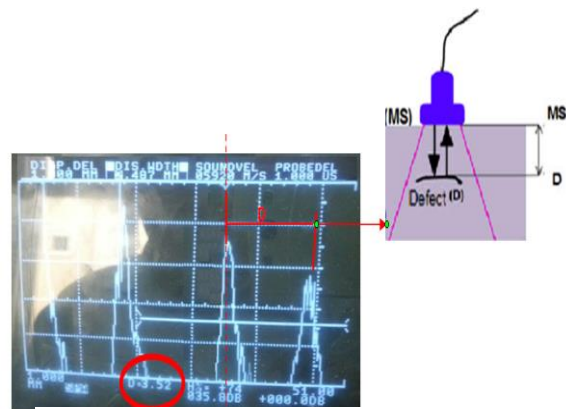
Figure 1: Ultrasonic results with defect

For the non-destructive testing using the scanning process, the pipe nipple was divided into four sections in order to scan all the area around the pipe. The results as shown in figure 6 shows time – distance relationship that will obtain the sound speed. When the wave of the sound reduces it means there is a reduction within the pipe thickness and the distance from peak to peak measures the depth of the thickness reduction.

The NDT indicates that the reduction in the thickness occurs in the dead area of the connector because of the velocity change and the turbulence factor.

covered by the probe has a diameter of 24 mm. To obtain more defined results different non-destructive tests can be applied such as radiography which can provide an image with more definitions to the defects.

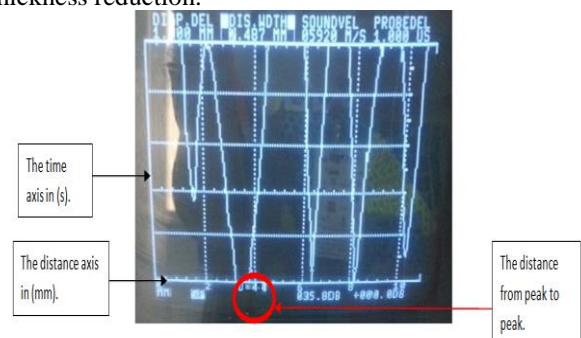
Figure 2: Ultrasonic results with no defect

In the beginning of the test the waves show the thickness of the pipe nipple that is in a good condition with no reduction. The graph in figure 7, shows the speed of the sound waves is stable in the first, second and third section, which means at this case the probe works as a sender only, it sends the waves then this waves travels through the pipe wall thickness 4.4 mm and then reflected back to the probe this indicated that the corrosion in the pipe nipple did cause some defects in the inner pipe wall to this time.

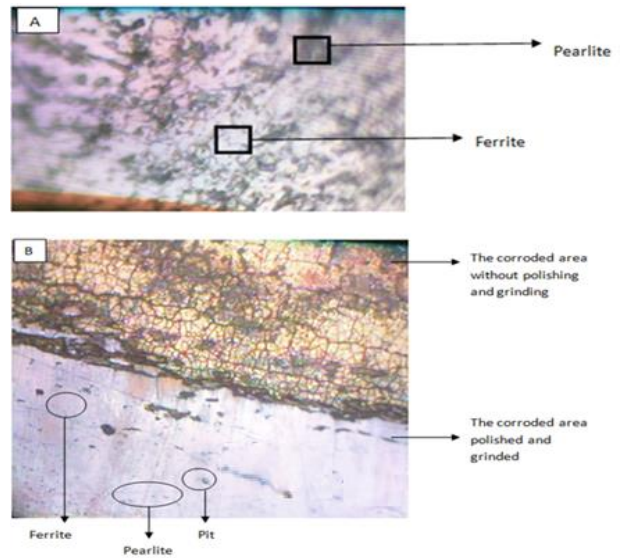
Figure 8: a - Cast iron microstructure with no corrosion
b. Microstructure of eroded cast iron

The samples were subjected to the microscope and the images are shown in magnification of X50, X100, X500. Figure 8: a) shows a sample taken from the inside wall of the eroded metal, the light area has grinded, polished and attached and the dark area shows the nature of erosion. The dark area shows the natural form of corrosion and the cracks states the breaking of the passive layer. This specimen (figure 8:b) was taken from the area where the thickness reduction was indicated, the micrographic showed that an irregular attack had occurred (figure 8:b).

The ferrite zone had been almost eroded and corroded and exposing the pearlitic zone. Comparing the corroded specimen with the non-corroded, in the first figure showed no signs of attack it had a typical a fine malleable microstructure. Some cracks were captured and they were starting to grow as the, as well as some pitting were found going deeply in the surface within the eroded surface as the dissolve of the passive layer has prepare a suitable environment for this attacks.

The micrographic test clearly shows that the ferrite zone was almost attacked leaving some pearlite at the same position. Examination of the micrographs indicated that the nipple connector reducer assembly had been given the usual annealing and normalization treatment for the fertilizing malleable iron. As a result of that, the resistance to erosion and corrosion was lower than pearlitic malleable iron. Pitting attack was distributed around the corroded zone, some of them were in their early stage but in another area it was going deeply in the material and it assumed it was the cause of the reduction in the thickness that was founded earlier during the NDT.

This attack can be cause due to different factors but in the case of the effected component it is caused when the protected layer in the internal wall of the pipe is almost attacked by erosion-corrosion which results in allowing some percent of chlorides present; thus unprotecting material and that provides a favorable condition to form pitting (figure 8:b).

The microstructural results indicate heat treatment of the replaced component that will use the same condition to produce a pearlitic malleable iron that suits the loading conditions or increasing the pipe diameter to reduce velocity and turbulence.
