Metallurgical Analysis of Fractured Connecting Rod

Anil Madaan^a, B.L.Gupta^a

^a Govt. Engineering College Bharatpur (Raj.) 321001

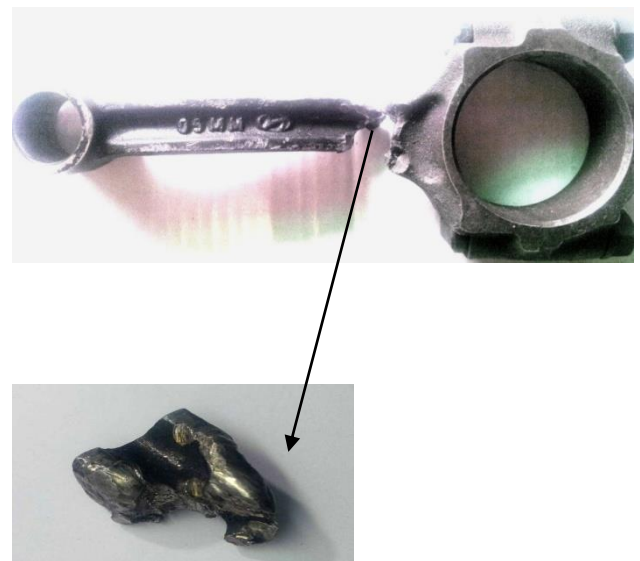
The failed connecting rod of Hyundai is shown in Fig . It is found that the fracture had taken place on the transition region between big end and the connecting rod shank. Beach marks typical of fatigue crack propagation are present . According to the curvature of the beach marks, the fatigue origin and the fatigue propagation direction were determined. The area of the fatigue crack propagation from the cracks that initiated at the internal surface is larger than that of the fatigue crack propagation where the crack initiated from the external surface.

Fig.1 Fractured Connecting Rod and Specimen according to SEM tool Holder

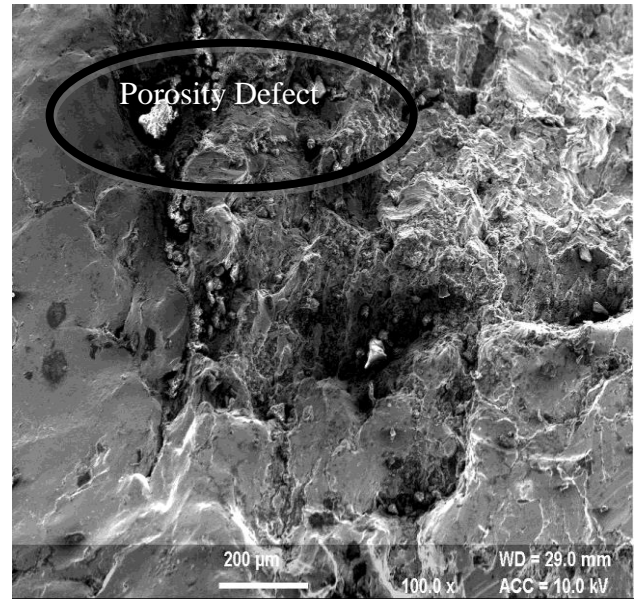
Fig 3: Image was taken at an manufacturing range of 100x

Gas porosity is the formation of bubbles within the casting after it has cooled. This occurs because most liquid materials can hold a large amount of dissolved gas, but the solid form of the same material cannot, so the gas forms bubbles within the material as it cools. Gas porosity may present itself on the surface of the casting as porosity or the pore may be trapped inside the metal, which reduces strength in that vicinity. Nitrogen, oxygen and hydrogen are the most encountered gases in cases of gas porosity.

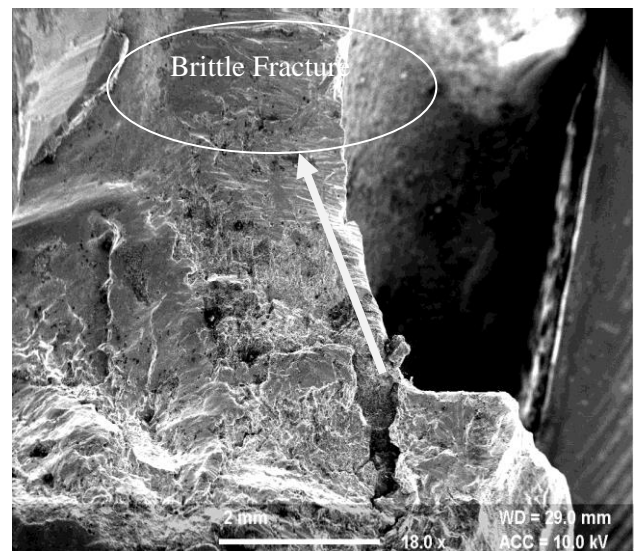
FIG4 .Image was taken at an manufacturing range of 100x

Beach marks or fatigue striations typical of fatigue crack propagation morphology were observed on fractures. It is showing casting defects i.e. gas porosity, dendritic shrinkage and accumulated inclusion, together with initiated crack. The characteristics of this shows that fracture is a brittle fracture-granular fracture (also cleavage fracture).

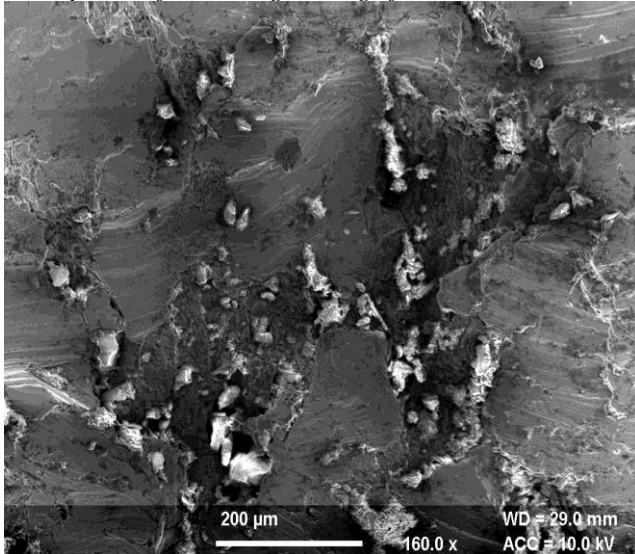
Fig 5: The image was taken at a magnification of 160x. to see the impure surface. White like crystals like material is impurity
