On the Causes and Effects of Earth Dams Failures in North-Eastern Nigeria

Abstract - An investigation of earth dam's failure in accordance with Association of States Dam Safety Officials (ADSO) 2011 guidelines was carried out in 3 northeastern states of Nigeria. A total of 42 earth dams were investigated comprising of 25 in Adamawa, 10 in Gombe and 7 in Bauchi States. Of this number, eleven (27%) were found to have failed, five (12%) were distressed, five (12%) were under construction and twenty one (49%) were functional. The failure modes exhibited include Hydraulic, Seepage, Structural and Piping. Sometimes, a combination of one or more of the failure modes with interaction in a complex manner was noticed in some dams. Lack of proper maintenance, embankment erosion, reservoir siltation and inadequate spillways are the major reasons responsible for failures of dams in the study area. To minimise incidence of failures, embankments should be maintained, reservoirs are to be desilted and spillways should be adequately designed and placed. Similarly, appropriate land use activities should be encouraged upstream. Slope protection in form of turfing (grasses) surd or rock rip rap is su

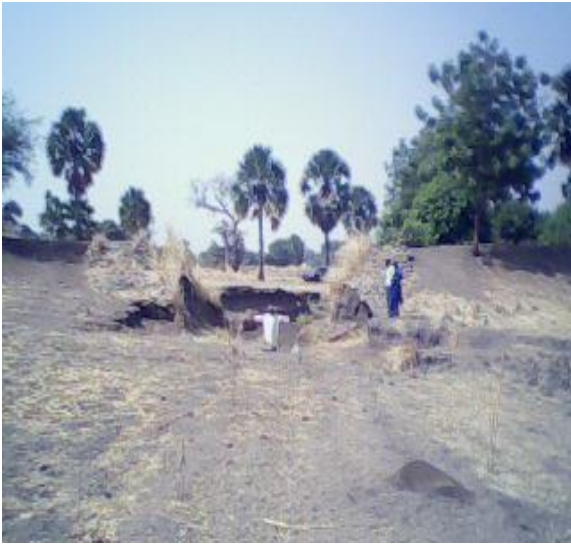
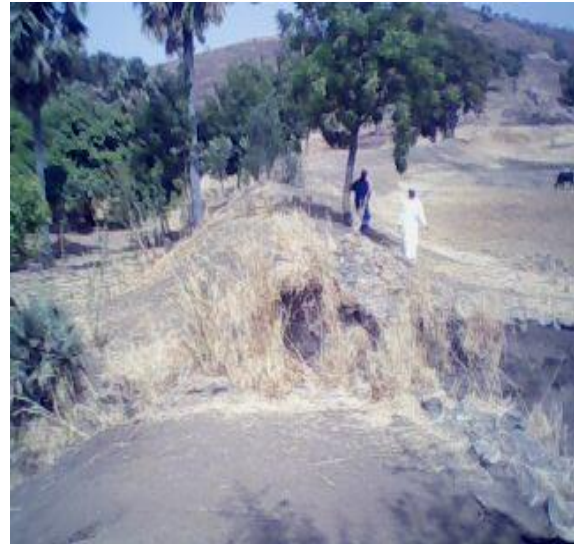
Nzuzu dam failed as a result of poor construction of the spillway coupled with general lack of maintenance. The stone pitched spillway gave way after a heavy storm; the flood breached the embankment below original ground level, retracing the original stream downstream. Animals also stampeded the embankment further weakening it and aggravating erosion problems. There is no slope protection of any kind for the dam. The impounded water in the reservoir escaped through the eroded spillway flooding some parts of Garkida town (Figs. 2 & 3)

Figure 2; Spillway Failure at Nzuzu Dam Garkida

Figure 3; Failure as viewed from Dam crest

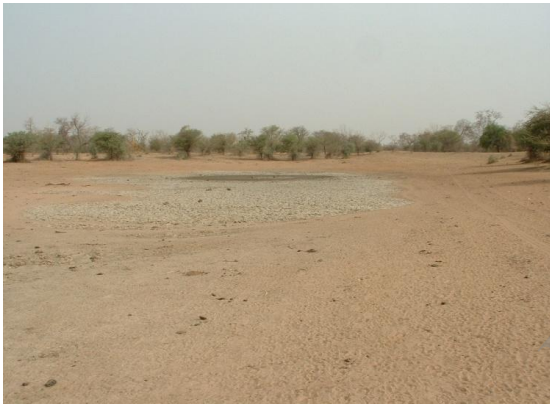
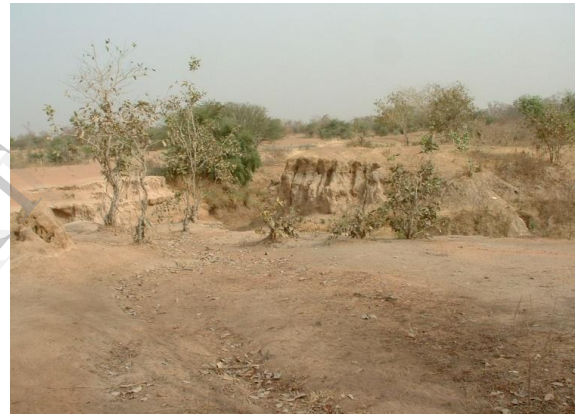
The reservoir of Nasarawo Gongoshi Grazing Reserve Dam1 (Dalehi) is silted up. Erosion has destroyed the embankment due to lack of spillway and maintenance. The dam is generally poorly maintained. There is no slope protection in place. The dam has completely failed with a gully cutting the right abutment below foundation level (Figs. 4 & 5).

Figure 4; N/G G Reserve Dam 1 Dalehi Silted up

Figure 5; Water overtops and cuts the dam forming a gully

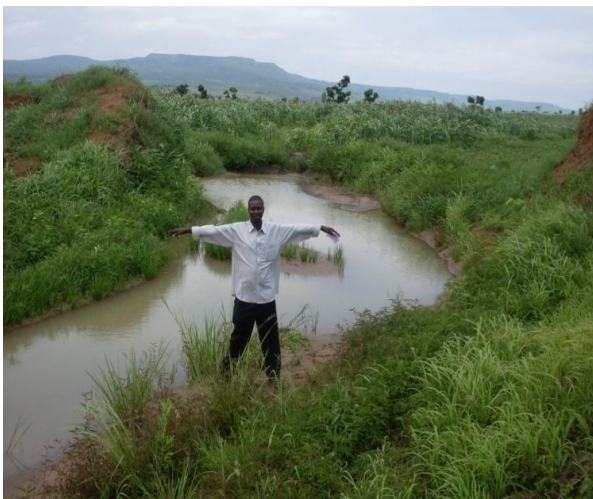
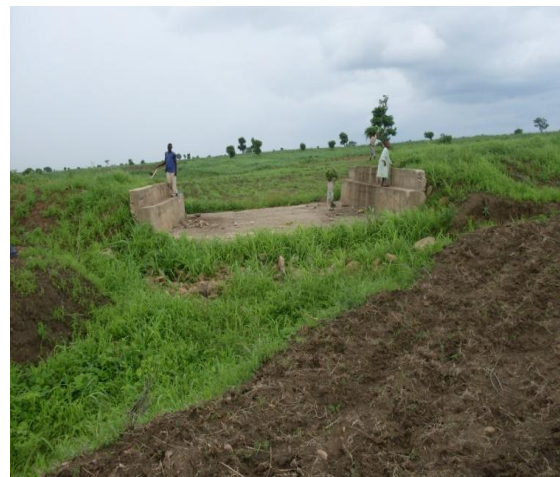
Bambam dam design height was not achieved when the contractor left the site and was paid off. Compaction was achieved using a dozer which usually does not give good results. The dam failed hydraulically when the reservoir water overtopped the otherwise short and settled embankment forming a complete breach of the dam with the stream water passing through freely (Figs. 6 & 7).

Figure 6; Complete Failure of Bambam Dam in Gombe

Figure 7; Bambam Dam Spillway

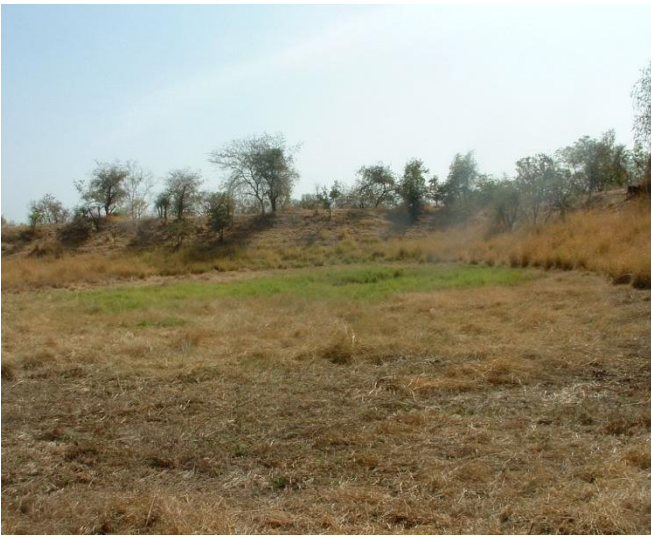
flow behind the dam due to lack of maintenance. The reservoir is completely empty. The dam has failed hydraulically. There is no slope protection, nor an appropriate spillway at site. There is virtually no access road to the dam site to facilitate maintenance (Fig. 8).

Figure 8; The reservoir of SB/GR Dam 2 remains empty

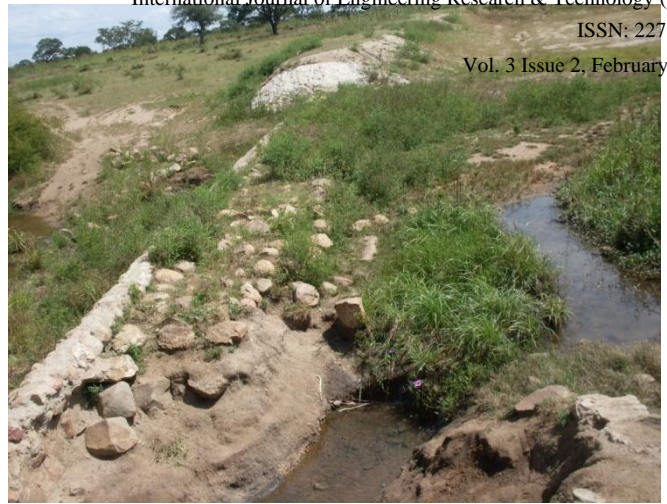
Dull dam failed as a result of a poorly constructed spillway which gave way during the first filling of the reservoir. The stone pitched spillway was fixed without a good foundation. These explain why the spillway failed and the embankment remained intact, allowing all the reservoir water to drain completely through the broken spillway. The appearance of ant's infestation on the crest shows a sign of danger from seepage and probably piping (Fig. 9).

Figure 9; Dull Dam Spilway Failure in Tafawabalewa Bauchi

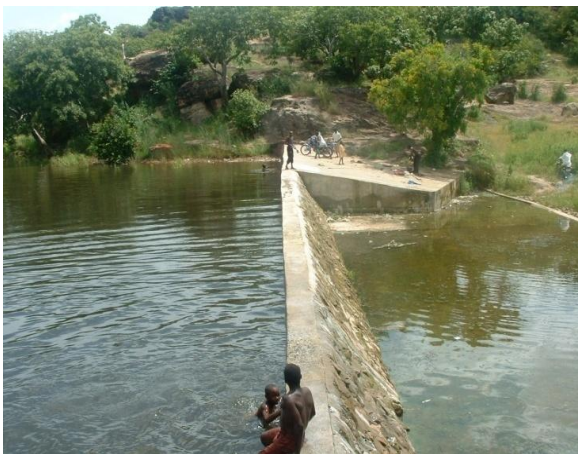
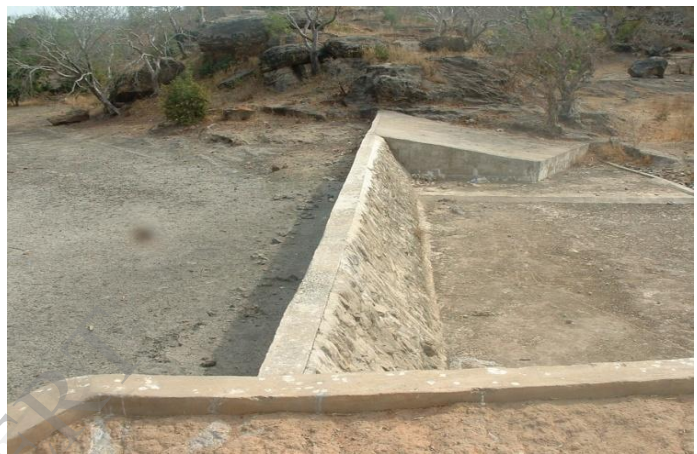
At Girei dam, weak clayey soils were noticed around the spillway area which manifested in ultimate spillway failure. Excessive wetness along the embankment and at the toe of the dam was also observed. Loose silty sands were observed as predominant soil in the reservoir area, hence the low water retention capacity of the reservoir. The reservoir was completely dry during the second site visit just after two months from the first visit when the reservoir was almost full and water was about to spill. There is termite infestation on the crest along the embankment, thus posing additional danger to the dam. Girei dam failed essentially as a result of excessive seepage, siltation and spillway failure. This explains the unique failure of Girei dam where the embankment remains intact while the reservoir remains empty for greater part of the year (Figs. 10 & 11).

Figure 10; Girei Dam reservoir about to spill and rehabilitated Spillway

Figure 11; Girei Dam reservoir empty after barely two months from first visit

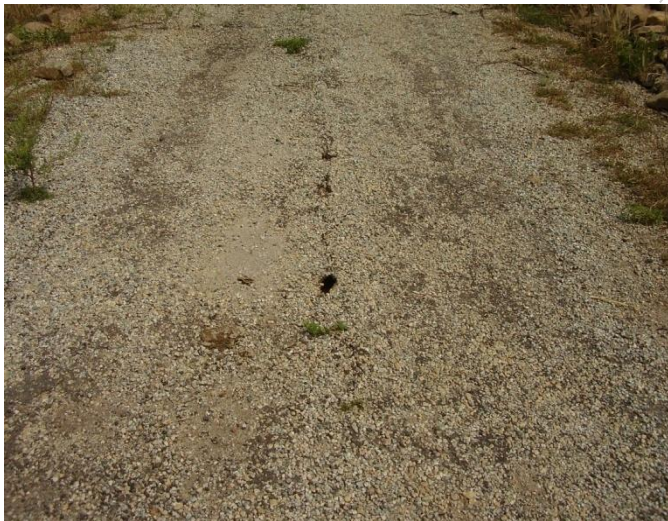
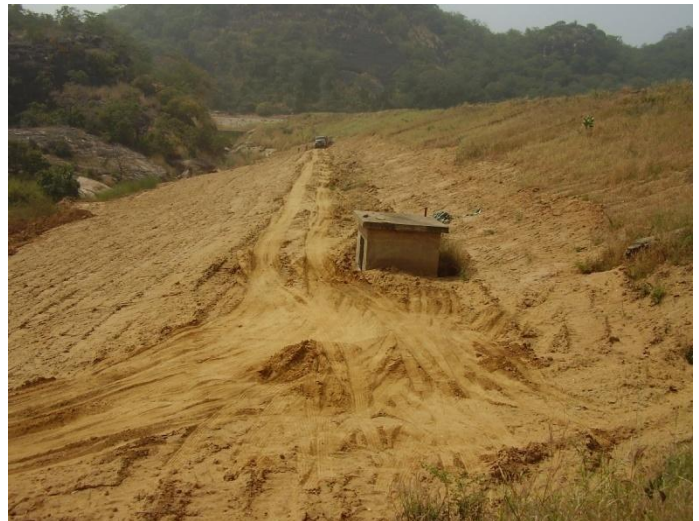
At Waya Dam in Bauchi, cracks were noticed on the crest at several positions as well as slope failures at different points on the embankment. The spillway was incapacitated and the flood wall failed subsequently. Seepage was noticed on the downstream shell of the embankment which resulted to piping and subsequently led to complete breach of the embankment. It appears that the design crest level was not achieved and coupled with a narrow spillway, the reservoir water overtopped the embankment. Both the spillway and the embankment suffered serious damages. The spillway was washed away by impounded water and the water tracks back and washed most of the downstream shell. Seepage resulted to piping and complete failure of the embankment as water from the reservoir escaped through the embankment. It was gathered that loose stockpiled materials were left on the embankment between successive layers during compaction after which the contractor left site. Later, the work was

continued as direct labor under the Upper Benue River Basin Development Authority (UBRBDA). The loose materials does not compact to desired level due to difficulty with terrain as the roller cannot be maneuvered to achieve that. Another view has it that, after the contractor left the site, vehicles, human and animals traffic created a loose dusty layer on the embankment. Loose materials (dust) in between the contractors work and that of UBRBDA staff (direct labor) was created. The loose material that was left on the embankment which could not compact very well gave way to seepage and resulted into piping which led to the failure of Waya dam in Bauchi (Figs. 12 & 13)

Figure 12; Cracks on the embankment crest at Waya Dam Bauchi

Figure 13; Rehabilitation work in progress at Waya Dam in Bauchi after failure

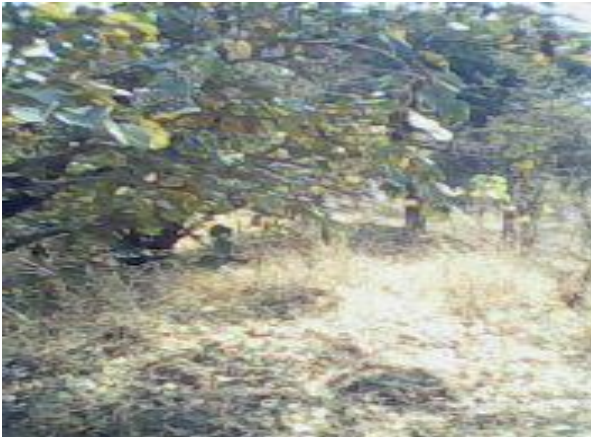
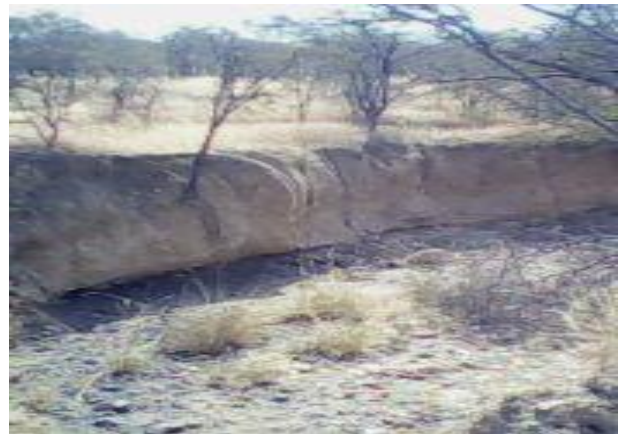
The Guyaku Grazing Reserve Dam2 failed as a result of general lack of maintenance. An eye witness account indicated that the dam was in serious threat of failure for a long time but no action was taken. The dam finally gave way when part of the embankment was washed away as a result of serious erosion and ultimate overtopping. There was no definite spillway in place to cope with the reservoir water that led to the ultimate failure of the dam. This resulted in the formation of a gully that cut the dam axis at the right abutment below original ground level (Figs. 14 & 15).

Figure 14; Guyaku Dam2 Poorly Maintained Embankment

Figure 15; A Gully cut the Embankment at the right Abutment

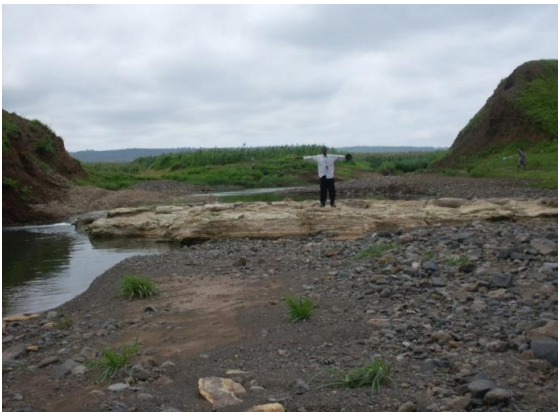
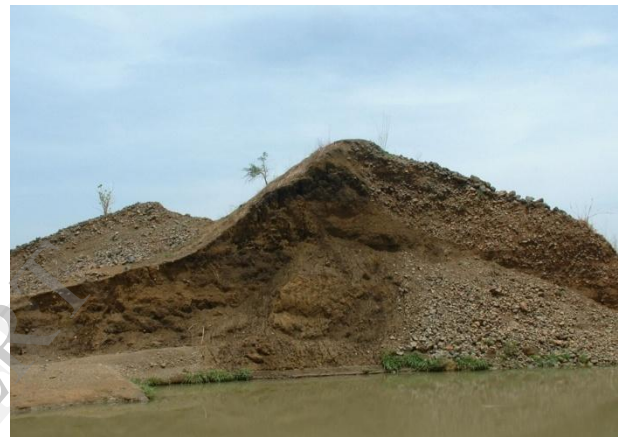
The spillway of the Cham dam was not completed signifying danger to the dam during high inflow regimes. Again, the design height of the dam was not achieved when the dam was hurriedly commissioned in 1992. The dam was constructed without following design specifications. Two different designs were found for the dam cross-section; one shows a zoned embankment with clearly delineated zones of central impervious core flanked with zones of pervious shells while the other one does not contain such zonings. The physical examination of the dam cross-section along the breach shows a homogeneous embankment with a mismatch of clayey to gravel size particles with no clear zoning. These are the major reasons for the dam failure. A similar phenomenon was observed on world population of dams by Foster et al, (2000a) and Foster et al, (2000b). The dam failed hydraulically and structurally when it was overtopped by a flashflood which undermines the height of the shortened embankment with uncompleted spillway and a very small outlet which could not drain the reservoir fast enough. With the absence of zoning, a complete breach of the embankment resulted in the cutting the dam up to foundation level, allowing the river to pass across the dam freely (Figs. 16 & 17).

Figure 16; Complete Failure of Cham Dam in Gombe

Figure 17; Crossection through the Embankment of Cham Dam in Gombe at the point of failure
