# Potential Cause of Dam and Bridge Failures due to Clogging by Drifting Floating Islands of Aquatic Vegetation

A Research Paper based on an attempted dam failure of St Marys dam

Mumba Kolala  
Ministry of Mines,  
Energy & Water Development (MMEWD)  
Department of Water Affairs (DWA)  
Box 70318, Ndola-Zambia

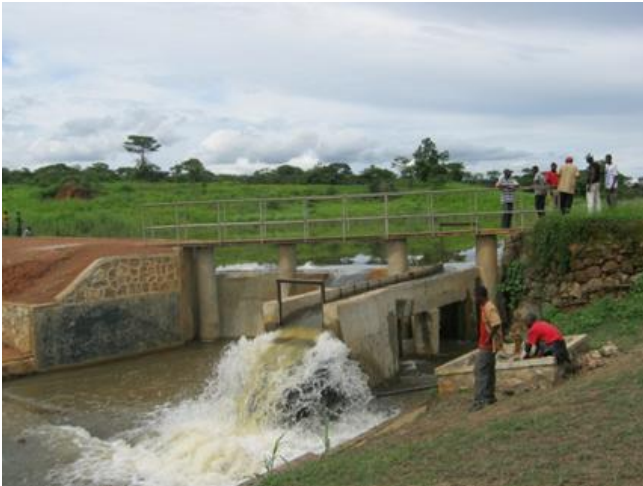
Fig 1a; A recently rehabilitated spillway of St Mary's dam before being clogged and damaged. Note that initially the dam had four pillars. December 2011. (Photo: Mumba Kolala).

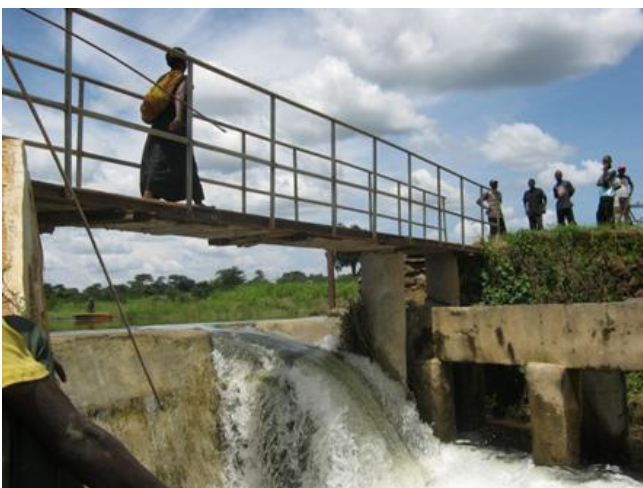
Physical observations reviewed that the concrete footbridge had its right hand side end dragged in the downstream direction for a distance of about 1m. To prevent the worst from happening, the footbridge end in question was not dragged that much to come off the headwall. However, all the four (4) footbridge pillars were displaced and fractured with two (2) of them at the far right completely collapsed and washed away within and beyond the stilling basin. Implying that the footbridge was found suspended by the headwalls and two but seriously fractured and partially displaced pillars.

Eye witnesses further stated that during the attempted failure incident, a number of prompt efforts were made to fragment the impounded floating islands so that they pass through the spillway. Nevertheless, the rescue efforts were hampered by the massive volumes of the debris, hydraulic dynamics of the river current and heavy rains that accompanied the event. The unsuccessful rescue of the dam from floating islands cannot be deemed as a surprise since they are well known to be difficult to clear. In the end the water in the reservoir built up to a level that was just less than 0.15m from overtopping the embankment's crest level. Although the force exerted on the pillars became too much for them to withstand, consequently the impounded floating islands forced themselves through the spillway at the expense of displacing and fracturing all the pillars of the footbridge, and completely collapsing and washing away two (2) of them.

Fig 1b; Traces of debris left behind hanging on one of the pillars of St Marys dam in the aftermath of the attempted dam failure. Note that only two (but fractured) pillars were left standing. February 2012. (Photo: Mumba Kolala).

- Dredging of dam reservoirs or upstream areas to dams that are heavily infiltrated with aquatic plants such as Typha;
- Dredging of upstream areas to bridges that are heavily infiltrated with aquatic plants such as Typha and are prone to flooding and surges of water.
- Design dams with bridges that have largest possible sizes of culverts or with pillars that are spaced with maximum possible spans. The same applies to ordinary bridges;
- To designing and construct bridges in a manner that does not allow ponding of immediate upstream areas.

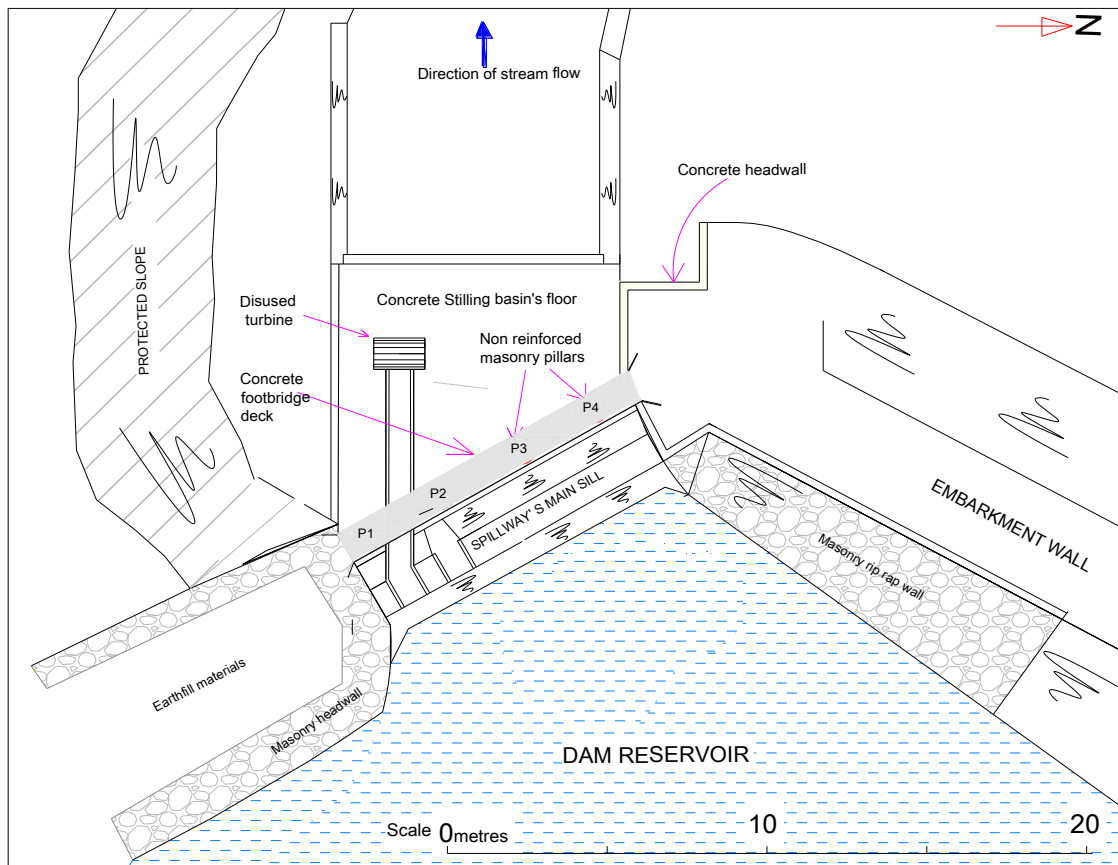
Fig 2a: Diagrammatic aerial view of spillway & adjacent area assuming that the reservoir is partially filled

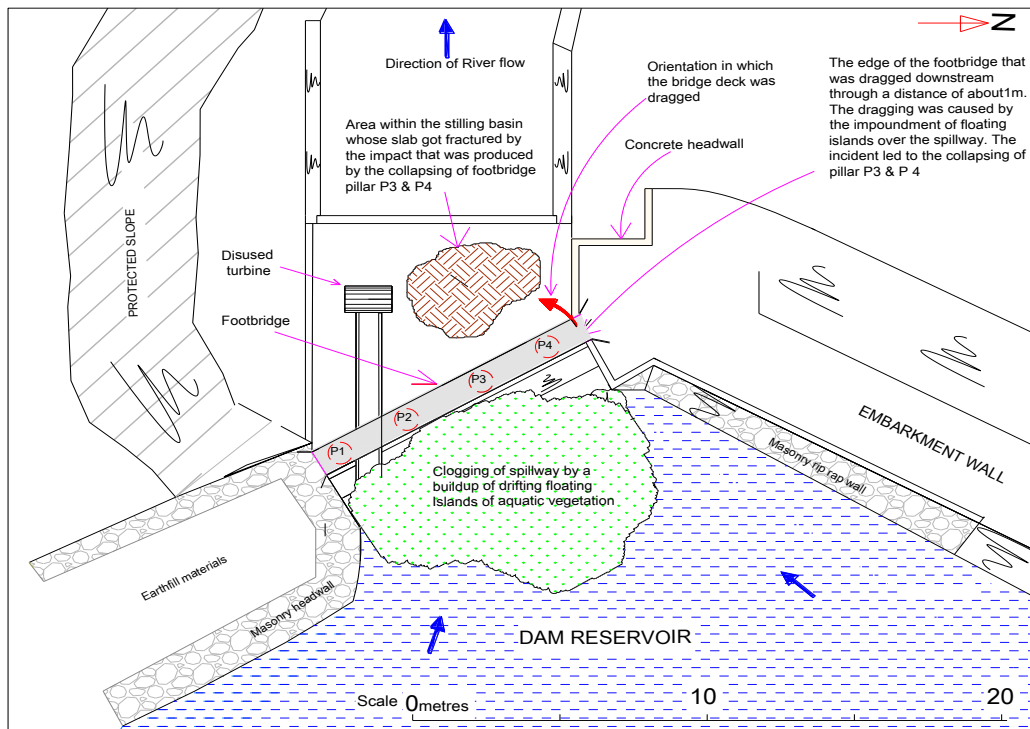
With no doubt it can be stated that the primary cause of the attested failure was attributed by the malfunctioning of a combination of spillways and a footbridge to let water flow through when a collection of floating islands clogged it during a series of heavy downpours. During the study, eye witnesses and care takers of the dam reviewed that, the attempted failure incident commenced when a collection of clusters of floating islands of hydrophytes were spotted drifting towards the spillway outlet. The said floating islands subsequently got trapped just above the main cascade of the spillway after being impounded by the pillars of the footbridge. The likelihood of the impoundment could be attributed by the fact that the average distances that separated pillars was about 1.7m and this was obviously to minimal to allow the mentioned clusters of floating islands of the weeds to bypass.

Fig 2b: Diagrammatic expression of events that characterized the damage and attempted dam failure

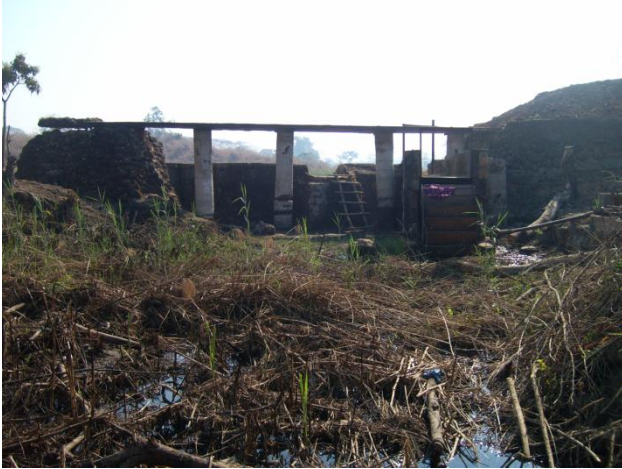
Spillway before the initial rehabilitation works July 2010. (Photo: Mumba Kolala).

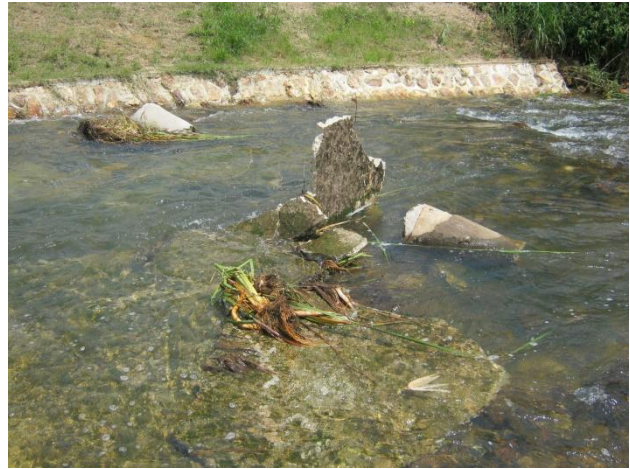
Further damage was noted on the reinforced slab of the stilling basin which had about 1/3 of its surface area ripped off and washed away.

In addition, other recorded damage during the incident was the ripping off of part of a reinforced slab to the stilling basin by the impact of the failing pillars.

Pieces of collapsed pillars & ripped off the concrete slab of the stilling basin. February 2012. (Photo: Mumba Kolala).

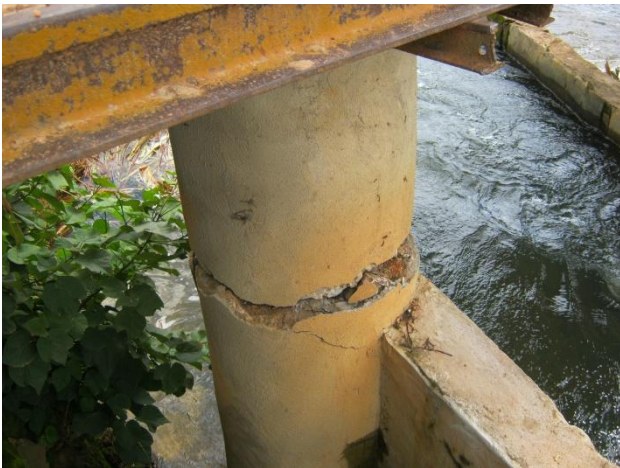
One of the two (2) severely fractured pillars that were left standing. February 2012. (Photo: Mumba Kolala).

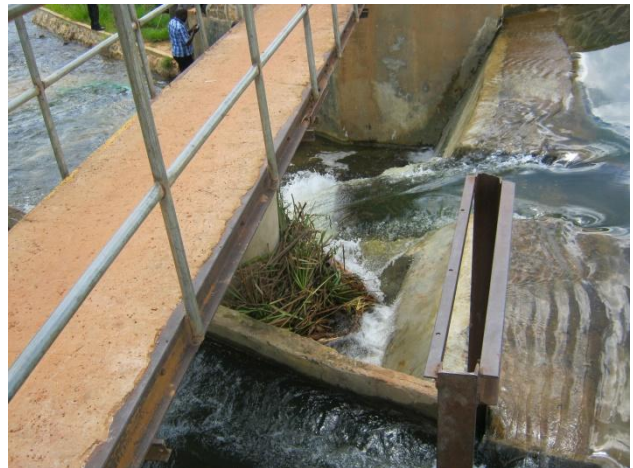
Traces of Typha debris left behind hanging on one of the pillars. February 2012. (Photo: Mumba Kolala).

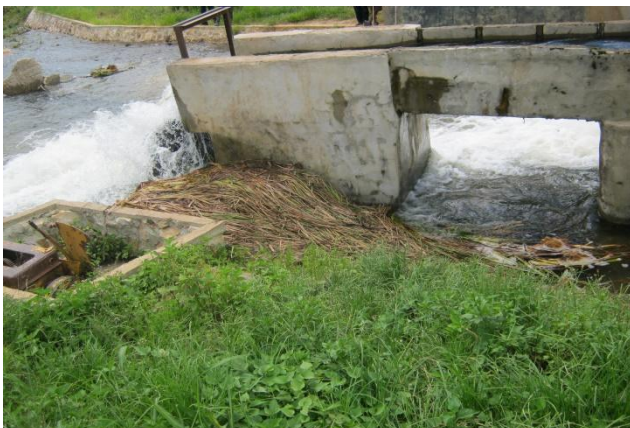
Stilling basin with deposited debris of some of the masses of Typha Plants that bypassed the spillway after the attempted failure February 2012 (Photo: Mumba Kolala).

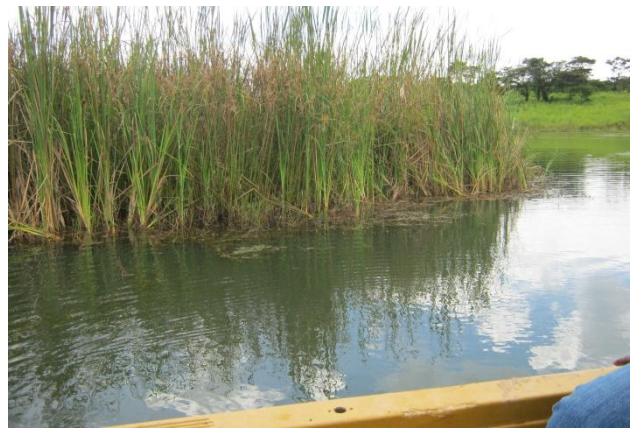
Consequently, during the mentioned period between 1997 and December 2011 i.e. a period that saw a prolonged draining (for over two decades) and then followed by occasions of filling and draining of the reservoir during the rehabilitation works, the roots of Typha plants got detached from the bottom of reservoir and turned into floating tussocks owing to the fact that their largely buoyancy biological tissue could no longer anchor them at the bottom of deep waters. Additionally, by February, 2012 i.e. when heavy rains and flush floods dominated, the reservoir was subjected to sharp rising and falling water level coupled with sharp changes in surges of water towards the dam's outlet systems (the Spillway). These fluctuation must have caused the already detached huge masses of floating islands of Typha plants to disintegrate and drift into deeper water in the centre of the reservoir where they were easily caught up by the strong river surges hence they were driven towards the spillway and were eventually impounded then led to the attempted failure of the dam but left behind a damaged spillway and a footbridge.

A floating island of Typha plants about to drift after others had moved & caused damage. February 2012. (Photo: Mumba Kolala).
