Redesign of Plans for the Rehabilitation of Over-Flow Bridge at Barangay Cansan, Cabagan, Isabela

Dr. Noel D. Binag
Associate Professor

College of Engineering and Industrial Technology
Rizal Technological University, Philippines

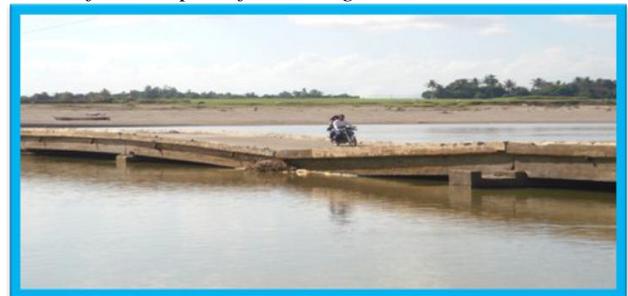
4.1.1 Deflected Span of the Bridge

Figure 5: Figure 3. Deflected Span of the Bridge

1. Passers riding in motorcycles drawn to the river due to absence of railings.
2. Road traffic accidents happened due to lack of safety signage, maintenance and unimplemented traffic control regulations.
3. Several accidents happened in the deflected parts of the bridge.

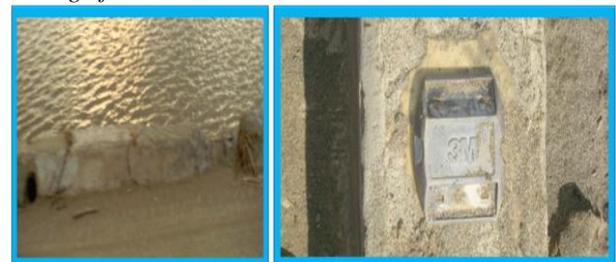
4.2. Damaged wheel guards as controlling part to prevent drawing of vehicles and motorists into the river.

Figure 6: Damage Wheel Guard and Reflectors

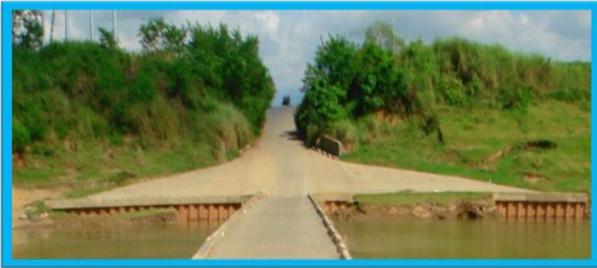
4.3. High slope of a road going down to the bridge that draws motorists into the river.

Figure 7: High Slope Road Connecting the Bridge

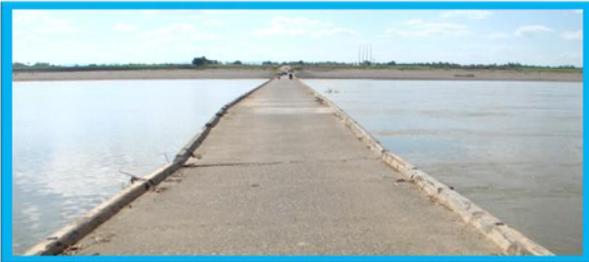
4.4. The width of the bridge cannot accommodate two four-wheeled vehicles at a time that caused traffic and delay to passers.

Figure 8: Width of the Existing Over-Flow Bridge and Guardrail Sidewalks

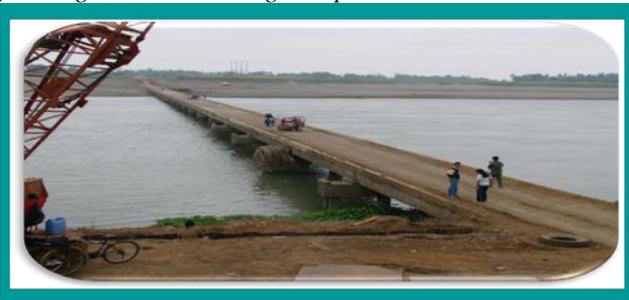
4.5. Height of the bridge from the water level during flooding that caused danger to passers.

Figure 9: Height of the Existing Bridge from the Water

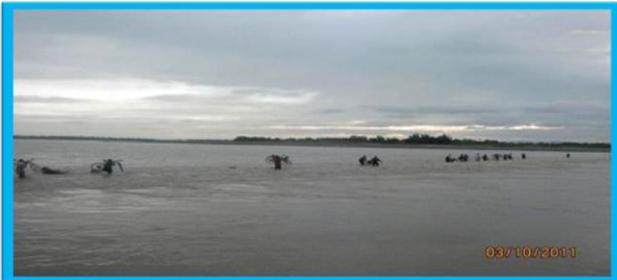
4.6. Water level during flooding

Figure 8. Water Level During Flooding

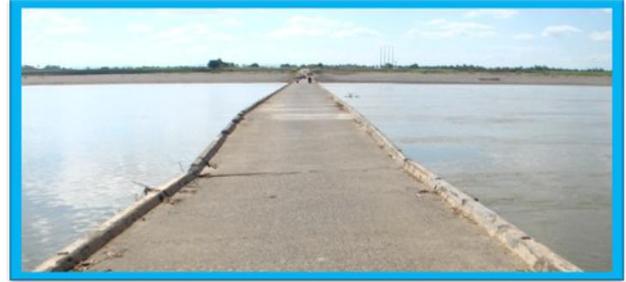
4.7. Absence of Lighting and Safety Signage

Figure 9. Absence of Lighting and Safety Signage

1. The DPWH and the LGUs of the Municipalities of Cabagan and Sto. Tomas should strictly follow and implement the standard requirements for bridge construction.
2. Proper management of the bridge by the LGUs.
3. Provide innovative design for an effective bridge as transportation facility.
4. Improve the existing over-flow bridge especially its height.
5. Provide safety measures with lighting facilities.
