# Rehabilitation and Retrofitting of Old RCC and Steel Buildings: An Evidence-Based Assessment Framework with Two Case Studies

Vishal Prasad and Prashank Mani  
Department of Civil Engineering  
Cambridge Institute of Technology  
Ranchi, Jharkhand, India

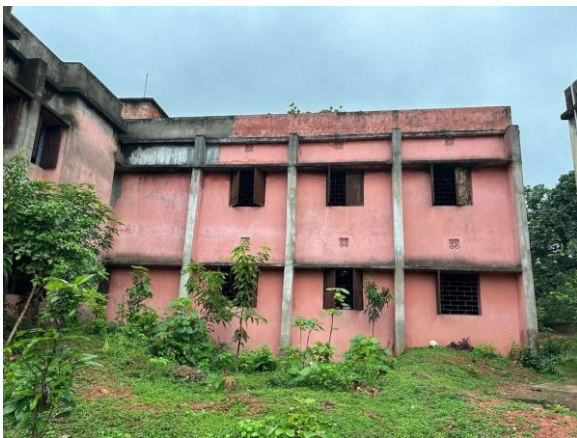
Fig. 2 shows an RC frame with regular bays, band beams, plastered infill panels and a parapet. The plaster is discoloured, with dark staining along the band beams and parapet that is consistent with persistent wetting and biological growth; plants are visible on or near the parapet, and the steel window shutters show rust staining [observed in photo]. The photographs do not show crack widths, delamination, exposed reinforcement, cover or concrete strength. The staining justifies inspection of the roof drainage, waterproofing and parapet joints, but it does not prove that the reinforcement behind the plaster has corroded.

Fig. 2. External elevation of the hostel showing weathering, staining and vegetation (photograph supplied by the author; date and orientation not recorded)

The author states that no physical tests were performed. No rebound-hammer, ultrasonic-pulse-velocity, core, cover-meter, carbonation, chloride, half-cell or soil results exist, so no test is classed as completed. The recommended sequence is: confirm geometry; inspect roof and drainage; map cracks and sound the concrete; run cover and bar-location surveys; use rebound hammer and pulse velocity for screening; select cores and chemical tests from the screening; investigate foundations where the load path is in doubt; and update the model with verified inputs [recommended, not performed].

The priority actions that follow from the evidence are to confirm the building configuration and restrict use where unstable concrete is suspected; control water by clearing vegetation and repairing drainage, waterproofing and parapet joints; complete the missing investigations; reconcile the model with the surveyed structure and re-run the existing-structure checks with corrected loads; and document and verify the as-built jacket and foundation works.
