# Stress Corrosion Cracking in CO<sub>2</sub> Compressor Intercooler

Prem Baboo  
DGM (Production & Process)

On dated 05/09/2017, the 3<sup>rd</sup> stage intercooler of CO<sub>2</sub> Compressor tubes were got damaged by stress corrosion cracking. The deep study was conducted with objective of how to developed crack on tubes.

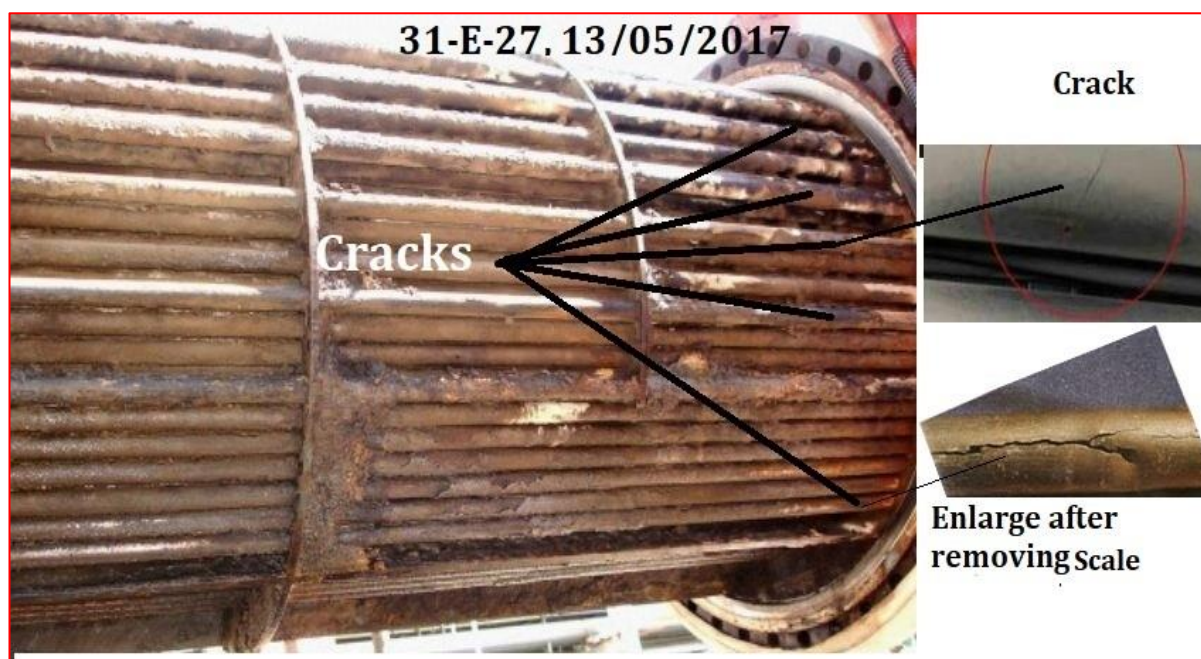
Fig-2 (31 E-27 CO<sub>2</sub> 3<sup>rd</sup> stage intercooler)

The SS 304L stainless steel tube cracked by trans granular stress corrosion cracking due to the presence of some impurity like sulphur and chlorine in a moist environment at elevated temperatures. The cracked tube section exhibited an equated microstructure without any evidence of sensitization or other material deficiencies. This is true the higher nickel (and molybdenum) content makes type 316/316L more resistant to SCC. In 304L molybdenum contents is zero. But in sample the Nickel Chloride found more. This is the evidence of Nickel contact with chloride made acidic environment and due to high pressure and temperature cracks are developed. Vibration also found in the equipment this can also lead to cracking.

National Fertilizers Ltd, (NFL) operates a fertilizer complex at Vijapur, Distt. Guna (Madhya Pradesh) consisting of two units Vijapur-I and Vijapur-II, plants were commissioned in December 1987 and March 1997 respectively. Ammonia Plants are based on M/s. HTAS's Steam Reforming of Natural Gas and Urea plants are based on M/S. Saipem's Ammonia Stripping technology. The Vijapur unit, which is an ISO 9001:2000 & 14001 certified, comprises of two streams. The Vijapur have two ammonia plant M/S. Haldor Topsoe Technology, Denmark capacity 1750 & 1864 TPD for Line-I & line-II respectively and four urea plant of M/S.Saipem In Urea plant 31 unit CO<sub>2</sub> compressor 3<sup>rd</sup> stage intercooler tubes were got damaged due to stress corrosion cracking on 5/09/2017 The problem analysed and repaired the tubes by replacing the tubes.

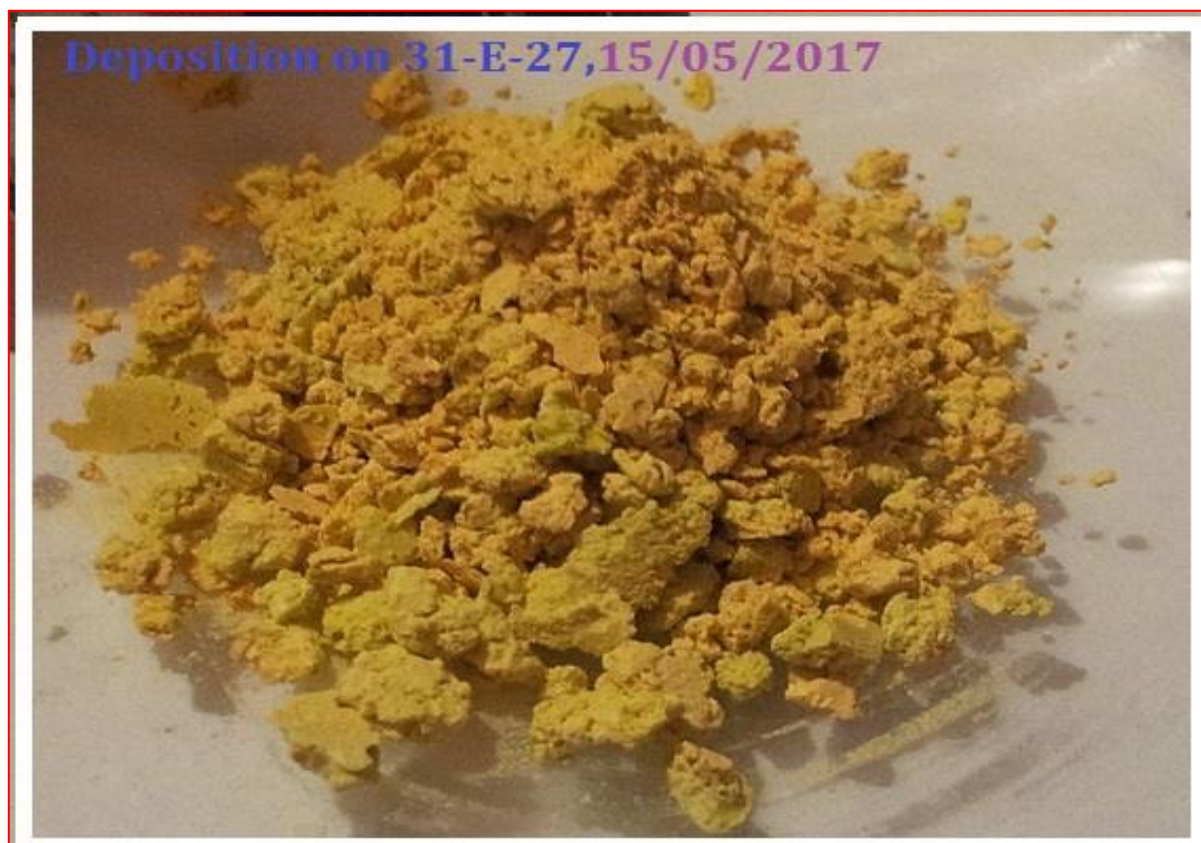
Fig-3 (deposition on shell side)

pH of the shell inside the shell side decreases from 7.2 to 4.5, which causes further acceleration of corrosion process. Large ratio between the anode and cathode areas favours increase of the corrosion rate. Corrosion products Fe (OH)<sub>3</sub> form around the pit resulting in further separation of its electrolyte. Due to high pressure and temperature at low pH cracks were developed on tubes. Mechanical damage of the passive film was caused by scratches. Anodic reaction starts on the metal surface exposed to the electrolyte. The passivity surrounding surface is act as the cathode. Non-homogeneous environment may dissolve the passive film at certain locations where initial pits form.
