# Rehabilitation of Structural Members

**Abstract**—In this project non destructive leakage detection method is adopted to detect early leaks that are not possible to detect through visual examination. The purpose of this work is to increase the durability of the building, avoid damages and minimize the energy consumption in repairing of water leaks on building. The leakage detection methods done are focused on cost effectiveness. The leak detection method uses infrared sensors to detect the water leaks in structural members. The temperature variation gives a colour change and thus the leaks are detected. The solution for water leak is prescribed. The sealing material is tested for water proofing property by impermeability test and it is applied on the existing damaged structure and the source of water leak is thus arrested. Thus the leak is sealed and the life of structural member is increased.

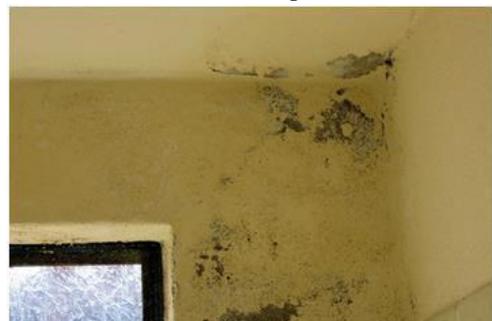
Fig.1. Image showing damages occurred in roof and wall due to water leakage

When hidden leaks go undetected, the problem threatens property values, your utility costs increase, and repairs become more costly. Small punctures, membrane splits or mechanical damage to waterproofing membrane result in wet insulation, mold, and costly interior damage. Leaks can go unnoticed and the water exit location might not correspond with the point of entry. Thus leak detection is an important criterion.

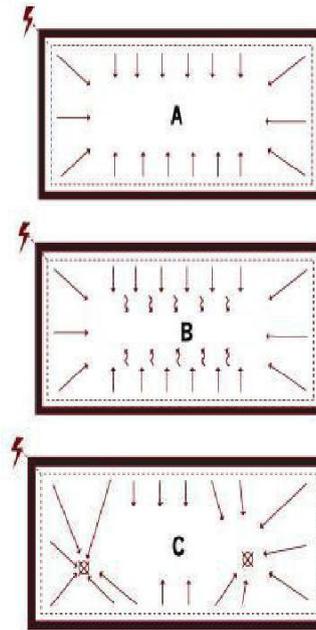
A. Small electrical pulses are directed onto the membrane. The electricity searches for a ground connection.

B. If the membrane is watertight, the electricity is isolated and does not find a ground connection.

Fig. 1. PRINCIPLE OF EFVM

C. If the membrane is not watertight, the electricity makes a ground connection and is pulled toward positive poles.

An electric field is created by applying water on the surface of the membrane and using the water as a conductive medium. The EFVM equipment delivers a low voltage pulsating electrical charge between the non-conductive waterproofing membrane and the conductive structural deck. A watertight membrane will isolate the potential difference, while breaches in the membrane will cause an electrical connection to occur. The inspectors read the directional flow of the current with a potentiometer to locate the point of entry with pinpoint accuracy. The EFVM technicians then complete the test by conducting a visual inspection of all wall junctions, perimeter details, and membrane penetrations. All breaches are numbered to allow for repairs by the water proofers onsite and are retested to confirm water tightness. Small electrical pulses are directed onto the membrane. The electricity searches for a ground connection. If the membrane is watertight, the electricity is isolated and does not find a ground connection. If the membrane is not watertight, the toward positive poles.

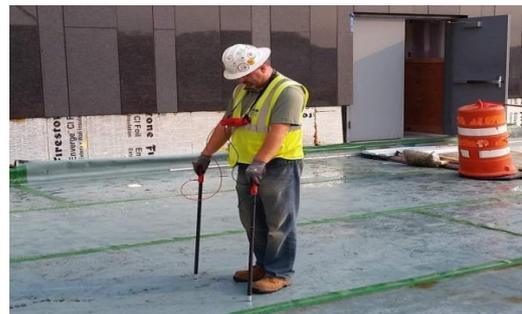
Fig.2. EFVM testing for leakage in roof

This method is useful for detecting leaks on larger roof areas, provided the membrane is an electrical insulator. This method utilizes the insulation property in combination with the fact that water is a relatively good electrical conductor. But it has serious issues of grounding in concrete.

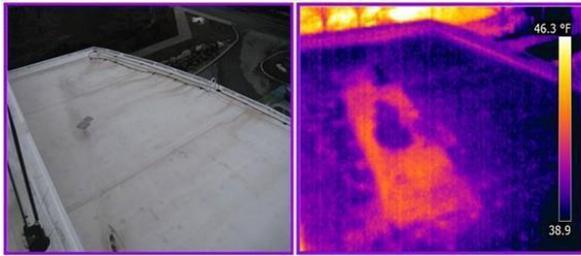
This is the method in which the IR rays produced by the body is received by the IR receiver and based on the temperature increase or decrease with reference to the reference temperature, the leaks in the members can be detected. An infrared inspection of your roof can detect evidence of latent moisture within your roof cavities and it can determine the potential for ice dams, plugged drains, and water retention that may cause roof damage and/or leakage which could lead to serious damage to your living area if not detected on-time. By infrared roof evaluation you can save a bundle (in the long run) by knowing if certain roof sections need minor repair now to avoid major repair or replacement later, or to simply determine if the whole entire roof needs to be replaced in the not-so-distant future. Thermal imaging can give you the existing roof information in a nice neat visual package. This roof looks great visually, but a major moisture build-up detected utilizing infrared camera

Fig.3. IR Imaging

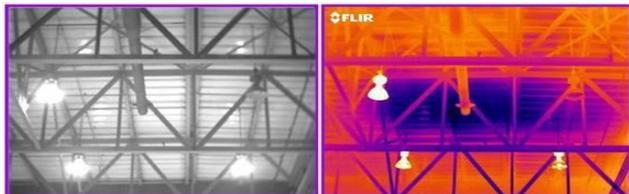
Fig.4. IR Imaging of Roof Truss

During a home inspection, roof leaks are typically discovered by direct observations, roof and then confirmed by utilizing moisture meters on the sheathing below. But if we detect a moist area and the roof sheathing is not visible from below (such as a finished cathedral ceiling or a ceiling below a living area) the exact area of the leak cannot be determined. Then the floor must be protected from the falling debris and possibly requiring a scaffold system. Then once we pinpoint the problem area, minimum surface areas can be removed in order to make the necessary repairs. It is good to prefer to perform all exterior flat roof inspections in the early evening hours. In order to perform the infrared inspection correctly, we require solar heating of a hot sunny day to heat up the roof surface.. If water is actively seeping into the cavity of a roof surface, the dry roof insulation will cool much faster than the soggy wet roof insulation, making it possible for me to observe the thermal differences. Regularly scheduled infrared roof inspections will allow you to find moisture damage and water leaks that have not yet become apparent. This is the most cost-effective approach to any roof maintenance.

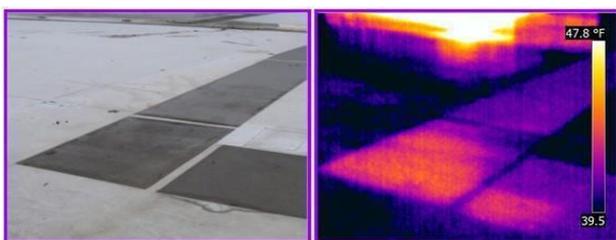
Fig.5. IR Imaging of roof leak

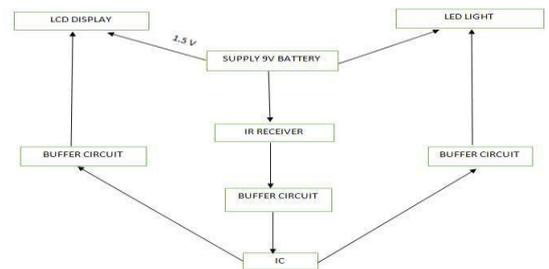
The equipment consists of a LED light, IR receiver, IC chip and a printed circuit assembly which consists of resistors, capacitors and transistors. All these are connected to a power supply which is the battery. The battery used is a 9V battery. The red and black wires form the positive and negative poles respectively. These wires are connected to the IR emitter and the LED light through 3pin (which includes the wire from the IR emitter that carries the information about the temperature to the IC) and 4pin (which includes wires from the IR emitter and the IC). It consists of one polarized capacitor of 33μF (i.e. the capacitor consists of positive and negative) and many non-polarized capacitors. The polarized capacitor is mainly for the

steady power supply and other capacitors for noise filtering. The resistors are for the voltage drop and increase if the sensitivity of the device is adjusted.

Once the 9V battery is connected and the power button is switched on the device starts to temperature of the body to which the device is focused. So the power button is switched on and the IR receiver is focused to the body with respect to which the reference temperature is fixed by the device. The reference temperature is indicated by the green colour light from the light source. These commands are given by the IC. Now the device is moved throughout the place where the leakage has to be checked. The IR rays emitted by the body are continuously received by the IR receiver and the temperature change is constantly displayed in the LCD display. If the temperature reduces from the reference temperature, there will be an indication by means of the LED light i.e. it turns to blue colour. If the temperature of the body goes beyond the reference temperature, then the light turns to red colour. There are 3 forms of sensitivity i.e. the sensitivity of 1-degree change in temperature, 5-degree change in temperature and 10-degree change in temperature. There also a sensitivity adjustment in which there will be no LED light indication.

Fig. 6. Block diagram of detector equipment

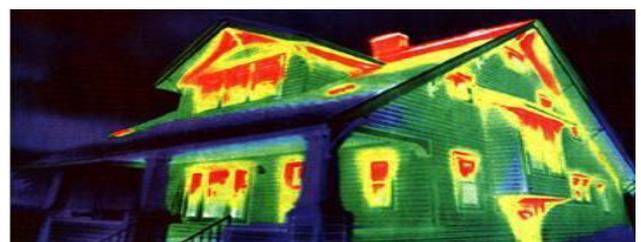
The device is focused to the place where the leakage detection has to be made. The sensitivity is adjusted. Based on the temperature and colour change the leakage can be confirmed.

Fig.7. IR testing for leakage in building
