A Pragmatic Approach Towards Avoiding Uncertainties in Construction of Metro Rail

Abstract— As a successful effort of providing efficient transportation facilities to the exponentially increasing urban population, Metro Rail Transit Systems have proved to be noteworthy. But such large projects demand a lot of research in safety, analysis and risk management to be established. In addition to the traditional safety precautions during construction, there needs to be a more sensible and realistic approach in the methodologies used during construction of Metro Rail. This paper presents two case studies which provide an insight into learning from past failures and challenges during construction in order to make future successes possible.

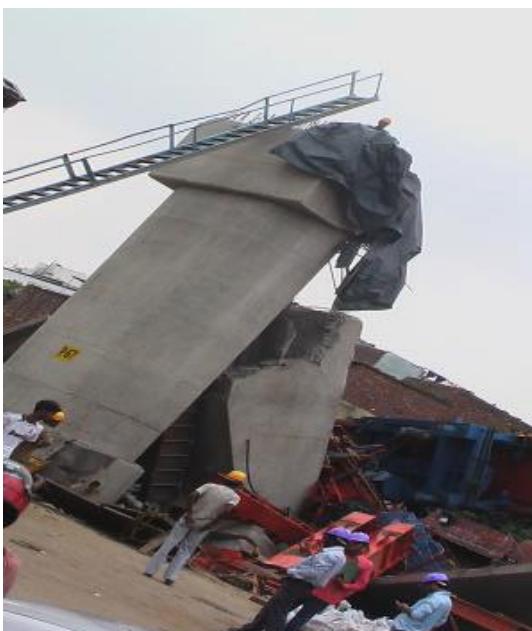
It was during the construction of Phase II of Delhi Metro Rail Project, that on 12th July 2009, while lifting segments of the superstructure, an accident took place in the Badarpur – Secretariat section near P-67. The pier cap of pier P-67 got collapsed causing subsequent collapse of the (i) Launching Girder (ii) Span between P-66 and P-67 which had got erected and pre-stressed, already (iii) Segments of the superstructure for the span between P-67 and P-68. The incident left 6 people dead and many injured.

- Structural designs should be proof checked by experienced structural engineer.
- Once failure observed, structure should be as far as practicable abandoned and new structure should be built up.
- More emphasis should be given on detailing of reinforcement to cater for connections and behavior of the structural components.
- Adequately experienced personnel should be deployed for erection works.

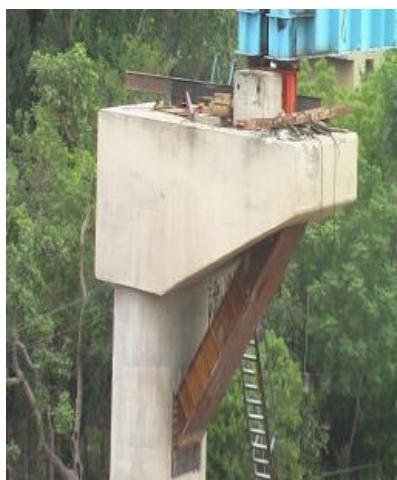
Initially the support system for viaduct was designed as portal pier till the casting of the pier was over. The shop owners in the nearby area put up resistance against casting of the other leg of the portal and it was subsequently decided by DMRC that this would be changed to a cantilever pier, similar to P-68 as shown below.

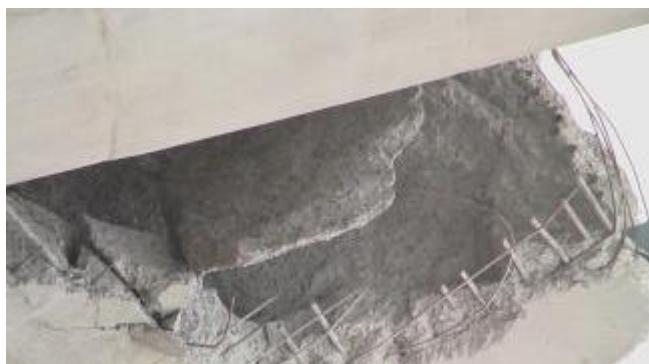
The top reinforcement of the cantilever beam did not have any development length into pier concrete. As learned from the sources, the top reinforcement of the cantilever beam had an "L" bend of 500 mm only.

There was insufficient bond length for the structure to behave like a cantilever beam.

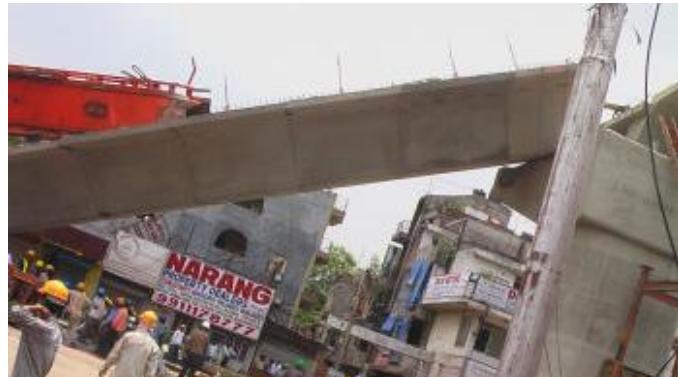
The launching girder had fallen as shown below, with the failure of pier cap. Also, the span between P-67 and P-68 fell inclined, supported by the ground at one end and pier cap (P-68) on the other.

During launching operation of the launching girder itself, this pier cap developed crack and work was stopped for couple of months. During this period, the cantilever pier cap was grouted in crack areas and further strengthened by introducing prop or jacketing. However, the behavior of the structure changed due to introduction of this jacket and the cantilever pier cap remained no more cantilever. The segments of superstructure for the span between P-66 and P-67 was erected and launched and the prop beam / jacketing could sustain the load to that extend. During the launching of superstructure segments between P-67 and P-68, only 6 segments could be lifted and the whole system collapsed when seventh segment was hooked for lifting.

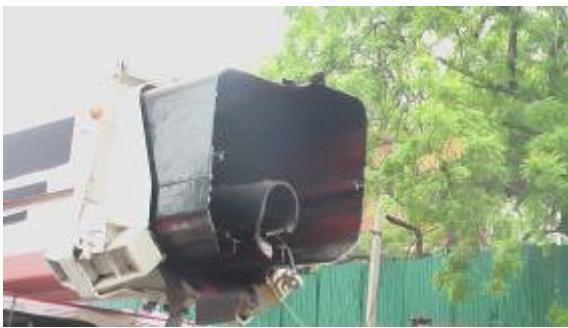
On 13th July, 2009, while clearing the site of all debris, 4 cranes were deployed by DMRC for taking out the entrapped launching girder. Three out of four cranes failed during this operation.

The boom of the crane, used for lifting the launching girder had failed in bending and showed a clear sign of overloading.

- Adequately experienced Engineer / Foreman should be deployed for erection works.
- In case of synchronized crane operation, sufficiently designed “working of cranes including checking by an experienced erection engineer should be documented in method statement and work should be taken up as per the method statement including fixing of location of hook of the crane, maximum boom extension, working radius etc.
- The use of different capacity cranes created an unbalanced condition resulting in their failure.

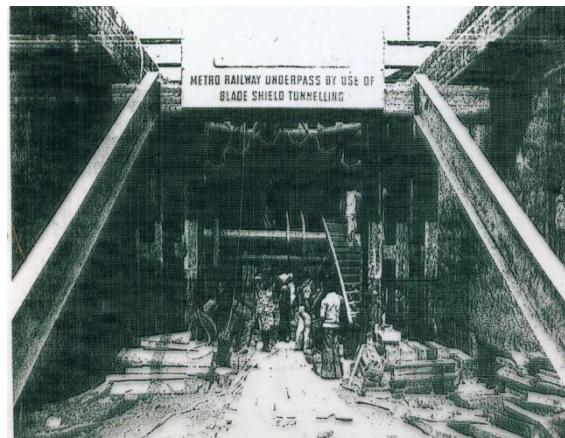
Fig 1

two tracks. For the 250 meters long, 5.1 meters dia. tunnel, a special Blade Shield Technique (FIG 1 & 2) was developed.

In this method segments (blades) were jacked individually to form a shield, due to which a very small jacking force was required to advance the shield in tricky ground conditions including strata consisting of cobbles and small boulders. In this process, ground cover requirements are minimum.
