A QGIS-Assisted Terrain Evaluation and Drainage Performance Assessment of the Shivajinagar Underpass.

Abstract -Flooding at depressed roadway structures such as underpasses is a persistent urban challenge, predominantly caused by inadequate hydraulic design and unfavorable site topography. The Shivajinagar Underpass in Chhatrapati Sambhajanagar experiences repeated monsoon flooding that disrupts mobility and deteriorates pavement conditions. This study applies a QGIS-based Digital Elevation Model (DEM) analysis to identify the terrain-related and drainage-related shortcomings responsible for the recurrent inundation. DEM-derived elevation profiles, slope rasters, contour maps, and flow-accumulation models reveal a significant central depression (583 m) situated below the entry (586 m) and exit (585 m) elevations. This inverted grade eliminates the possibility of gravity-driven discharge. Field observations confirm insufficient drain invert depth, absence of sump wells, lack of pumping facilities, and non-compliance with IRC:SP:42-2014 and IS 17482:2020. Comparative assessment with functional underpasses demonstrates the need for sump-pump systems, grated inlets, and deeper drain g

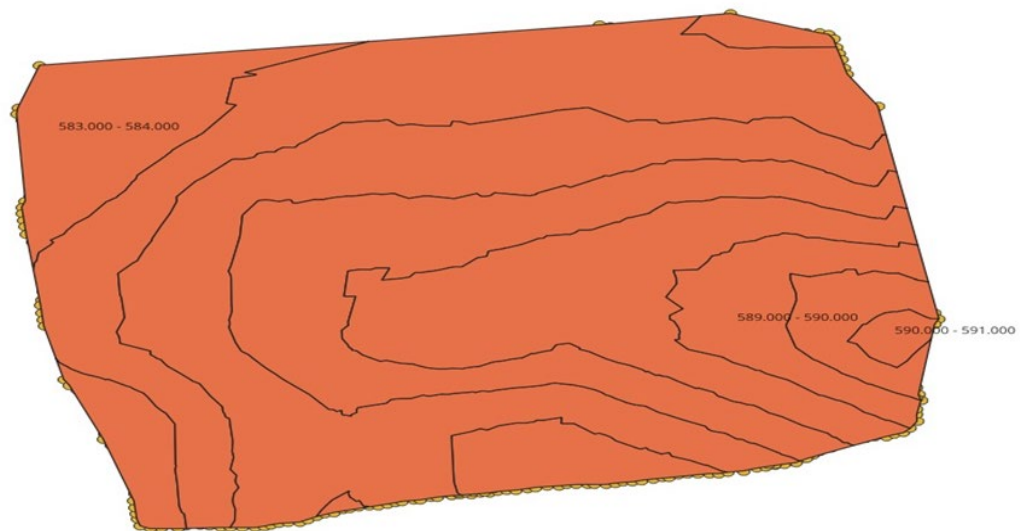
- QGIS Slope and Contour tools were used to compute gradient distribution and generate 0.5-m contour intervals. Flow accumulation maps identified convergence zones where stormwater collects.

Fig .11. Contour Map Extracted from QGIS of the selected study area

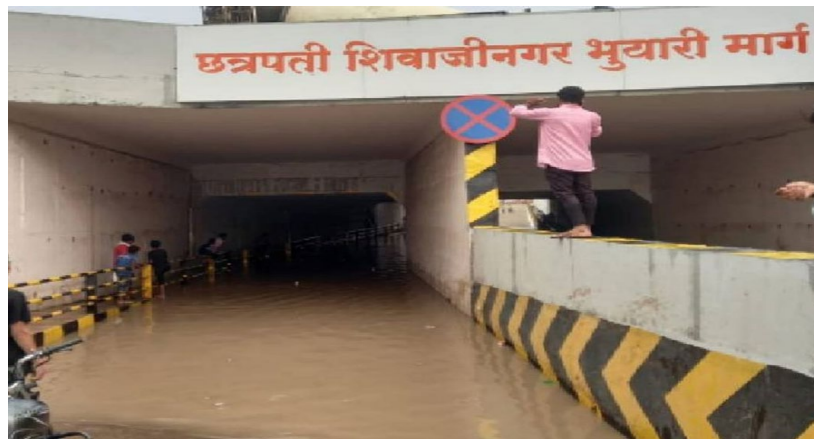
The Shivajinagar Underpass experiences frequent and prolonged waterlogging during rainfall because the structure functions as a natural topographic depression. QGIS-based elevation analysis confirms that stormwater from both approaches converges toward the center, resulting in stagnation and disruption of vehicle movement. The existing drainage layout lacks the capacity to remove water efficiently, leading to recurring flooding even under moderate rainfall conditions.

2. Side Drains at Road Level : Field observations and QGIS visualizations show that drain inverts are almost flush with the road surface, violating IRC:SP:42-2014 requirements. Such drains cannot intercept runoff, resulting in water accumulation at the center.

3. Absence of a Sump at the Lowest Point : No sump has been provided at the 583 m depression, despite IRC and IS provisions mandating sump pits in depressed underpasses. Without a sump, stormwater has no designated collection point.

Fig 12. Water Accumulation At the Shivajinagar Underpass Site

- (1) There should be a Provision of a sump at the 583 m low point;
- (2) It is Mandatory to Provide a duty-standby pumping to lift water to 586 m; By following the strict provision of IS Codes Standards.
- (3) It is recommended to lowering the drain inverts to ~582.5 m;
- (4) There should be an installation of grated inlets; and
- (5) It is necessary to provide a safe pumped discharge line.

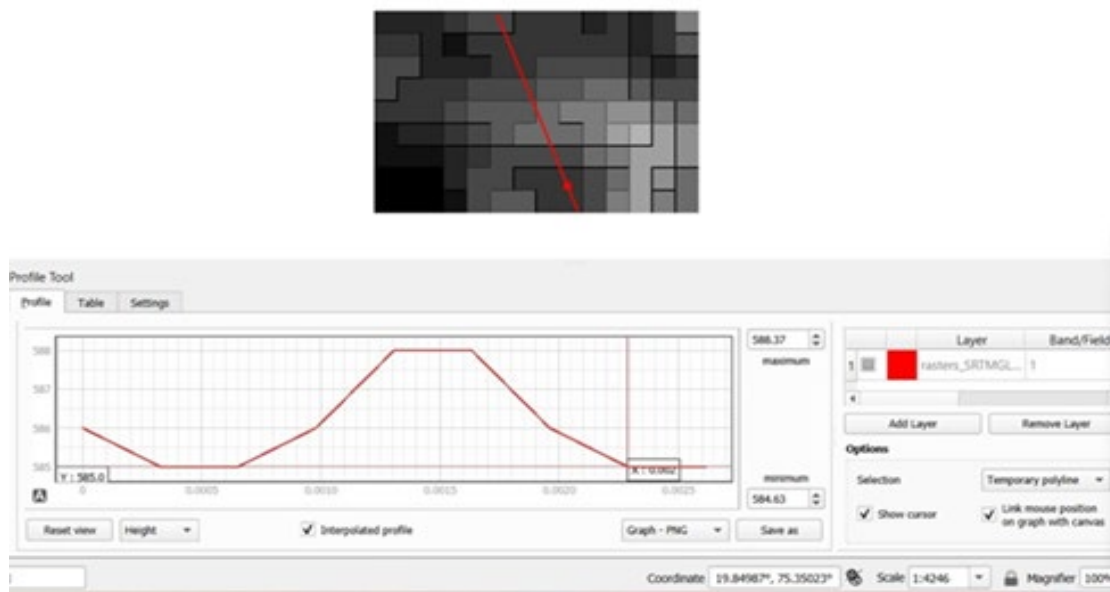
QGIS and field observations consistently show that the Shivajinagar Underpass has a distinct concave elevation profile, with levels dropping from 586.0 m at the entry to ≈ 583.5 m at the center and rising again to 585.0 m at the exit along a total length of 22.76 m. This confirms that the underpass floor lies at the lowest elevation, forming a natural depression. DEM-based interpretation further shows a 2–3 m elevation fall from both approaches toward the center, causing runoff from both sides to converge at the midpoint.

Fig 13. Elevation Profile at the Entry Point of the Shivajinagar Underpass(586 m)

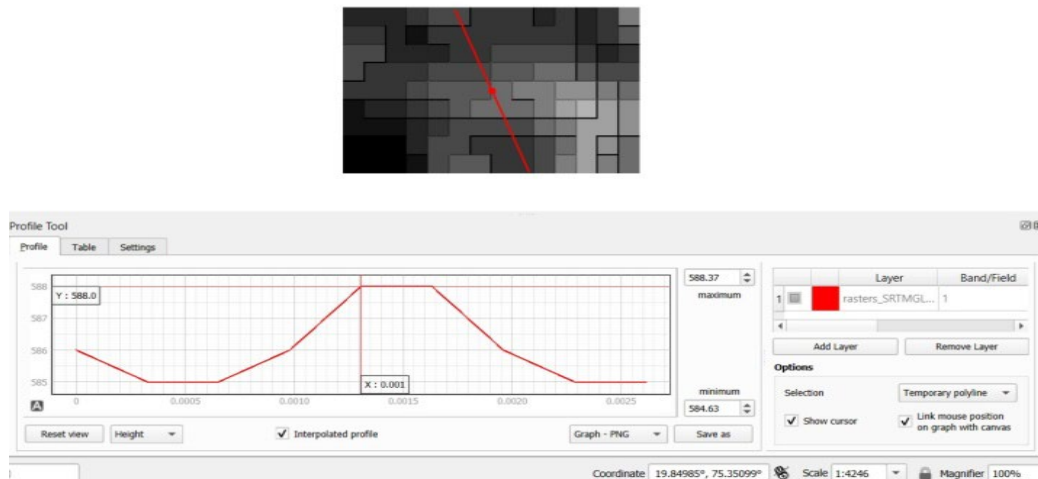
The QGIS elevation sampling (Z-values such as 586.4 m, 583 m, and 585.5 m) verifies that the minimum elevation lies exactly at the roadway center and not at the drain locations. Because the side drain inverts are nearly at the same level as the carriageway, there is no hydraulic head to drive gravity flow. As a result, the drains act only as structural elements and not as functional outlets, and the ponding zone aligns precisely with the lowest DEM pixels. The elevation peak of ~ 588 m above the railway track reflects the original ground level before excavation, confirming that the internal road level at 583.5 m is significantly lower due to the underpass construction beneath a raised embankment.

Fig 14. Elevation Profile Beneath the Railway Embankment (583m) Surface Elevation 588m
And height of underpass 4.5 m (588- 4.5= 583 m)

QGIS elevation analysis confirms that the Shivajinagar Underpass forms a closed depression (≈ 583 – 583.5 m) situated below the approach elevations (585–586 m), making gravity drainage impossible. As per IRC and IS standards for urban underpass drainage, the system must therefore be redesigned to incorporate a sump, pump-based evacuation, lowered drain inverts, and effective inlet structures. The first requirement is the construction of a dedicated RCC sump well at the 583 m low point, designed in accordance with IS 456:2000 and watertightness provisions of IS 3370. The sump invert should lie about 0.5–1.0 m below the pavement level (≈ 582 – 582.5 m) as recommended in IRC:SP:42-2014. Since the discharge level (585–586 m) is higher than the depression, a force-drainage system is mandatory. Under IS 6934:1998 and IS 8414, a pump installation comprising one duty and one standby submersible pump must be provided, with a pumping head of approximately 3 m based on the QGIS-derived elevation difference. Automatic float control and redundancy are essential to ensure uninterrupted operation during rainfall.
