# A Study on Construction Management with Focus on Public Construction and Maintenance Management

This project mainly focus on preventive maintenance. The experimental study was distinctly divided into a definite sequences of the work for a factory at Tondiarpet, Chennai the canteen building situated inside the company was taken for repair and maintenance work. It is a G+1 building of 30 years old. The building had cracks and spalling of concrete in columns. Five of the columns which were badly damaged were observed, repair and rehabilitation work is processed to stabilize the building.

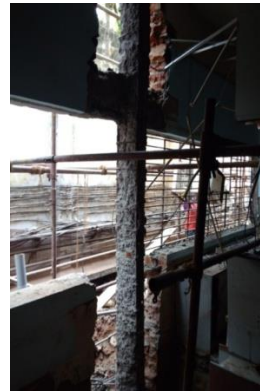
Fig. 1. Removing brick work

The column to be worked upon was isolated by removing the brick work around the column (Fig 1). After the removal of brick work the plastering of the column was removed by mechanical means. After exposing the core concrete with the corrode rebar's, the rebar's were thoroughly cleaned using rust remover agents. Additional rebar's were anchored in the columns to increase their durability by means of placing shear connectors using specialized chemical (Fig 2).After placing of additional reinforcements, the column was made ready for concrete with an epoxy bonding agent (Fig 3). Concreting was proceeded with a repair based material, micro concrete with powder aggregate ratio 1:0.5 (Fig 4) and applying AR compound after deshuttering (Fig 5) finished with redoing of brick work and plastering (Fig 6).

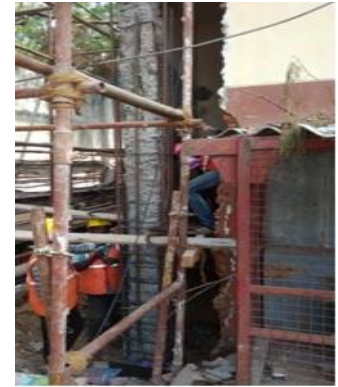
Fig. 2. Additional Reinforcement

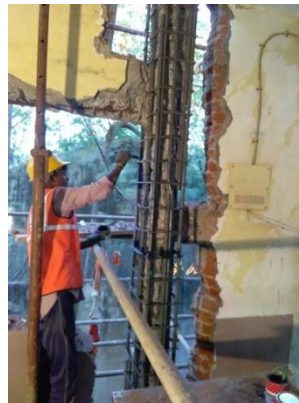
Fig. 3. Epoxy bonding agent

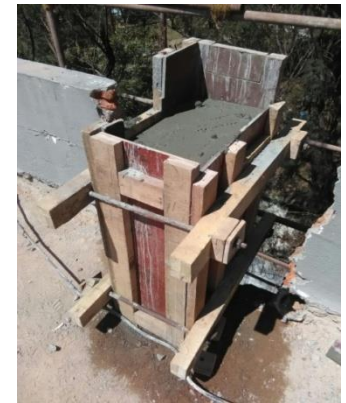
Fig. 4. Concreting with micro concrete

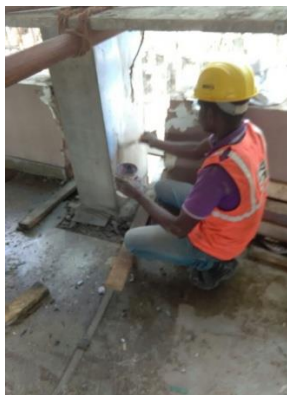
Fig 5 Applying AR compound

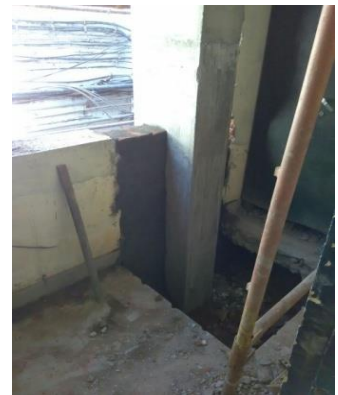
Fig 6 Redoing of brick work and plastering
