Application of RULA and NIOSH Ergonomic Risk Assessment Methods: A Case Study in Construction Industry in Turkey

Muge Ensari Qzay¹, Oguzhan Cakir², Rustu Ucan³
^{1,2,3} Department of Occupational Health and Safety
Üsküdar University
Istanbul, Turkey

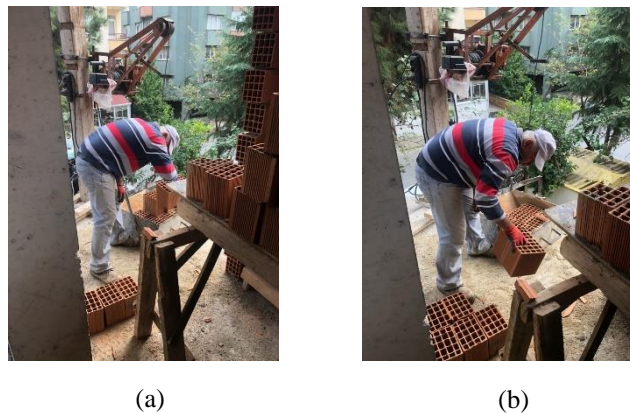
Fig. 1. Brick stacking process a) at the origin b) at the destination

Brick Stacking Process: Within the scope of the construction project, unloading and stacking of bricks process is seen in Fig. 1a. A floor crane is used to carry bricks from the ground level to higher level. The bricks are carried by a crane with basket and unloaded from the basket to the floor and the bricks are stacked on top of each other at horizontal and vertical distances as shown in Fig. 1b.

Brick stacking process is evaluated by NIOSH method. As a result of the analysis made at the origin and at the destination of the movement; The Lifting Index value (LI) for the origin was calculated as 3.55 and the LI value for the destination was 4.80 (Table 1). Since both values are greater than 3, the procedure is very risky and requires immediate ergonomic improvements. It was observed that the critical factor was the low frequency multiplier (FM) value which is related to the number of work repetitions per minute.

It should not allow the employees to carry more than one bricks at one time during the unloading and stacking of the bricks taken from the basket at the floor. While carrying the bricks, the load should be kept as close to the body as possible and stacking should not be allowed above a certain height. This will relieve the tension in the upper arm. During the heavy working process, the number of repetitions per minute and the total working time of one day should be reduced.

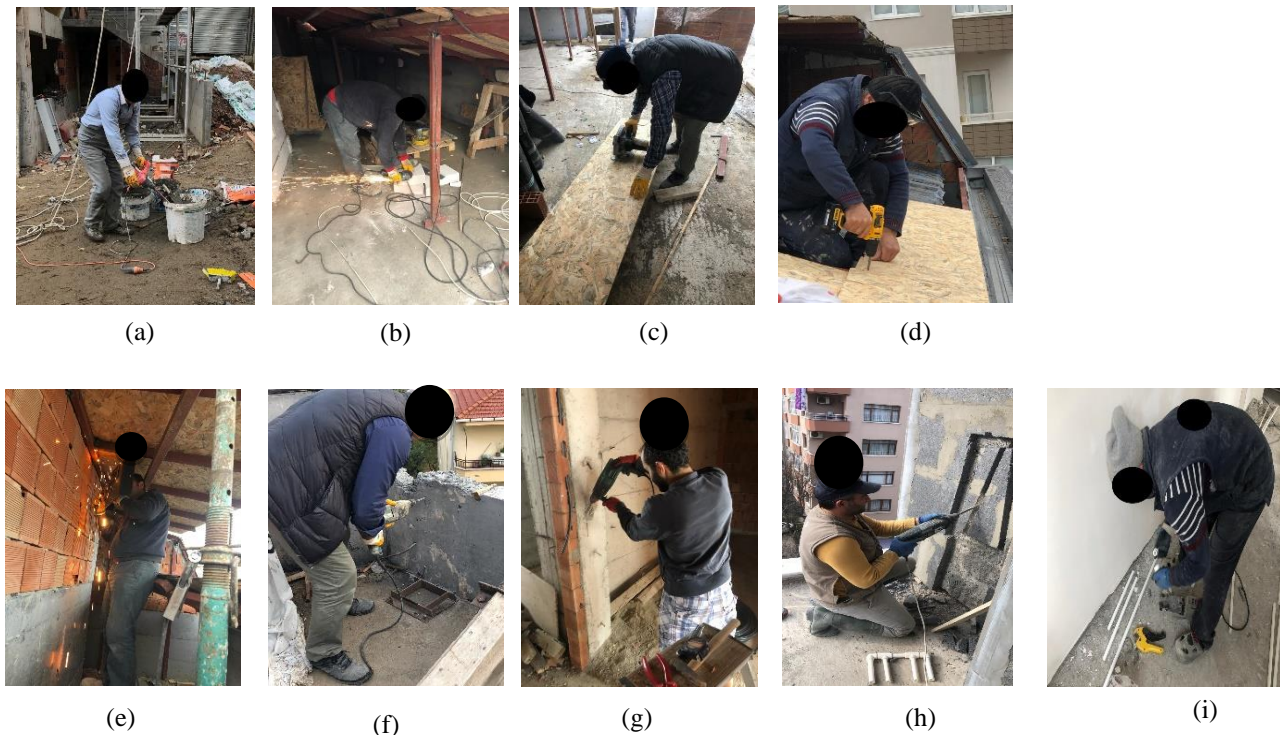
Fig. 2. a) Plaster mortar preparation process b) Metal cutting process c) Die cutting process d) Roofing process e) Welding process f) Concrete crushing process g) Drilling process-I h) Drilling process-II i) Plumbing process

Preparation of Plaster Mortar Process: Analysis for the preparation of plastering mortar, which is a generally used material for construction works, is evaluated by RULA. In Fig. 2a, the posture of the employee is examined while preparing plaster mortar. The result of RULA analysis is calculated as 7 (Table 2) and this score indicates a high level of risk for the task and requires an immediate intervention. The causal factor for the event is to carry a heavy item, a handheld mixer, during the process by the employee.

Metal Cutting Process: The metal cutting process is examined by the RULA method (Fig. 2b) and the score is 7 (Table 2). RULA showed a very high-risk level that would require immediate intervention. The process is considered critical in the assessment, due to the difficulty caused by the angle between body and legs and also by the weight of grinding machine used in.

Die Cutting Process: Die cutting process is another frequently performed process in construction works and it is examined by RULA method (Fig. 2c). The RULA score is calculated as 7 (Table 2). This score is highly hazardous and requires an immediate intervention. The factor of the event is considered the difficulty caused by the angle between body and legs and as well as the weight of the grinding machine used in. Having suitable work benches for iron cutting and die cutting operations will prevent bending of the employees and prevent strain their waist. In addition, suitability of work equipment for the purpose and the weights of the equipment must therefore be readjusted.

Roofing Process: The roofing process is evaluated by the RULA method (Fig. 2d). The RULA score is calculated as 6 (Table 2). The risk level determined by RULA corresponding to this score includes serious risk level and ergonomic interventions should be developed for roofing areas. Some equipment such as platform and scaffolding should be used in roofing and in all exterior wall coating processes. In welding, the maximum height at which the worker will work without using ladders or scaffolding must be limited. The employee must be positioned in accordance with the procedure.

Welding Process: The welding process is evaluated by the RULA method (Fig. 2e). The RULA score is calculated as 5 (Table 2). This value indicates that the posture is unsecure and requires changes in short time.

Concrete Crushing Process: The concrete crushing process, which is a frequently studied process in the sample area, was evaluated with the RULA method (Fig. 2f). RULA score is calculated as 7 (Table 2). This value shows that the posture is very dangerous and requires immediate change. The weight of the equipment in concrete crushing operations should be easily handled. Also, the load per person should be reduced with auxiliary apparatus. In addition, the total daily working time of the employees and the repetition time per minute should be reduced in repetitive tasks. In repetitive tasks, the number of repeats per minute and the total daily working time should be limited. In addition, it is recommended that the employee should be in a suitable posture according to the working procedure and the drill should be held closer to chest when drilling.

Drilling Process: The study was evaluated by the RULA method (Fig. 2g and Fig. 2h). The RULA score (Table 2) is calculated as 7 and requires immediate change (Table 1).

Plumbing Process: The Plumbing Process is examined in the sample area by the RULA Method (Fig. 2i). The RULA score is found to be 7 (Table 2). This risk value is very dangerous and requires immediate intervention.

During the preparation of plaster mortar, it should be prevented carrying the mixer by the employee manually during the process thus during this process the mixer should be fixed on the bucket and the bucket should be moved by transport systems.
