# Application of the PAVER Pavement Management System for Airport Pavement Rehabilitation: A Case Study of Adamazin International Airport (2024)

Mohammed Abuzaid Ahmed<sup>1\*</sup>, Adam Ishag Ibrahim<sup>2</sup>

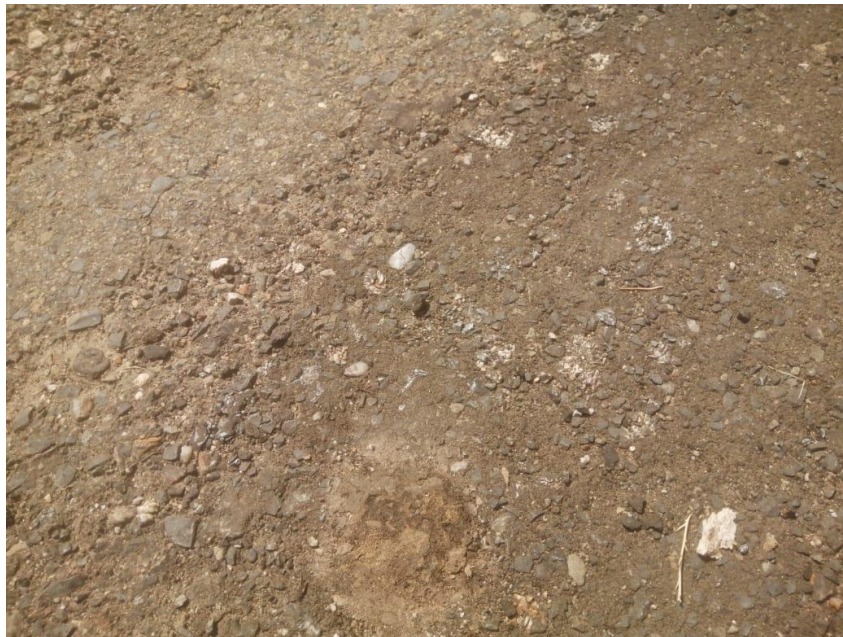
Adamazin International Airport is a regional facility whose primary runway and apron pavements had exhibited visible surface distress prior to 2024, prompting a comprehensive rehabilitation program. The pavement network was evaluated and rehabilitated using the PAVER pavement management methodology, consistent with FAA guidance for airport pavement management systems (FAA, 2014). Figure 1 show the crushing and scattering of the pavement layer in the top surface in the runway, and figure 2 showed the erosion the pavement in apron area.

Figure 1: surface layer erosion of runway pavement

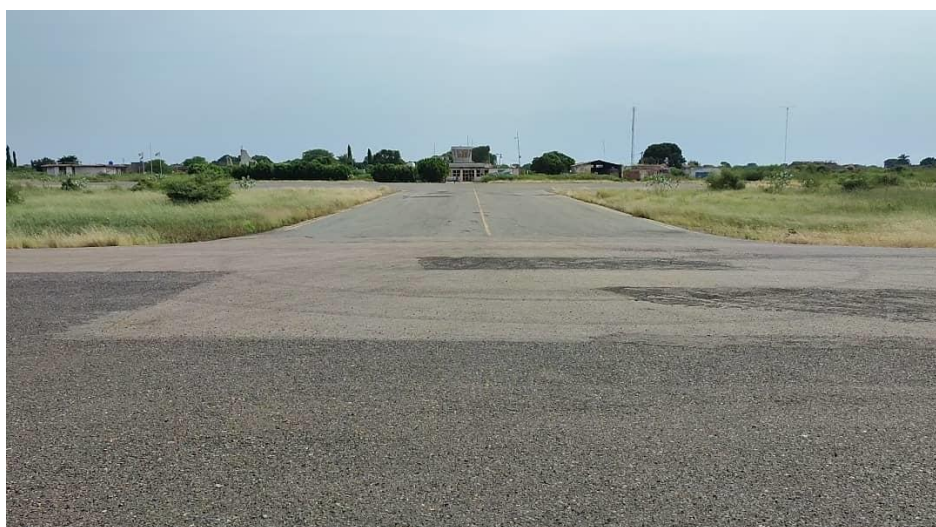
Figure 2: erosion in apron area

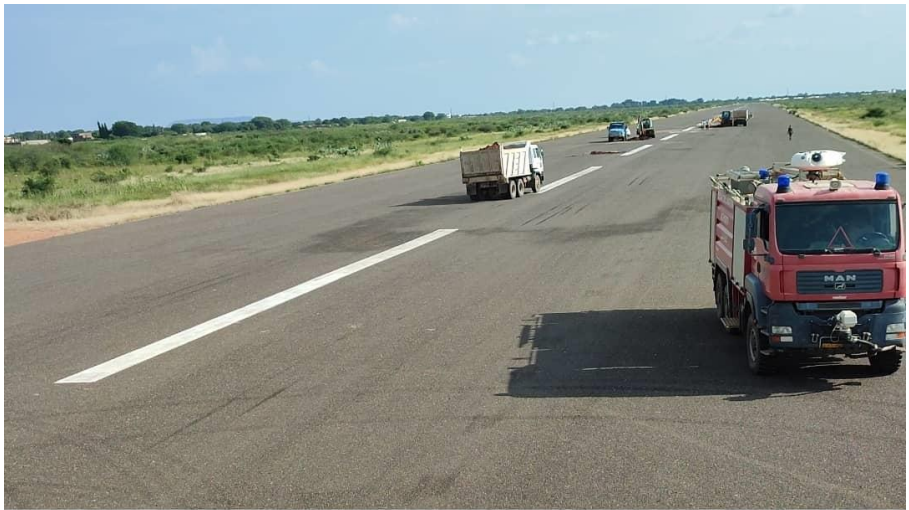
Figure 5: applying the maintenance in runway

Following completion of rehabilitation works in 2024 as shown in figure 5, 6, a post-rehabilitation monitoring protocol was implemented consistent with PAVER's recommended re-inspection cycle. Condition surveys were repeated at approximately six-

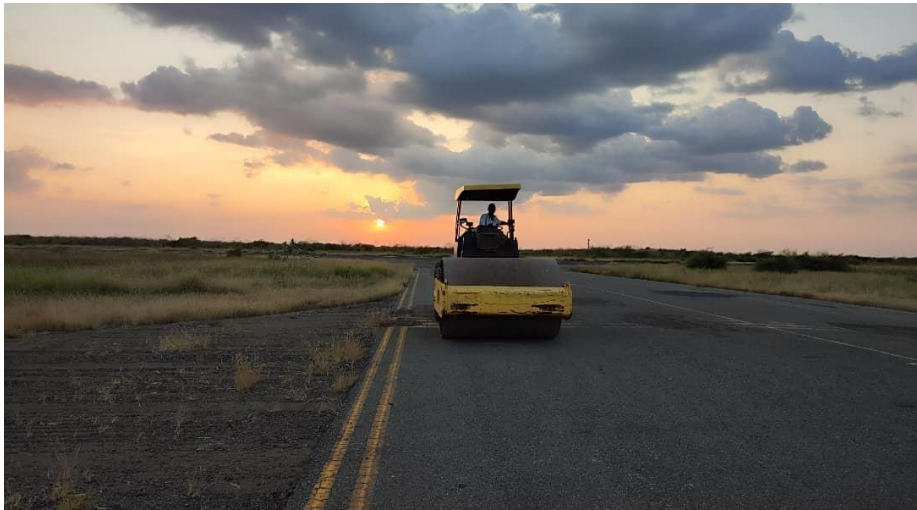
Figure 6: the compaction to treated pavement to the top surface

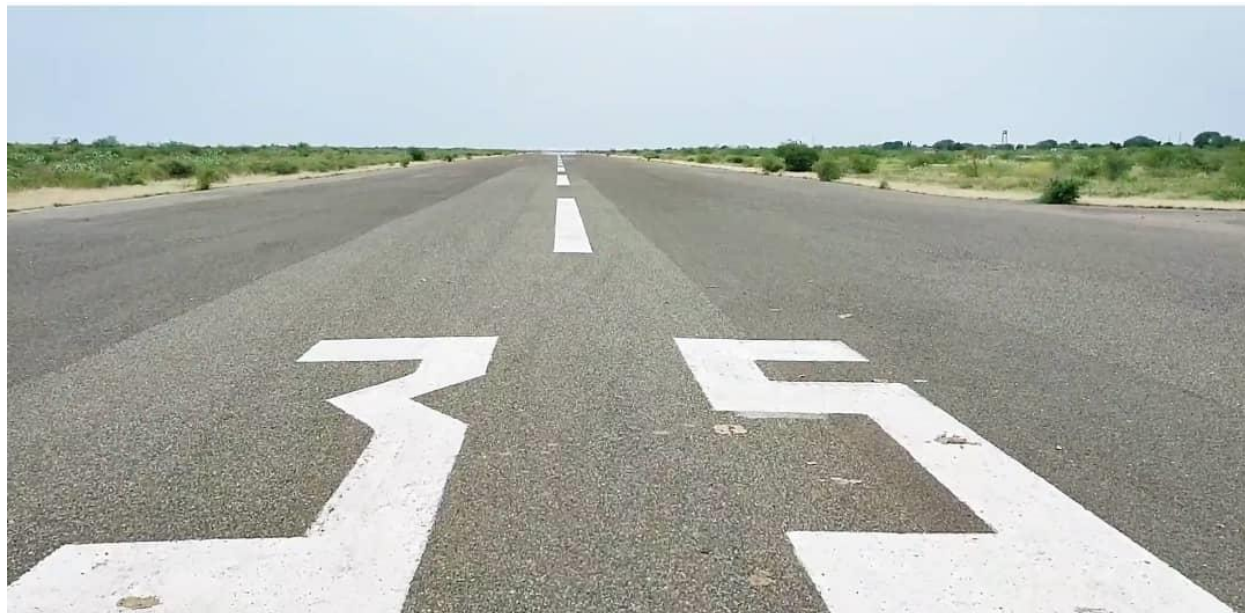
month intervals using the same sample-unit locations and inspection procedure as the baseline survey, allowing direct comparison of PCI values over time. At each inspection, surveyors recorded PCI score, distress type and severity (if any), and any indicators of incipient structural failure (e.g., new cracking, deformation, or material loss). No load-bearing capacity testing (e.g., falling weight deflectometer) was conducted as part of this monitoring program; the analysis presented here is based solely on visual condition survey data. Moreover, the figure 7 illustrated signs color in runway for guiding the aircraft for taking off and landing.

Figure 7: added signs to the runway after the maintenance completed

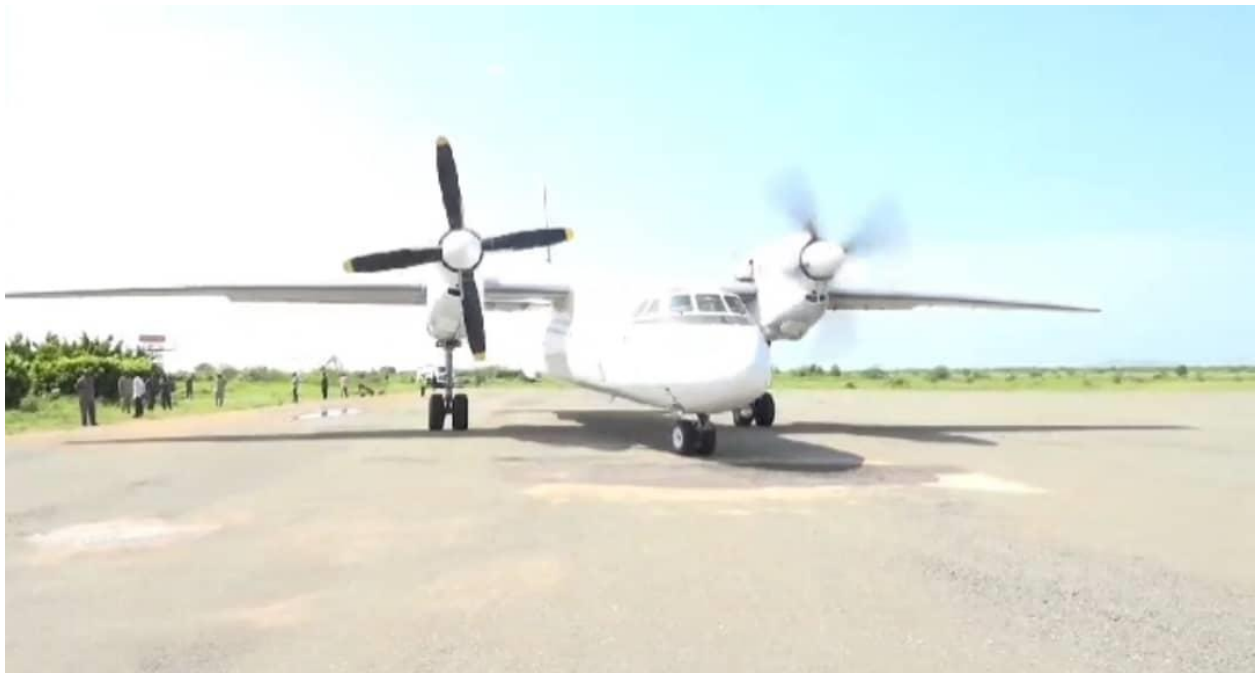
Furthermore, the arrival of first aircraft after maintenance has been recorded and shown in figure 7.

Figure 7: arrival of the first aircraft after maintenance
