Asphalt Pavement Performance in Extreme Weather Events in Tropical Country

Abstract—In the tropical climatic countries like Vietnam, Thailand..., for the last few years, the air temperature often raises up to 42.7°C and thus it heated up the asphalt pavements to 75°C. Additionally, more torrential prolonged raining often occurs at high temperature. In such the extreme weather, a large increase in asphalt pavement distresses such as rutting, shoving, slippage and potholes happened often with both of the new and normally used highway pavements. These asphalt pavement distresses are costly and decreasing serviceability of highways.

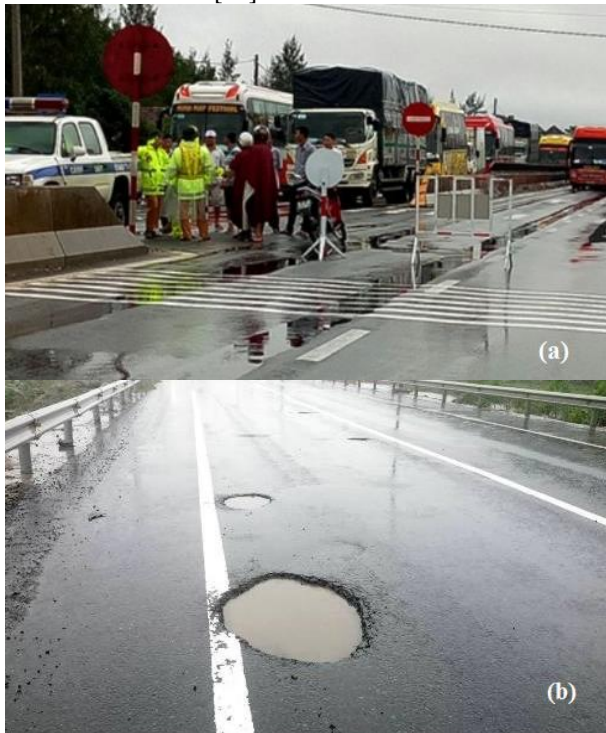
Figure 1. Rutting (a) and potholes (b) observed in 1A Highway in the extreme weather conditions in NCC region of Vietnam

previous peak of 555 millimeters on October 9th, 1995. The asphalt pavements of the 1A national highway have been defenseless against continuous torrential rains in the two days. Damages of the asphalt pavement have also been observed even in new pavements as presented in the Figure. 1 (b). The 1A Highway across Thua Thien Hue province (from Phu Bai district to Bac Hai Van district) has been upgraded, expanded and exploited more than a year has damaged and appeared many "potholes" after a long period of heavy rain. The phenomenon of which asphalt pavements have been stable in a long time to be suddenly distressed in the "extreme temperature" days or to be devastated after long rains as mentioned above, remained a question on the role of environmental factors [10].

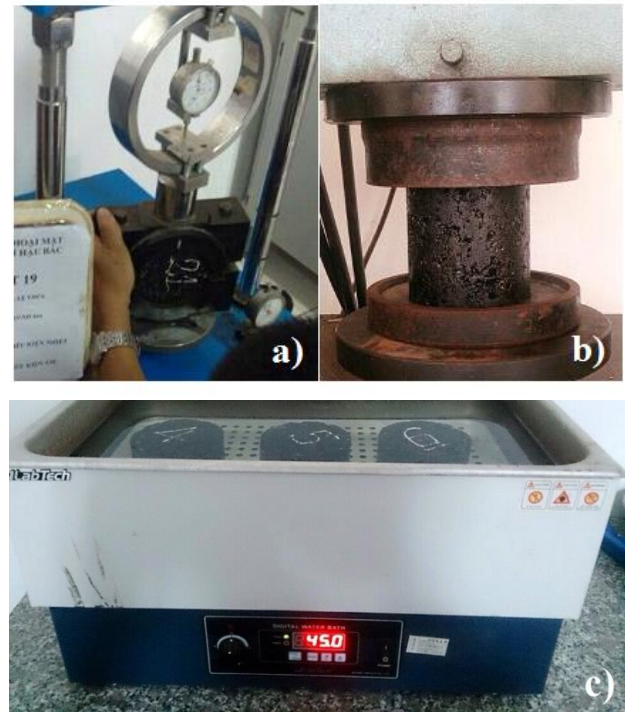
Figure 4. Experimental setup for (a) ID test, (b) UC test and (c) electrical immersion water bath

Water has lots of adverse effects on asphalt pavement performance. Water damages can be defined as the loss of strength and durability in asphalt pavement caused by the presence of water. Hence, it's the need to correctly identify the problem and isolate issues of contributing factors like material variability and construction practices for a better understanding of water effect on pavement deterioration. The water damage is induced by the loss of the bond between the asphalt cement or the mastic and the fine and coarse aggregate. The tests of identifying the water sensitivity potential for an asphalt-aggregate mixture can be divided into two major categories based on mixture type: those on the loose mixtures and those on compacted mixtures [2]. Typical compacted mixture tests to include indirect tensile with the modulus and strength measurement, immersion-compression, abrasion weight loss, and sonic vibration tests. The major advantage of these compacted mixture tests is that the mixture physical and mechanical properties, water/traffic action, and pore pressure effects can be taken into account. The AASHTO Standard Method of Test T283, "Resistance of Compacted Bituminous Mixture to Water - Induced Damage," is one of the most commonly used procedures for determining HMA water susceptibility. In this study, the compacted specimens are brought to a constant temperature by a 60° C water bath for the different immersion time of 40 minutes, 24 hours, 72 hours and 120 hours as in Table 3. The electrical water bath for both ID and UC tests as in Figure 4-c.

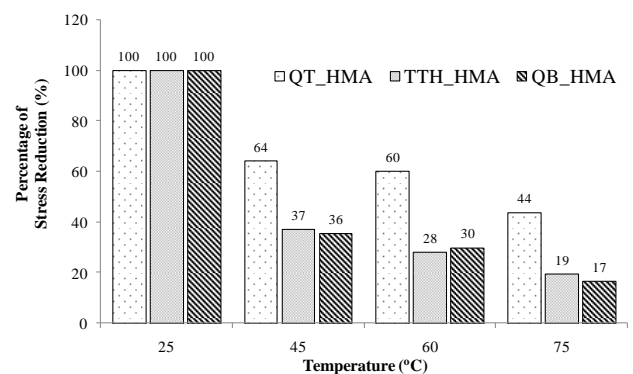
Figure 4. Stress reduction of 19mm aggregate specimens versus temperature in the ID tests

Figure 4 shows the responses of the specimens with different types of aggregates at four temperatures in the ID tests. There are two general trends observed for the effect of aggregate types of stress. The first, TTH_HMA specimens and QB_HMA specimens show the same form of the stress reduction while the QT_HMA specimens show the less stress reduction of temperature 45 °C, 60 °C and 75 °C. All HMA specimens have nearly same stress value of the lowest temperature 25 °C (640 kpa in ID tests) then suddenly drops at 45 °C with the remained stresses of 64% and 36% for QT_HMA specimens and QB_HMA specimens, respectively.

The stresses lightly decrease from the temperature from 45 °C to 60 °C but continue to decrease more at the higher temperature (at higher 60°C). Note that the Vietnam Standard Design of asphalt pavements considers the temperature of 60 °C as the design temperature condition. Particularly, the TTH_HMA specimens and QB_HMA specimens decrease significantly with the remained stress of 17% while the QT_HMA specimens show the remained stress of 46% at the temperature of 75 °C. The result indicates that the aggregates do not significantly affect bond strength and failure mechanisms of asphalt-aggregate systems at low temperature. The QT aggregates show less temperature sensitive than others. The reason is that the compression strength of QT aggregate (around 101 kpa) is quite higher than the compression strength of TTH aggregate and QB aggregate (75-80 kpa). In the temperature conditioning of the higher pavement temperature observed in the field may need to rethink about temperature sensitivity of the temperature limit and aggregate types for the current asphalt concrete design code in the NCC region of Vietnam.

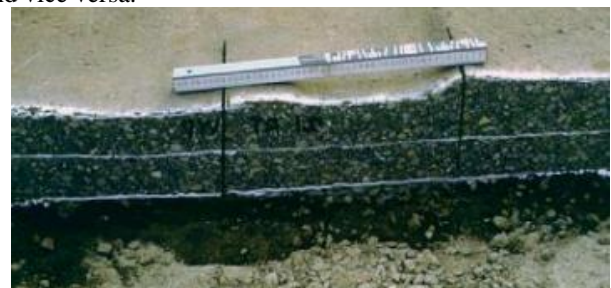
Figure 5. Cross-section of rutting asphalt highway pavement on site

Figure 5 shows popular subsidence of wheel tracks. As the air temperature rises, the surface temperature increases, the asphalt material from solid state to quenched and liquefied state, reduces the binding force between aggregate particles and vice versa.

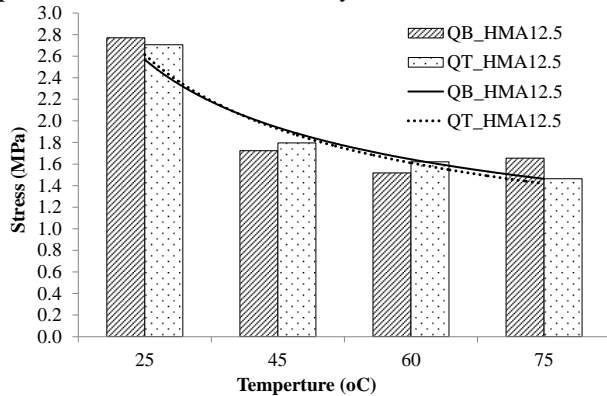
Figure 6. Stress of 12.5mm aggregate specimens versus temperature in the UC tests

In order to assess the stability of HMA subjected to high-temperature conditions, the UC tests using the QT_HMA and QB_HMA specimens are analyzed. The results showed in Figure 6 pointed out that the effect of temperature on the compressive strength is quite similar. This shows that the ability to withstand the compression of vehicle axle load is

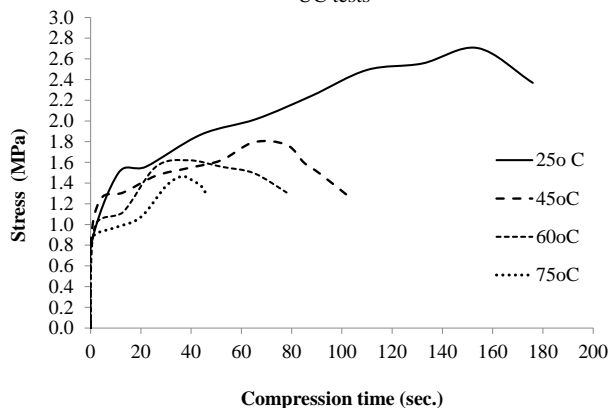
Figure 7. Stress of QT_HMA 12.5mm aggregate specimens versus temperature in the UC tests

similar to the two stones aggregation. The detail of QT_HMA 12.5 mm behavior is shown in Figure 7.

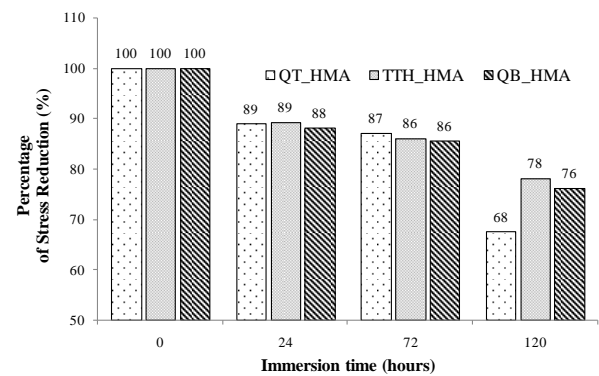
Figure 8. Stress reduction of 19mm aggregate specimens versus immersion time in the ID tests

Figure 8 shows the responses from the specimens at the four periods of immersion times for both the ID with different types of aggregates. The water sensitivity of asphalt mixtures of different aggregate types subjected to the different water conditioning is evaluated based on the stress reduction comparisons. The characteristics of aggregates and immersion time greatly affect the bond strength and failure mechanisms of asphalt concrete. The tensile strength of all HMA specimens changed after water exposure. After 24-hour immersion conditioning, the strength of the specimens suddenly drops about 11% then lightly reduces from 24 hours to 72 hours. After 72 hours, the stress reduction of the QT_HMA specimens reduces more significantly than that of the TTH_HMA specimens and QB_HMA specimens. It means that the QT aggregates are more sensitive to water conditioning than that of TTH aggregates and QB aggregates. It can be interpreted that limestone aggregates and asphalt have a higher adhesive bond than that of granite aggregates, and thus more resistance to adhesive failure.

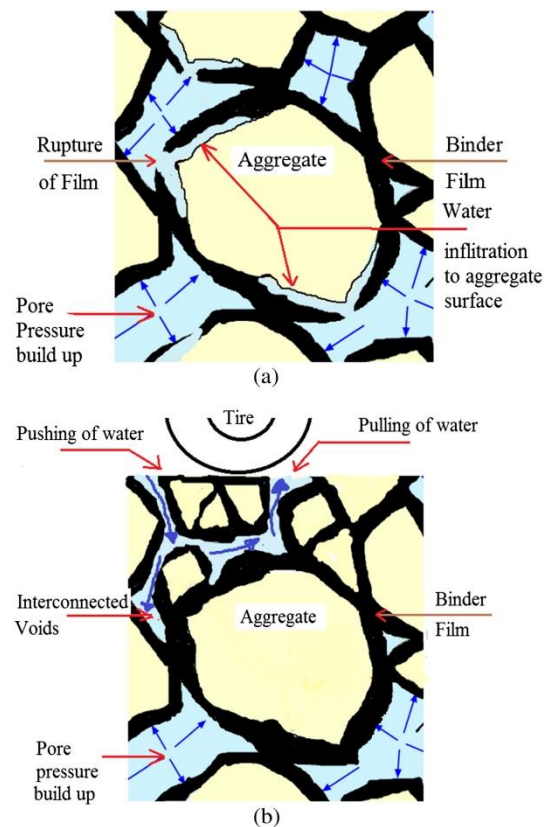
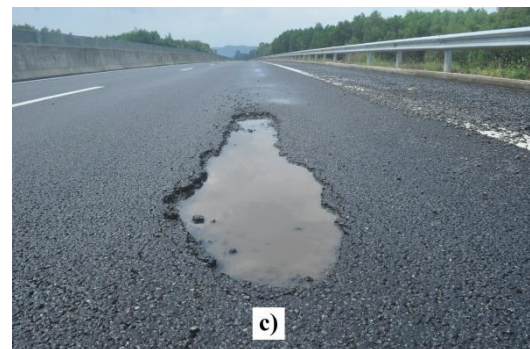
Figure 9. Deterioration Mechanism of Asphalt Pavement Subjected Extreme Water Conditions (a, b) and Pothole Failure on site

thermal shrinkage, and axle load, HMA is often intruded by water, which makes the bitumen membrane - aggregates bond weakly, especially where the bitumen membrane defect is interrupted like Figure 9.a. Under the pressure of the wheel surface, the water is pressed into the cracks to create a hydraulic wedge, making the pore pressure increase, leading to asphalt material decaying as shown in Figure 9-b. As the wheel passes, it almost immediately absorbs water with the asphalt material decayed from the cracks causing loss of materials such as potholes, layer separation or surface honeycomb as in Figure 9-c.

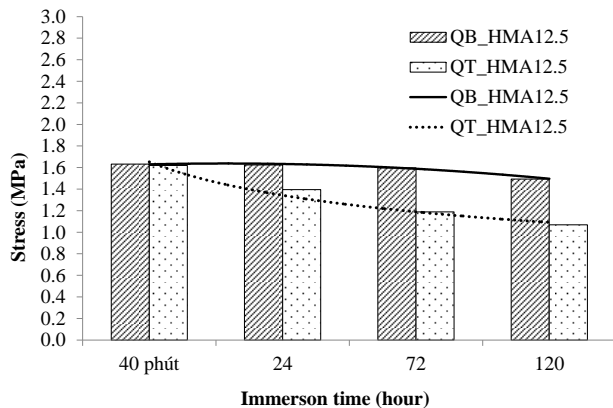
Figure10. Stress of 12.5mm aggregate specimens versus immersion time in the UC tests

The results of the UC tests show that the curve of stress versus immersion time of QT_HMA specimens reduce more significantly than that of the QB_HMA specimens, especially in 120 hour immersion times as in Figure 10. The detail of QT_HMA 12.5mm behavior is shown in Figure 11. The result leads to rethinking in consideration of the QT aggregates as the best aggregates for the asphalt mixture design of the 1A national highway.

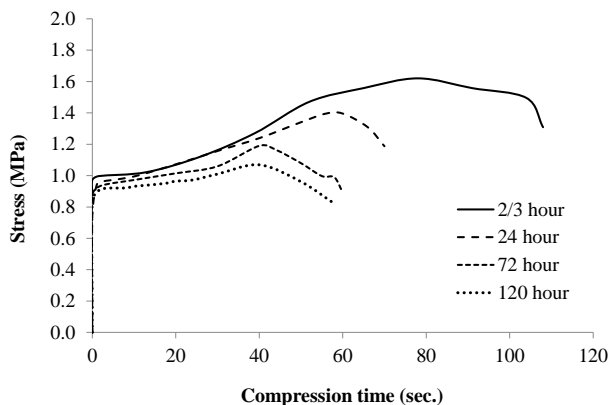
Figure 11. Stress of QT_HMA 12.5mm aggregate specimens versus immersion time in the UC tests
