# Assessing Crisis Damage: A Comparative Study of Satellite and Drone Orthophotography

Muhannad Al-Nadabi, Mohammed Al-Harthi, Amol Ganesh Deshmukh

<sup>1</sup>Geomatics Engineering Department, Military Technological College, Muscat, Oman  
[2116013@mtc.edu.om](mailto:2116013@mtc.edu.om)

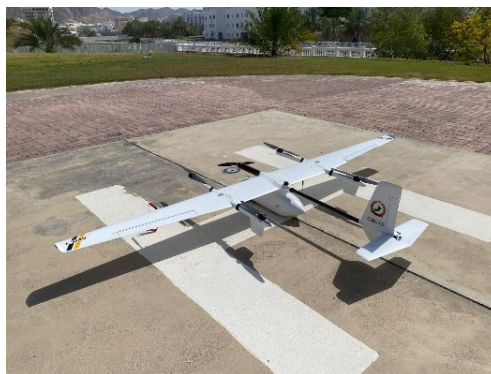
Figure 3. Picture of Drone (CW 15-II)

The CW-15II drone has been used in this project, which appears to be a good fit because it has characteristics that can help with data collection. The drone's ease of use and capacity to thoroughly plan the mission ahead of time are key features, allowing for optimal aerial coverage and image overlap to suit the project's objectives. Furthermore, the CW-15II's support for post-processed kinematic (PPK) technology is a considerable advantage. PPK allows for more accurate positioning of captured imagery by merging the drone's GNSS data with a reference station, boosting the overall quality and precision of photogrammetric outputs such as point clouds, Digital Surface Models (DSM) and orthomosaics [5].

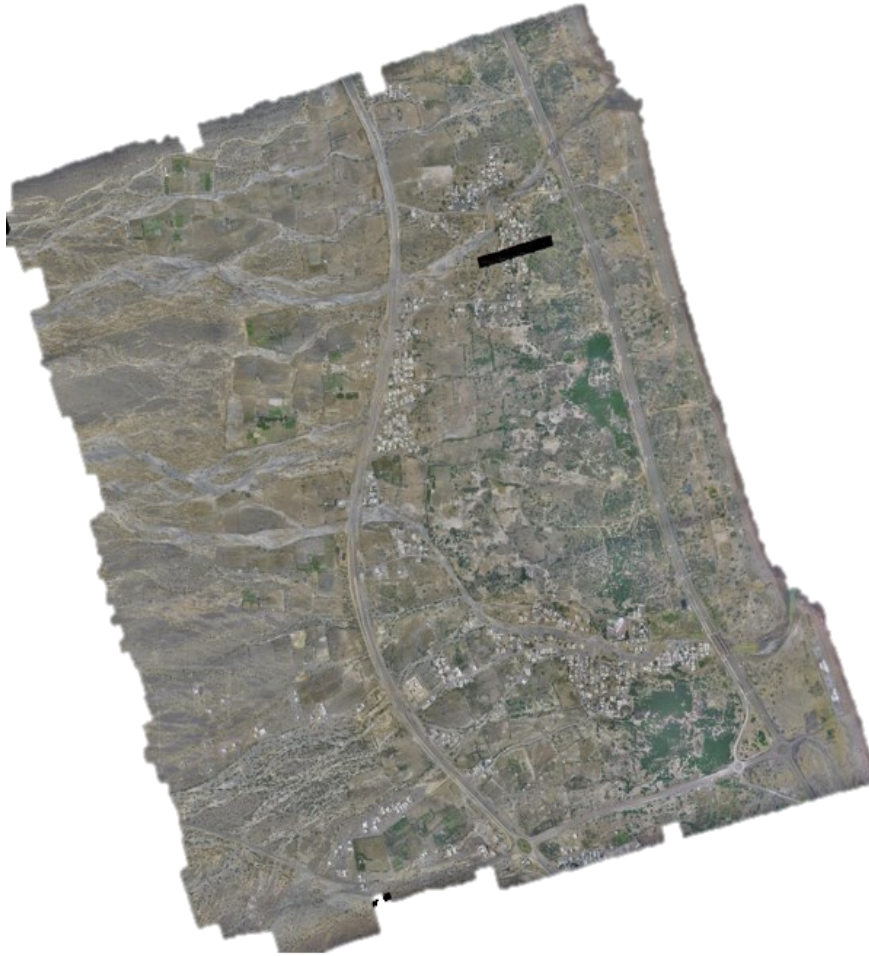
Figure 12. Orthomosaic of the study area

These comprehensive orthophoto outputs were built on the high-resolution drone images, corrected with ground control points. The photos were corrected to accurate, distortion free orthographic projections at 4.1 cm pixel resolution for detailed spatial analyses and change detection.

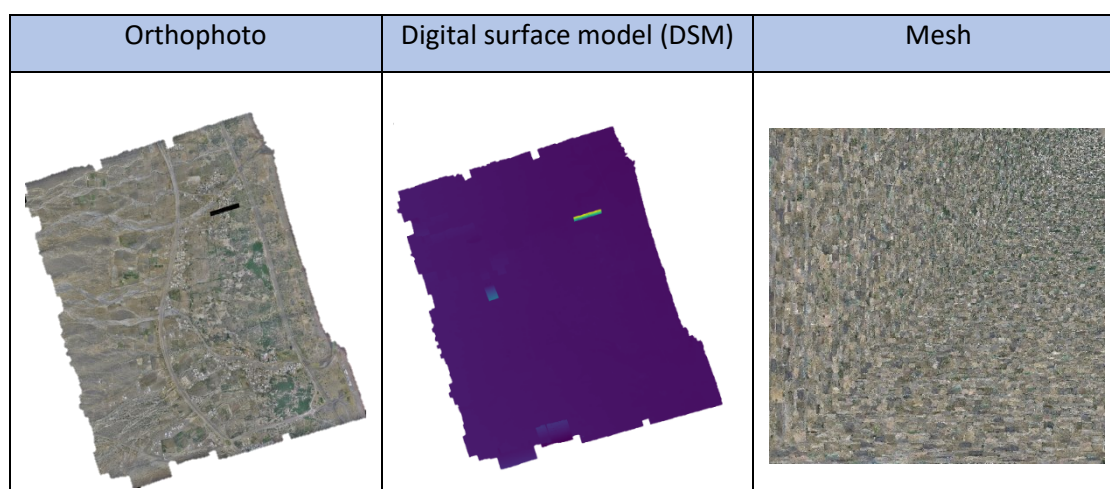
Figure 15. Outputs derived from this project

The main goal of this project is to create high-resolution orthophotos for Shinas, including highly dense Abu Baqarah locations, by applying drone-based aerial feature extraction. I did this by flying a CW-15II drone platform and took larger photos from these surveys. After this, the images were processed to undergo steps such as georeferencing, aerial triangulation, and orthophoto generation for creating the final orthophoto product using Pix4Dmatic software. The product is an orthoimage with a highly accurate Ground Sample Distance (GSD) of 4.1 cm that well depicted both terrain, infrastructure, and land cover features in substantial detail. I used this high-resolution orthophoto to delineate areas that had been disturbed by or influenced by storm events. I mapped the changes in landscape made by water erosion and landsliding through multi-spectral analysis of drone-derived orthophotos along with high-resolution satellite images. By comparing these differences through the analysis of ArcGIS Pro software, a detailed picture emerges, understanding how it has affected local valleys and other topographic features in the area that could be useful for disaster response, infrastructure planning, and environmental management in this region. To conduct this comparative evaluation, I captured the exact features and locations that were damaged in ArcGIS Pro. This detailed investigation was used as the foundation for creating an orthophoto.
