Assessment and Repair of Damaged Concrete Structures due to War Case study (The Republic of Yemen)

Abstract— Lately, many wars occurred in many Arab countries, including Republic of Yemen. Thus, those wars caused a lot of damage to infrastructure in general and to the concrete structures in particular; after an explosion, it is common that people are in doubt to determine which buildings should be demolished, which ones must be repaired, and which ones must be strengthened and how to do it. This study has been prepared to answer the previous questions and explain what can be done easily, practically, simple, and relatively with a low cost. Moreover, an integrated methodology was prepared to assess the various structural and non-structural damages caused by wars on concrete structures, in order to suggest appropriate restoration methods according to the results of the assessment, through the application on six case studies of concrete structures that were damaged as a result of the war in Yemen erupting from the year 2015. In addition, it will produce solutions to assist the participating companies in carrying out the required remediation of the affected reinforced concrete element

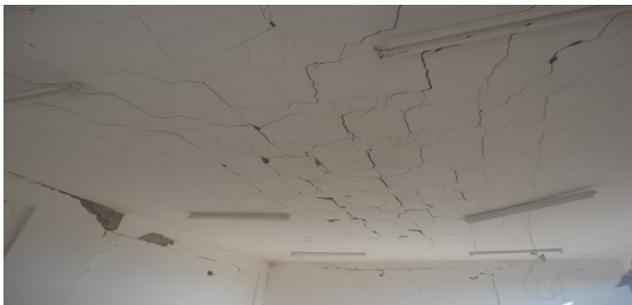
Fig. 2. Plastic deformation with cracks in concrete slab.

Structural elements subjected to plastic deformation as a result of explosion pressure, thus the resulting deformation is a displacement that occurs to the element (slab, beam, column, concrete wall), usually this displacement takes horizontal direction and, in some cases, could be vertical, considering that the members deform during the positive phase of shock wave, and in many cases the member cracks but still in service without any loss in cross section, Fig. 2.

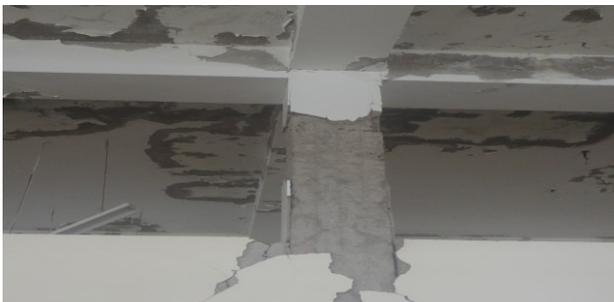
Fig. 3. Scaling in concrete column.

Loss or crushing of the surface concrete mortar, as a result of vibration that causes the force of the explosion wave when the structural member is tough enough so that does not collapse under missile strike, depending on several factors, as the intensity of the shock that results from the force of the explosion, as well as the distance between the element and the site of the explosion and the hardness and quality of the concrete element material, Fig. 3.

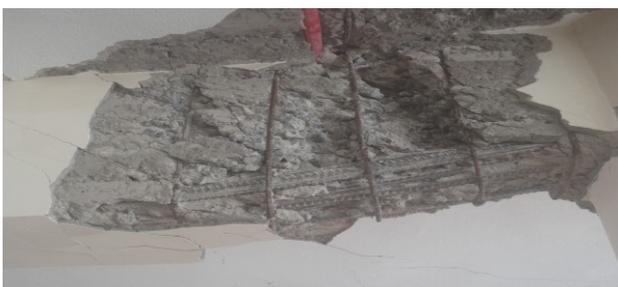
Fig. 4. Spalling in concrete beam

The spalling is more severe than the Scaling, where spalling usually in the shape of a flake, as a result of vibration that causes the force of the explosion wave when the structural member is tough enough so that does not collapse under explosion strike but losses part of the cross section while stays in service but in critical condition, Fig. 4.

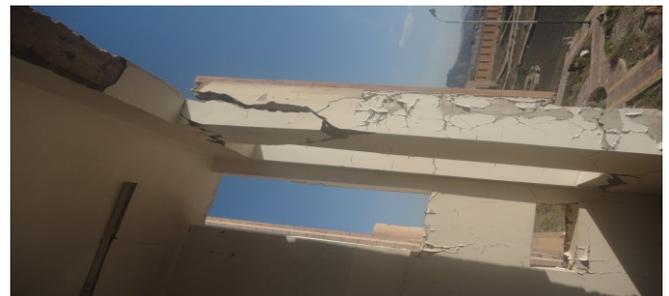
Fig. 5. Separation in concrete column

As a result of the intensity of the force of the explosion wave and the fragments flying from the explosion or from other damaged elements, linear elements such as beams and columns are subjected to shear forces greater than the resistance of these elements, which causes fracture, in addition to steel yielding and permanent deflection with large cracks, Fig. 5.

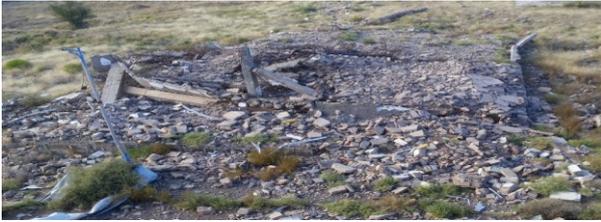
Fig. 8. Total collapse in R.C structure

Total collapse of building subjected to explosion loading takes place when the building is located in a very strong shock wave circle or when a very destructive missile strikes the building causing several structural members to be out of service leading the structural system to failure, Fig. 8.

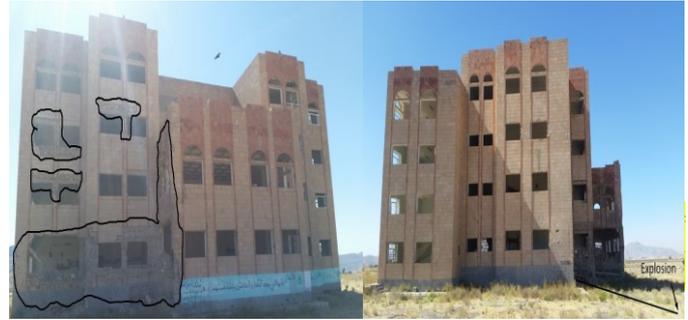
Fig. 11. General view of damaged building and Location of the explosion.

The building is an educational institute located at Sanhan area in Sana'a city. The damaged building was identified during the site visit and it was composed of four stories. The building was subjected to an air bombardment with two missiles at the beginning of the war, as the bombing was indirect at a distance of 12 meters from the northeastern corner of the building, Fig. 11.

Through the site visit and the initial visual examination, and a description of the external and internal damages It turns out that the original capacity of the building has not decreased and that no major hazard is present and no observable permanent deformations of the structural, minor structural damage, slight nonstructural damage and fracture in non-structural components of the structure, such as windows and doors, as a result the building can be described as "Safe for use".

Since the building is safe for use and as a result of this damage is confined to a very simple area of the building, and the building was exposed to indirect bombardment, therefore, the structure does not require a preliminary assessment.

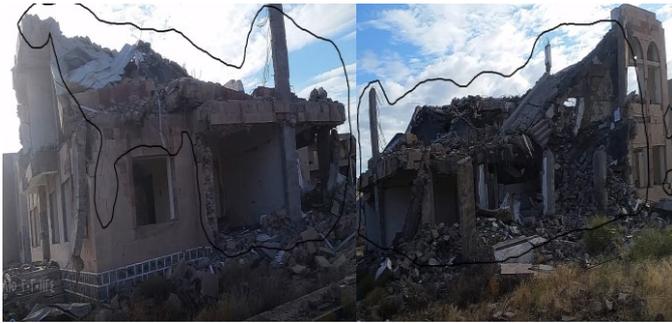
Fig. 12. General view of damaged building in Jahana

The building is a residential located at Jahana area in Sana'a city. The damaged building was identified during the site visit and it was consisted of two stories, it subjected to a direct air bombardment with three missiles, Fig. 12.

Through the site visit and the initial visual examination, and a description of the external and internal damage. It turns out that the building exposure extensive damages such as total collapse, extensive cracking with observable permanent deformations and large spalling for the most structural elements (about 80%). The strength and stiffness of the element or structure were reduced to dangerously low levels, and the building maybe prone to sudden collapse. As a result, the building can be described as "Un safe for use (dangerous for use)" and It is not possible to conduct a preliminary assessment because entering the building poses a danger because the structure is almost collapsed.

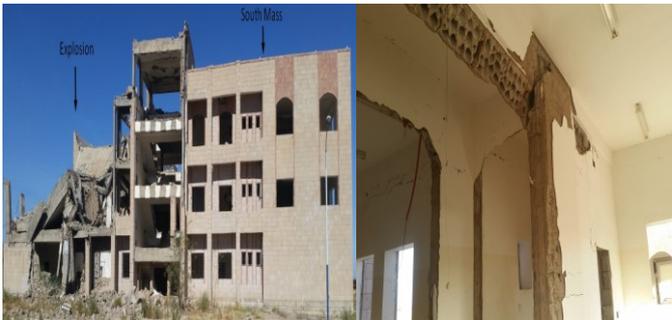
Fig. 13. General view of damaged building in Hamdan (South mass)

The building (South mass) is an educational located at Hamdan area in Sana'a city. The damaged building was identified during the site visit and it was found that it is a three stories. The building subjected undirect bombardment with four missiles, Fig. 13.

Through the preliminary assessment of all the damaged individual elements of the building and according to criteria for preliminary assessment of damaged building, the building is "Dangerous for use (unsafe)" Table V.

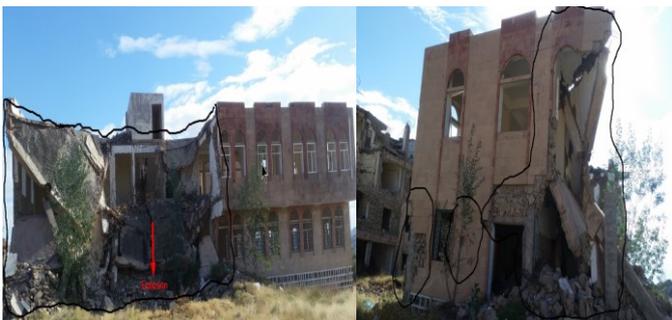
Fig. 14. General view of damaged building in Juhana

The building is an educational located at Juhana area in Sana'a city. The damaged building was identified during the site visit and it was found that it is a two stories. The building subjected direct bombardment with two missiles, Fig. 14.

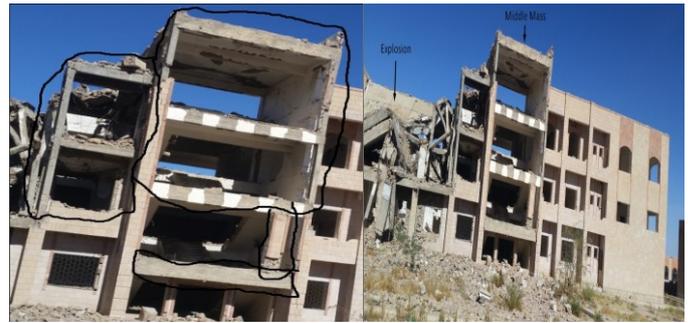
Fig. 16. General view of damaged building in Juhana

The building (Middle Mass) is an educational located at Hamdan area in Sana'a city. The damaged building was identified during the site visit and it was found that it is a three stories. The building subjected undirect bombardment with four missiles, Fig. 16.

Through the site visit and the initial visual examination, and a description of the external and internal damage. It turns out that the west part of building on the first and second stories exposure extensive damages such as total collapse, extensive cracking with observable permanent deformations, large spalling and fractures of some elements. The strength and stiffness of the element or structure were reduced to dangerously low levels, and the building maybe prone to sudden collapsing as a result, the building can be described as "Dangerous for use (unsafe)" and the building requires a preliminary assessment.

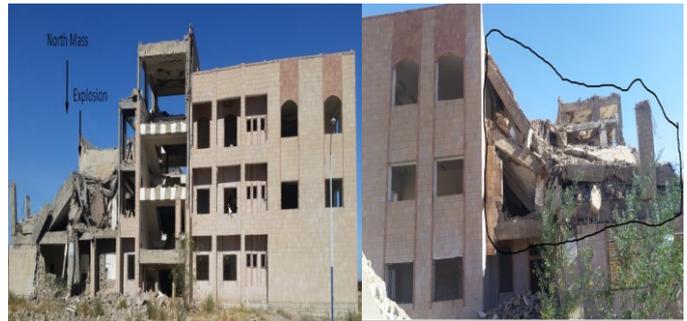
Fig. 19. General view of damaged building in Hamdan

Through the site visit and the initial visual examination, and a description of the external and internal damage. It turns out that the west part of building exposure extensive damages such as total collapse, extensive cracking with observable permanent deformations and large spalling for the most structural elements. The strength and stiffness of the element or structure were reduced to dangerously low levels, and the building maybe prone to sudden collapsing, in addition to destroying most non-structural elements as a result, the building can be described as "Dangerous for use (unsafe)" and the building requires a preliminary assessment.

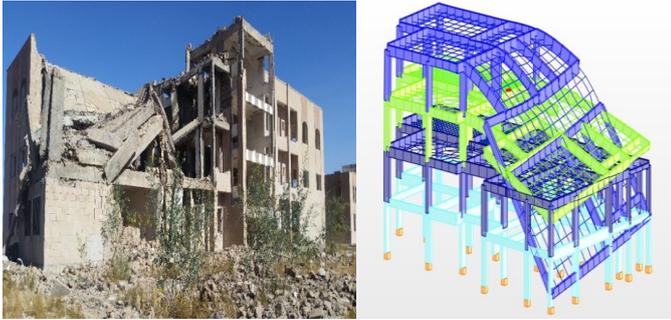
Fig. 20. General view of damaged building

Adopted computer modeling (Robot) by applying a complete simulation of the building after the occurrence of damage, and applying the loads on it during the occurrence of damage. The building has been modeled according to structural drawings after documents review and verification of as-built construction. Removing the columns that were severely damaged (from severe to total) and applying the loads present during the explosion Fig. 20..

It turns out that the path of the loads has changed as a result of exposure of some elements to total collapse. The non-damaged elements and have not been subjected to total collapse may have decreased their resistance as a result of the redistribution of loads and moments, as a result: 1) The elements that have

been exposed "damage severity" (Severe to Total) Should be removed and rebuilt using appropriate scientific methods. 2) The elements that have been exposed "damage severity" (severe to total) can be restored using appropriate scientific methods but after assessment of residual strength .3) The elements that have been exposed "damage severity" (slight) can be restored using the simple ways but after assessment of residual strength . 4) The elements that have been exposed "damage severity" (none) Should assess of residual strength.
