Assessment of Physical Structure with Geological Features Interaction to Flooded Area “Mucuruzi Village”

Keywords— Physical structural, Elevation, flood, Mucuruzi Village

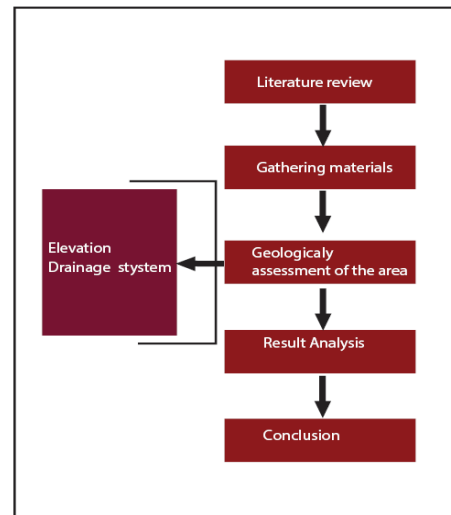
Fig.3.1. Research plan alignment

Assessment has been carried out using geological and mapping instruments such GPS compass and other related tools.

All data collected have been compiled in excel worksheet and used to produce a topographical map using ArcGIS software. All Geological features located or interact with study area were deeply analyzed straight forward on the field.

The survey method was used for collecting terrestrial data, combination of satellite imagery with computer aided map-ping method was used for creating topographic maps.

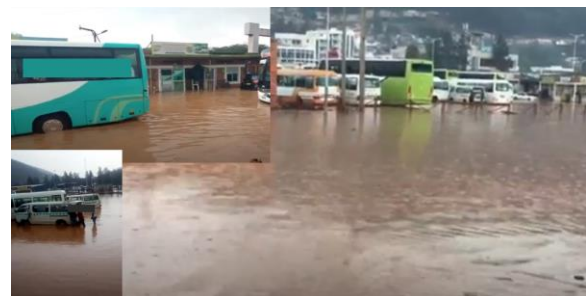
Image. 4.1. Mucuruzi Village flood.

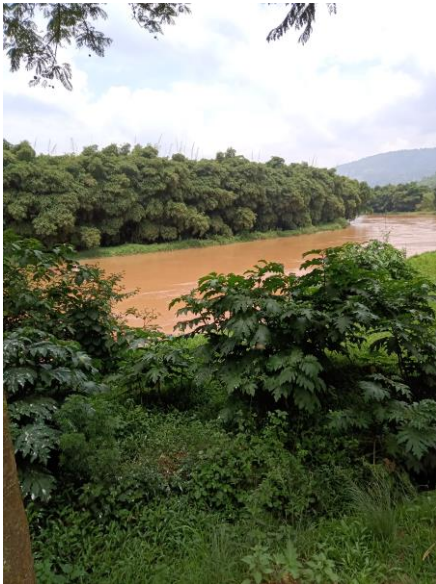
Image .4.3. Nyabugogo River closer view

Only one considerable geological feature which is Nyabugogo River was found and its contribution can be considered even though is not playing potential role in Mucuruzi villlage flood causations.
