Behaviour of Rubberised Fibre Sandcrete Hollow Blocks In Building As Masonry Structural Element

A.M. Mukaddas^{1*}, A. M. Maleka², A. Saidu³, A. Shu'aibu⁴
^{*1,2,3,4} CivilEngineeringDepartment,Federal
Polytechnic,Bauchi,BauchiState,Nigeria.

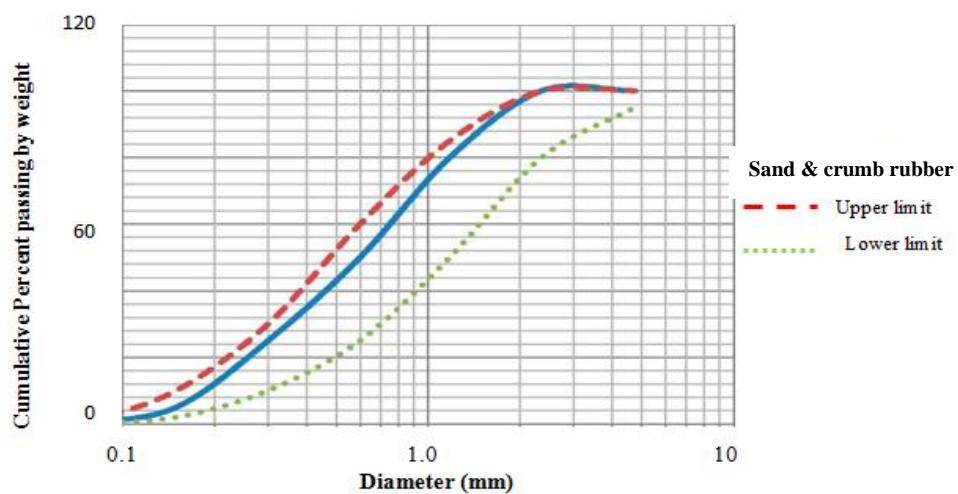
Figure 1: Sand and crumb rubber grading

Sand was obtained from a local quarry along Bauchi-Dass road in Nigeria and it has a maximum grain size of 2.36 mm passing sieve no.4 in accordance with ASTM C33[27] specification for fine aggregates. and can be classified as fine sand in zone II of aggregates for concreting as shown in Figure 1 having specific gravity, particle density and absorption of $2.63, 1702\text{ kg/m}^3$ and 2.0% respectively.

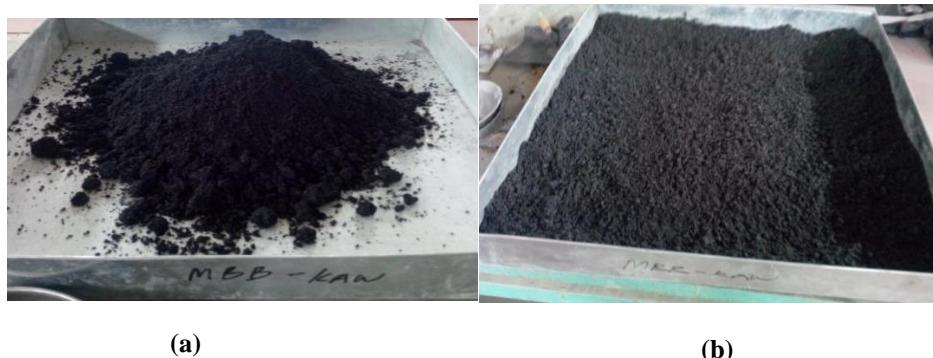
Figure 2: Soaked and Treated (TCR) crumb rubber aggregate.

Crumb rubber as in Figure 2(a) shredded locally by shoe coblers in a local market in Bauchi state, Nigeria was used to replace fine aggregate. It particles sizes ranges from 4.75 mm to less than 150 μm . It was clean as no impurities such as steel, thread or any other materials that could be detrimental to its performance was observed. The crumb rubber was graded in the same particle size as the fine mineral aggregate passing ASTM sieve no.4 and was pre-treated with cement paste before used in the mix in accordance with [15] and [17] to improve its mechanical and durability properties respectively. The crumb rubber pre-treatment process was carried out by soaking it in water for a minimum period of one (1) day, then it was dried in an open air container until a saturated surface dry (SSD) condition was reached. After which it was mixed with dry composite cement powder in a tilting concrete mixer until a homogeneous mix was achieved. The treated crumb rubber (TCR) was then air dried as shown in Figure 2(b). The compacted density and fineness modulus of the treated crumb rubber aggregate was determined to be 668 kg/m^3 and 0.9 respectively in accordance with [28] as presented in Table 1. Moisture content (MC) and water absorption (WA) of the TCR were not determined due to the fact that, the cement coating on the crumb rubber will be washed off during the testing process. The crumb rubber is also a non absorbant material, thus repel water on its surface. The crumb rubber used in this research is from cracker mill process.

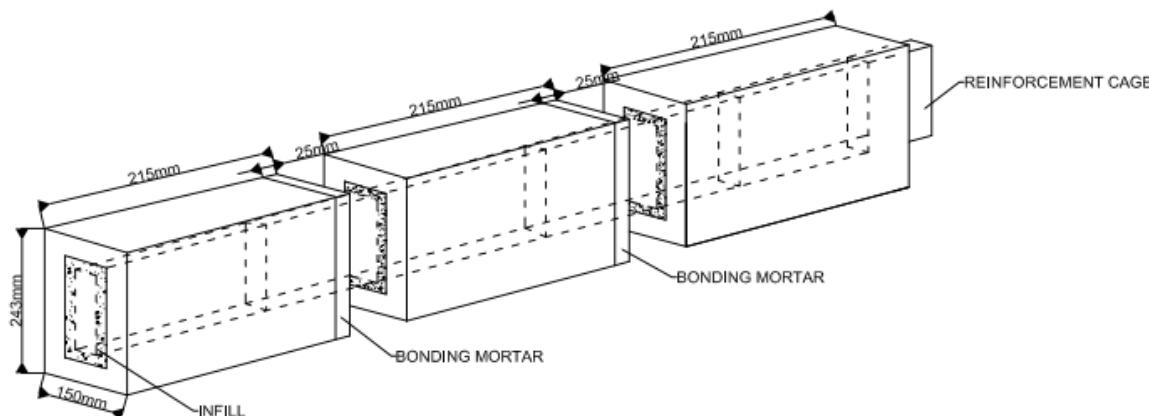
Figure 3: Hollow block beam assembly with reinforcement and infill

- The hollow block was placed on a 250 mm x 250 mm oiled wooden platform in a vertical position and wetted with water.
- Infill was poured in the block hollow up to the cover depth for the reinforcement and the reinforcement cage inserted into the hollow.
- Infill was added to fill up the block hollow containing reinforcement cage in 3 approximate equal layers and each layer tamped 21 times with 16 mm diameter steel rod.
- After filling the first hollow block, 25 mm 1:2.75 mix mortar was placed around the thickness of the block before the next block was placed on it by guiding it around the protruding reinforcement cage.
- The process of wetting, filling and compaction were repeated up to the last block to complete the beam.

- The beam is now complete and allowed to set by staying overnight Figure 3. The beam was then placed horizontally and covered with jute sack and wetted twice daily for 7 days thereafter left under lab condition until testing at 21 days.
- The beam was placed on the flexural testing apparatus and load gradually applied until failure while noting/recording the maximum load causing failure and the failure mode.

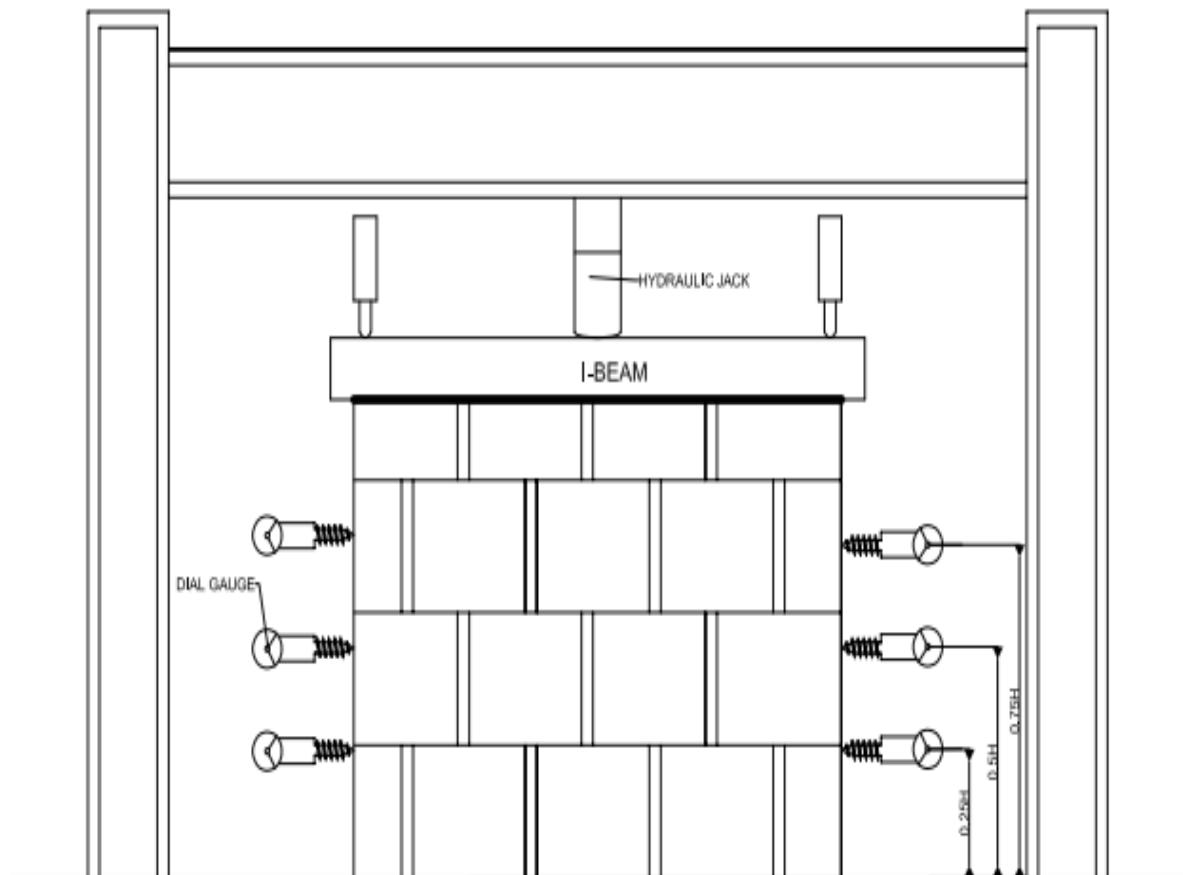
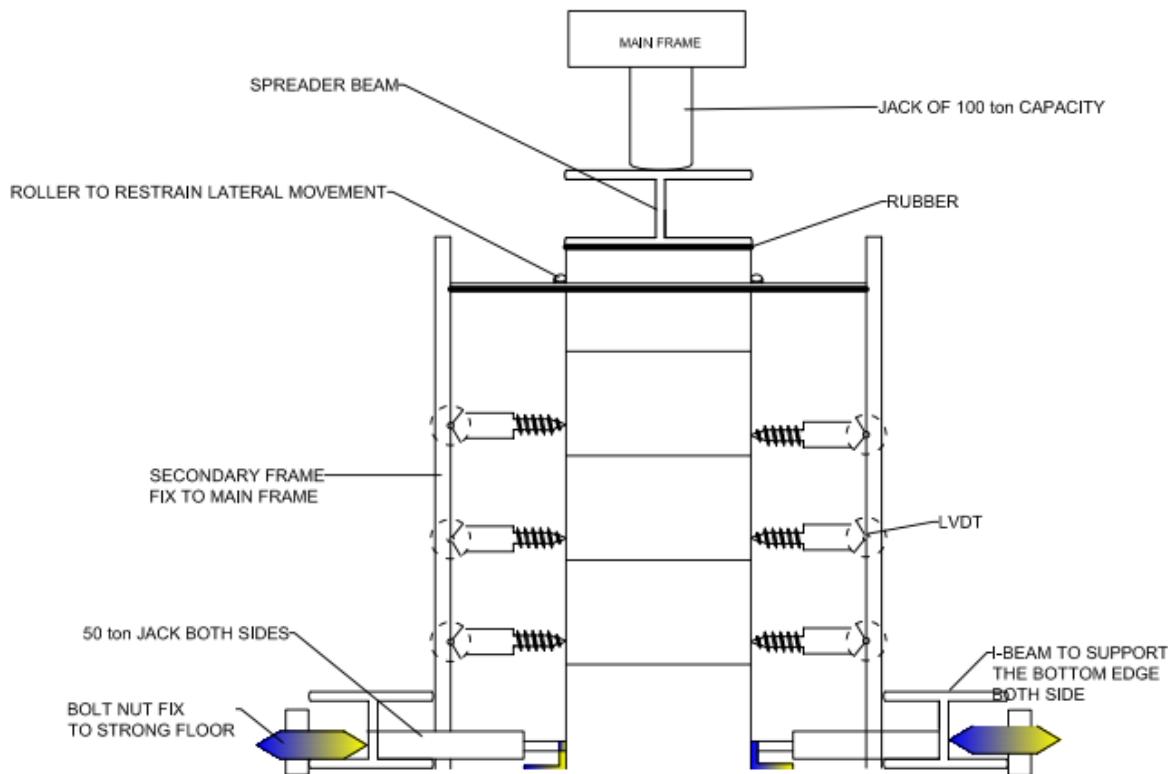
Figure 4: Wall Test Set-up

The panel wall was assembled inside the main frame test as shown in Figure 4, while the secondary frame used to hold Dial guage placed at both sides of the wall surface at 1/4, 1/2 and 3/4 heights from the bottom of wall panel to measure both lateral and in-plane deformation of wall. Two Dial guage were placed at the both side on the top of wall with its needle touched the spreader beam in order to measure the vertical deformation of the wall. Boundary condition at the top of wall was arranged to allow rotation and prevent lateral deformation at the top by using two steel shafts of 50 mm in diameter, with two steel channels in both ends were clamped to the main frames by four clamps. At the bottom of the wall the boundary condition was arranged to prevent rotation and lateral deformation by using steel beam at both sides. Rubber was placed at the top of the wall to provide a level surface. A spreader beam was placed at the top of the wall to transfer the applied load at a rate of 1 N/mm² per minute.

Wall specimen was prepared according to BS 5628-1 [31] with a minimum cross-sectional area of 0.125 m². The size of wall panel used was 1 m in height, 0.9 m length and 0.15 m thickness which consist of 12 units of stretcher blocks (S) and 6 units of half stretcher blocks (HS) for each type of wall sample. These blocks are stacked on top of each other with approximately 25 mm mortar joint layers and painted white so that the crack deformation can be easily and clearly observed.

The wall performance was obtained by using steel frame connected to hydraulic jack and steel spreader beam which transfers the load from the jacks to the walls as shown in Figure 6. A total of 6 unit Linear Variable dial gauge were used for wall deformation measurements.

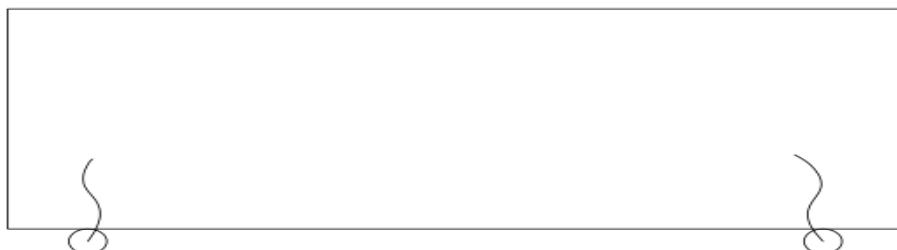
Figure 5: First mode of failure showing hairline cracks at the supports only

The beam failure mode was characterized by shear failure at the supports which occurred first as cracks at the supports and propagate gradually in size resulting in peeling at the edges and supports as shown in Figure 5 and Figure 6 respectively. These failure characteristics is commonly associated with conventional hollow block systems [38]. However, Test beams series D and E exhibited flexural cracking at the centre in form of hair line crack then gradually propagated in size until failure (rupture) as expected due to the crumb rubber and fibre within the matrix.

However, results of the first phase were lower than the theoretical predictions. Although the tests samples generally didn't fail due to flexure but failed due to shear stresses at the supports by cracking and peeling which was attributed to strength and density variations between the infill and sandcrete blocks as well as the rubberised fibre sandcrete blocks.

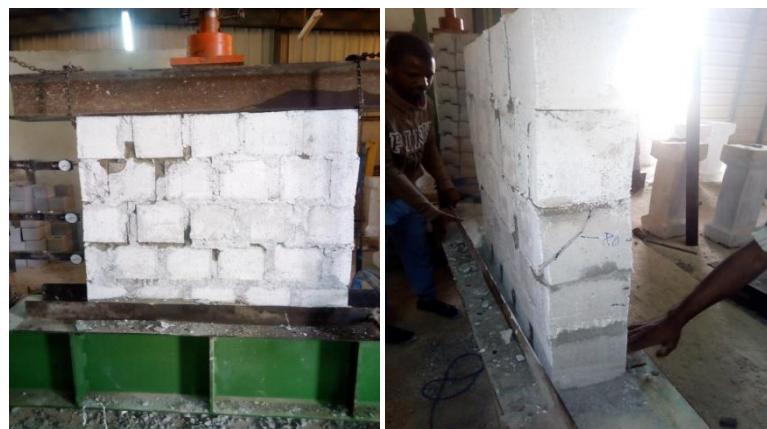
Figure 7: Failure of RFSBW panel

The failure of pattern of rubberised fibre sandcrete block wall panel is as shown in Figure 7. The first cracks appeared at 25% of its ultimate load at 0.75 of wall height. The cracks rarely appeared showing that RSFBW panel is not having much of tensile stress as the load increases but crushing cracks appeared most between the blocks bed joints. However, as the load reached 150 kN, tensile cracks becomes critical at the left side of walls until it failed at 200 kN.

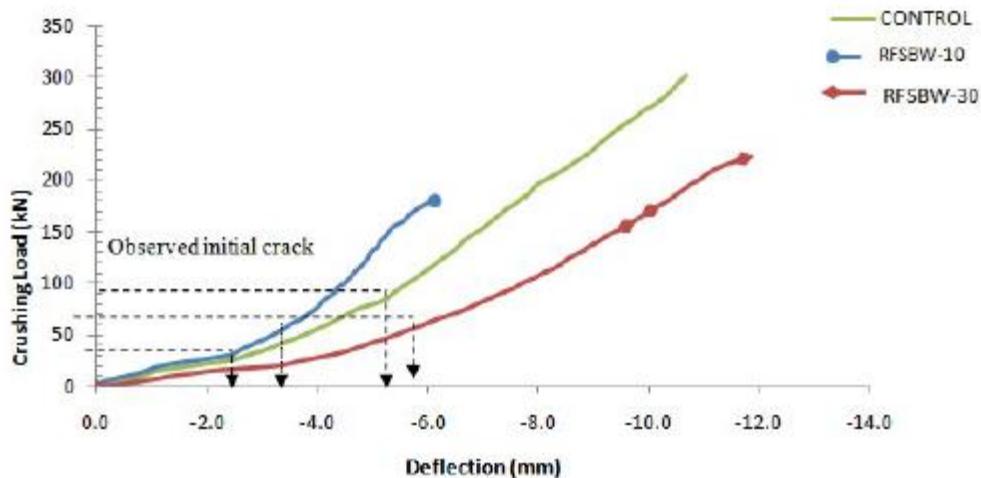
Figure 8: Load-Deflection Relationship of Wall Panel showing first crack

The axial displacement of un-stiffened rubberised fibre sandcrete block wall (RFSBW) tested panels is shown in Figure 8 which are control cement mortar matrix panel 1:2.75 and RFSBW with 10% and 30% CR replacement and 1.0% OPFF addition tested under the action of axial load. The panel's recorded different structural responses were the control and RFSBW-10 specimen displayed similar trend and having almost same initial value of stiffness which was higher than that of RFSBW-30. The increase in initial stiffness upon increase in applied load could be as a result of the presence of composite materials (crumb rubber and OPFF) which gave the mortar the ability to absorb more energy, as also demonstrated in [38]. The panels' displacement increased up to 2.8 mm, 5.29 mm and slightly higher for panel RFSBW-30 which rosed up to 6.14 mm before a change in pattern occurs. This is particular possible because of the increase in quantity of crumb rubber. After the initial displacement, the wall started to act as a rigid body hence the response became different compared to conventional masonry. This is a normal behavior of composite masonry walls where the material exhibits absorption characteristics of the applied load. After this point, the displacement rates become more constant and the panel's strength increased significantly with the applied load until it reached its ultimate capacity of 176 kN, 291 kN and 220 kN with maximum deflections of 5.91 mm, 10.49 mm and 11.60 mm for control panel, RFSBW-10 and RFSBW-30 respectively.

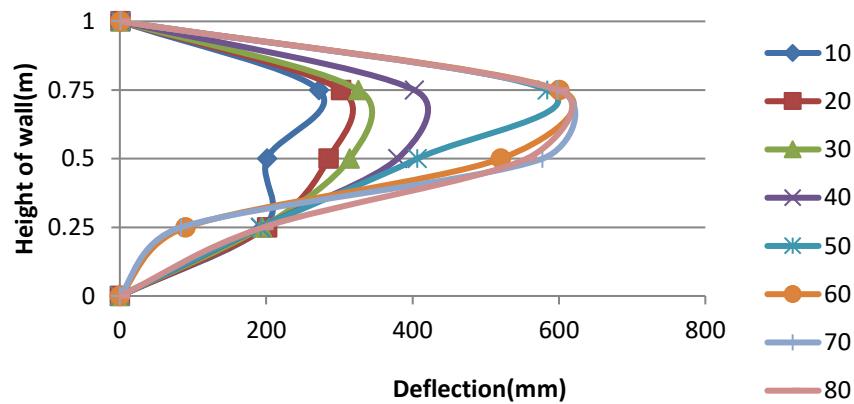
Fig 13: Lateral Deflection Profile of Panel with 10% Rubberized Fibre Mortar (RFM)

The Lateral displacement of wall shell was determined by recording readings of the dial gauges located along the centerline of the tested panel at 1/4, 1/2 and 3/4 from the bottom of wall height as earlier shown in Figure 6. Uniform compression load was applied from the top of the walls which was distributed and transferred to the wall shells in each side resulting in lateral displacement of the walls. The behavior of wall was assessed by measuring the wall lateral deflection over its own height as shown in Figure 9 and Figure 10. The deflection profiles against the height of wall are plotted at 10 kN load increment up to the maximum applied load.

From the plotted profile (Figure 9), it showed that the wall deflected with an increase in applied load, the deflection propagates gradually when more load was been applied. Although when the deflection occurred, it has shown that the highest deflection occurred at 0.75 panel height as expected with a value of 599 μ mm at 80 bar (Figure 10). The wall panel containing 30% CR showed that the wall deflected with increase in load, the deflection occur as more load was been applied although as the deflection occur it has shown that at 0.75, occur the highest deflection with the value 183 μ mm at 80 pressure (bar).
