Cost Effective Treatment of Well Water around Vadavathoor Dumping Yard

¹Asst Professor, ^{2,3,4}UG Students, Department of Civil Engineering

Amal Jyothi College of Engineering

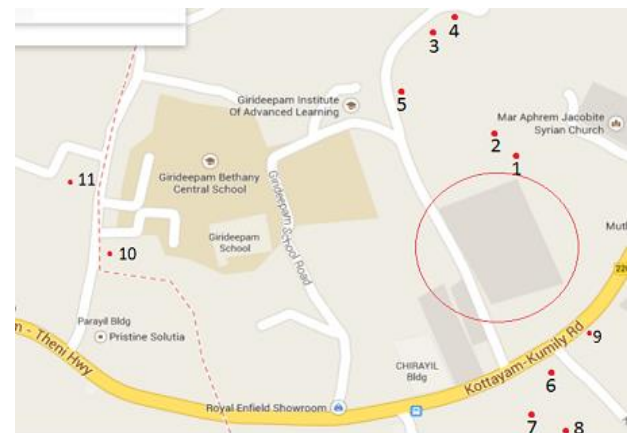
Fig. 2: Location of wells

wells in all directions of the dumping yard. Fig.2 shows the selected wells, nine wells were selected for the sampling and analysis.

On comparing the water quality results of 3 months, it could be inferred that the water is polluted. Also, on taking the weather conditions into consideration, it is noticed that the water is more polluted during the rainy season. This might be due to the fact that the rainwater is flowing through the waste forms a very thick black leachate. This leachate percolates through the ground and contaminates the groundwater. Also on comparing the parameters of different wells, it was observed that the flow of the leachate were towards the lower areas i.e. towards wells 1, 2, 6 and 7 as marked in Fig.2.

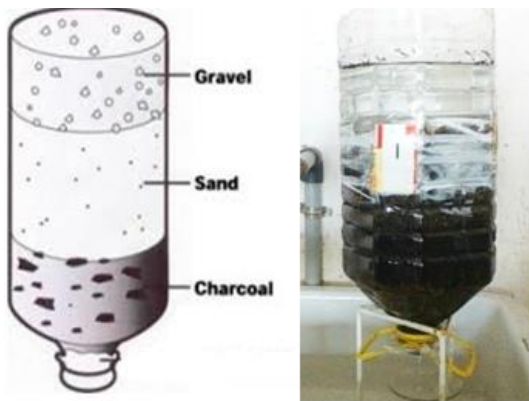
Fig. 3: Constructed Low Cost filter

Two filters were made- one with coarse material; size of the charcoal and sand were between 2.36 mm - 1.18 mm and the other with fine materials; size of the charcoal and sand were between 600 μ - 300 μ . The charcoal was crushed and sieved through the required sieves. Sand was also collected and sieved. These were then filled in a 2L plastic bottle with its bottom cut open. A wire mesh was

laid first followed by gravel, so as to support the overlying layers. A layer of charcoal was then laid at a depth of 5cm, followed by sand, at a depth of 10cm. A layer of gravel was laid again so as to filter out the larger particles in the water. The charcoal is an adsorbent to remove colour and odour. The sand screens out the impurities and promotes biological activity. The filter is then saturated and washed using tap water so as to remove any sorts of impurity, dust and dirt.

The sample was then allowed to flow through the filter and the water quality analysis of the water sample and filtered water were tested and inferred as per IS 10500, 2012.

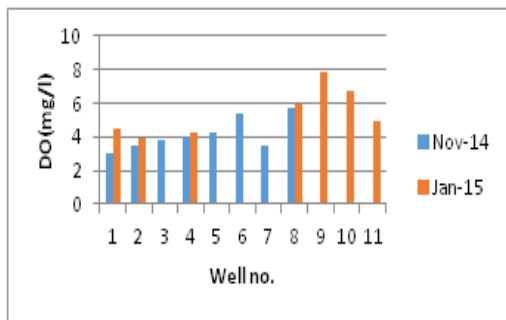
Fig.6: Variation in DO

Fig. 5 shows the variation of chloride during 3 different seasons. Chloride levels of all the wells were within the permissible limits Fig.6 shows the variation of DO, DO of

the samples were analysed only for November and December. From the results it is observed that wells 1 to 5 are polluted
