Decommissioning & Inspection Repairing of Ammonia Storage Tanks

Abstract - This article describes the methodology followed for the de-commissioning, inspection, repairing and re-commissioning of both ammonia storage tanks, repairs and modifications carried out on the tank. Ammonia Storage Tanks (T-2301A & B) at M/S. National Fertilizers Ltd was commissioned in 1987 and is in service since then. In the year 1999, after about six years of service, ice formation and bulging of PUF insulation was noticed between the concrete floor and tank's bottom plate along the periphery of the tank(T-2301B). In order to inspect and to carry out the necessary repair it was decided to de-commission the tank. The entire activity ranging from de-commissioning to re-commissioning was carried out in house. Only support of external agencies was taken for repair and inspection supervision. The old tank of capacity 10,000 MT was decommissioned in 2015-16 for internal inspection and to replace bottom load bearing along with insulation and foam concrete blocks all around the periphery. Decommissioning of Ammonia storage tank was a challenging task which involved intense thought provoking especially for empty

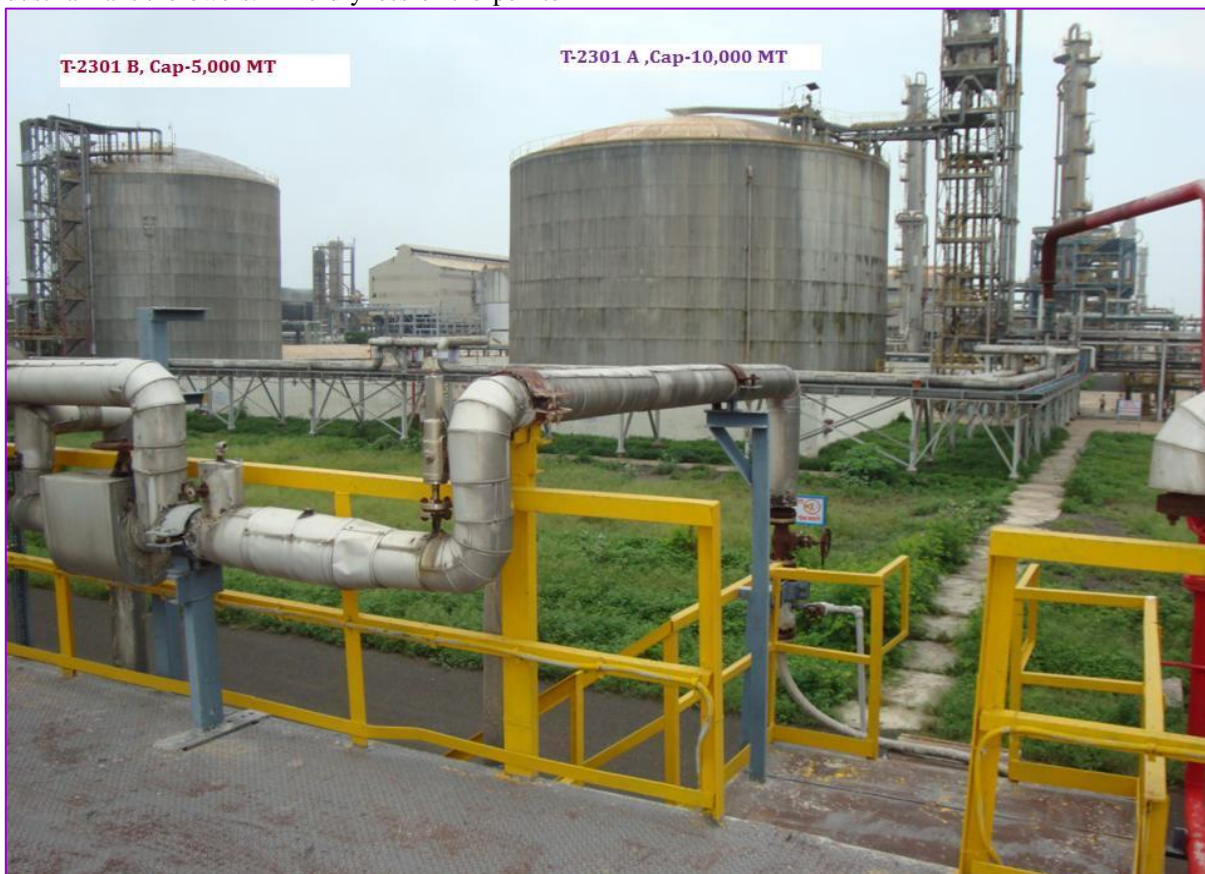
Fig. – 3

The simplest form comprises an inner tank which is the insulation. The simplest form comprises an inner tank which is surrounded by an outer tank, from the roof which is suspended a surrounded by an outer tank, from the roof which

is suspended an insulated deck designed to fit loosely with in the shell of inner tank. insulated deck designed to fit loosely with in the shell of inner tank.
