Electromechanical Impedance Based Structural Health Monitoring of Steel Frame Structure Using Surface Bonded PZT Sensors

Siddharth Mahadeo Tayade¹, Avinash D. Jakate², Dr.Suchita K. Hirde³

¹Student, M.Tech(Structural Engineering), Government College of Engineering, Amravati, Maharashtra, India

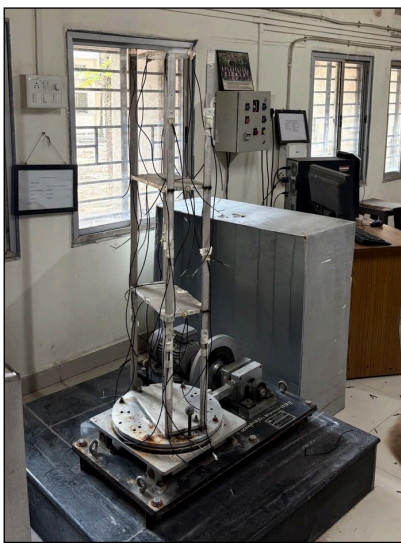
The experimental investigation was carried out on a laboratory-scale steel frame structure consisting of multiple beam-column connections. The structure was designed to simulate practical structural behavior under different damage scenarios.

Fig 1: Experimental Steel Frame Structure Used for EMI Analysis

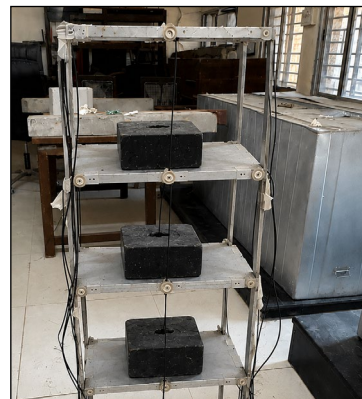
Additional mass was introduced at selected locations to study variation in resonance behavior.

Fig 3: Mass Addition Damage Condition

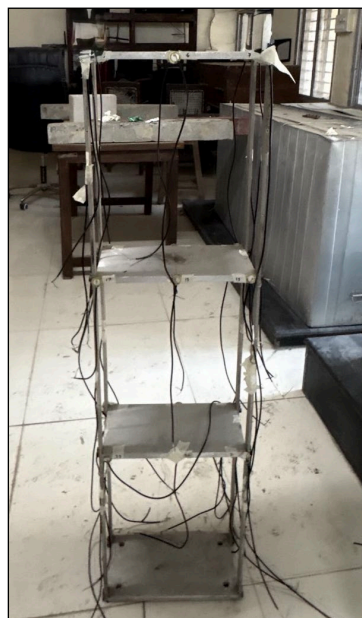
Partial loosening/removal of bolts was introduced to simulate stiffness degradation.

Fig 4: Partial Bolt Removal Damage Condition

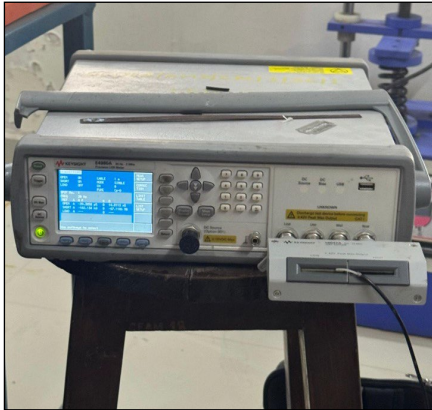
The impedance signatures were obtained using an LCR meter over a selected frequency range. The experimentally acquired data were exported to Excel format and processed using MATLAB. The frequency range of 10 kHz–400 kHz was selected to maximize local electromechanical coupling sensitivity while minimizing dominance of global structural

vibration modes. Higher frequency excitation improves localized impedance sensitivity toward minor stiffness degradation and structural discontinuities.

Fig 5: Experimental Setup for EMI Data Acquisition Using LCR Meter

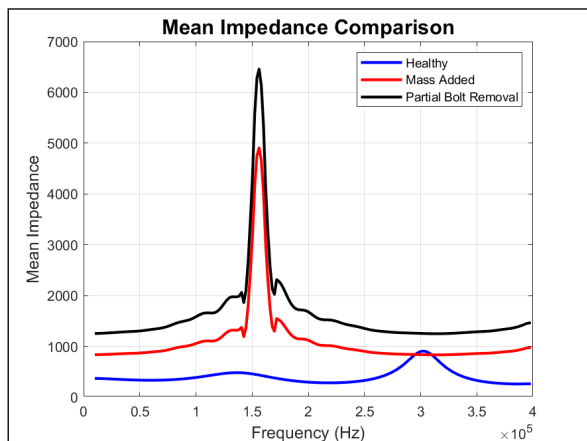
The impedance signatures obtained under healthy, mass addition, and partial bolt removal conditions showed clear variation in resonance behavior. The healthy condition exhibited smooth impedance curves with stable resonance peaks, whereas the damaged conditions showed peak shifts, amplitude reduction, and curve distortion. The partial bolt removal condition produced the maximum impedance variation due to stiffness degradation.

Among all sensors, Sensor 3 showed the highest impedance deviation followed by Sensors 5 and 12, indicating that these sensors were located closer to the damaged structural region.

Fig 7: Mean Impedance Comparison

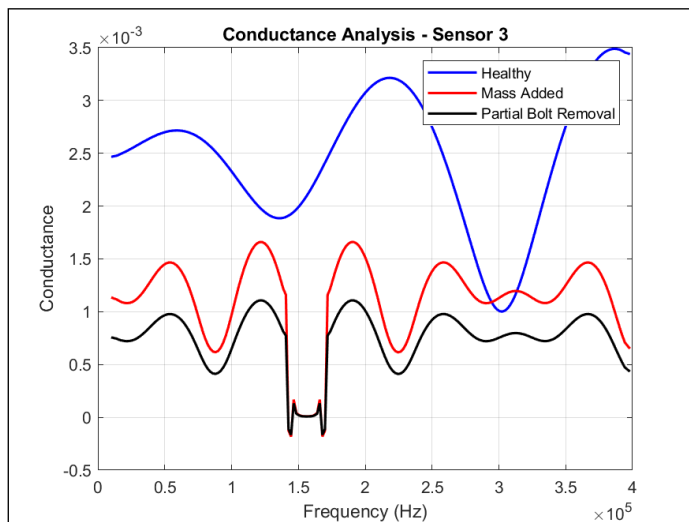
The conductance signatures showed noticeable variation under damaged conditions. The bolt removal condition produced severe conductance distortion and reduction in peak sharpness due to increased energy dissipation and local structural discontinuity. The conductance signatures additionally reflected local electromechanical coupling behavior between the bonded PZT sensors and the host structure. Under damaged conditions, resonance peak broadening and conductance reduction were observed due to localized stiffness degradation and increased structural energy dissipation.

Sensor 3 exhibited maximum conductance variation, while Sensors 24 and 30 showed comparatively lower variation due to larger distance from the damaged location.

Fig 8: Conductance Analysis for Sensor 3

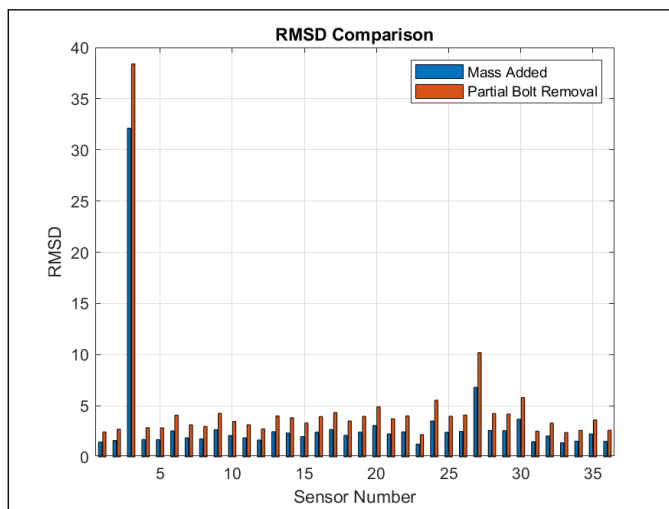
The RMSD analysis effectively quantified structural damage severity. Higher RMSD values were observed under bolt removal condition compared to mass addition condition. Sensor 3 showed the maximum RMSD value, indicating severe local structural disturbance near the damaged region.

The gradual reduction in RMSD values away from the damaged location confirmed the localized sensing capability of bonded PZT sensors.

Fig 9: RMSD-Based Damage Severity Comparison for Selected Sensors

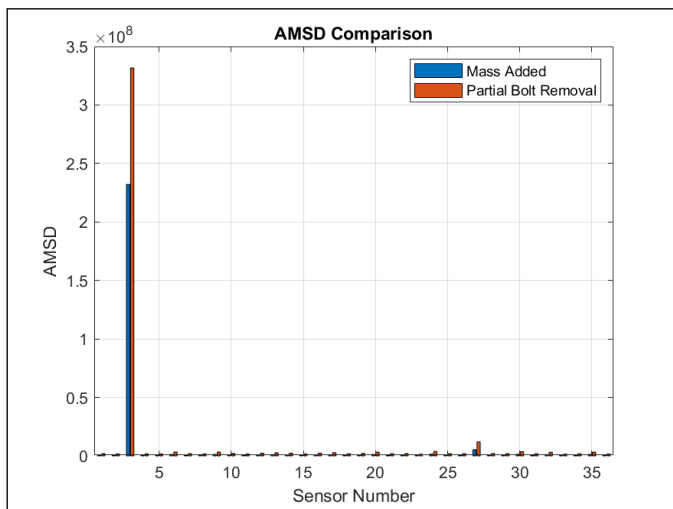
The AMSD analysis showed higher energy variation under damaged conditions. Larger AMSD values were obtained near the damaged region due to severe impedance signature distortion caused by stiffness degradation.

Sensor 3 exhibited maximum AMSD value due to severe structural disturbance.

Fig 10: RMSD Variation under Healthy and Damaged Conditions

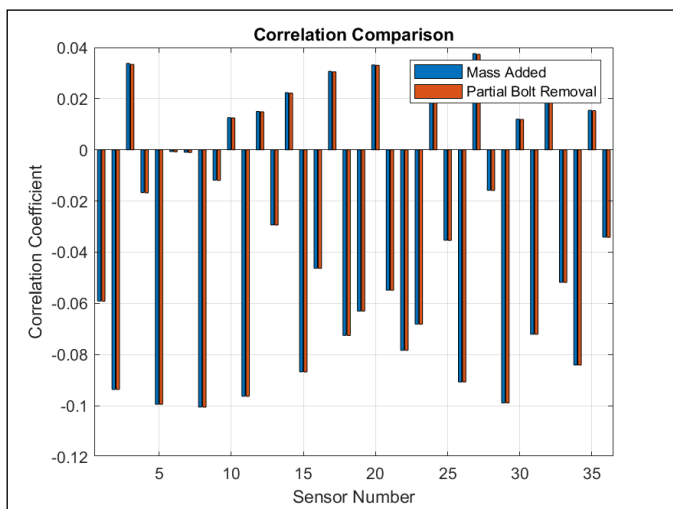
The correlation coefficient values decreased significantly under damaged conditions, especially for the partial bolt removal case. Negative correlation values indicated severe resonance distortion and structural modification. The correlation coefficient analysis demonstrated variation in impedance signature similarity under damaged conditions. Lower correlation values indicated increased deviation between healthy and damaged structural responses. However, correlation coefficient alone is insufficient for complete damage quantification and must be interpreted together with RMSD, AMSD, and resonance frequency shift analysis

Sensor 3 showed the minimum correlation value, confirming severe impedance variation near the damaged region.

Fig 11: Correlation Coefficient Comparison Graph

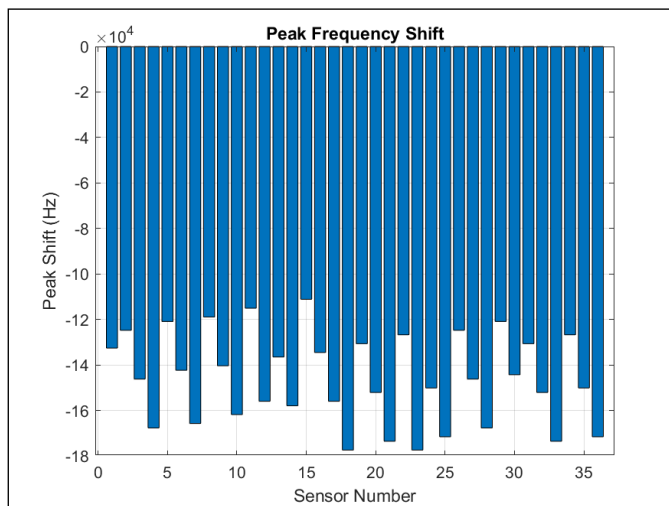
Peak frequency shift analysis revealed downward resonance movement under damaged conditions due to reduction in structural stiffness. Sensors located near the damaged region exhibited larger frequency shifts.

Sensor 3 exhibited maximum resonance shift due to severe local stiffness degradation.

Fig 12: Resonance Frequency Shift under Bolt Removal Condition

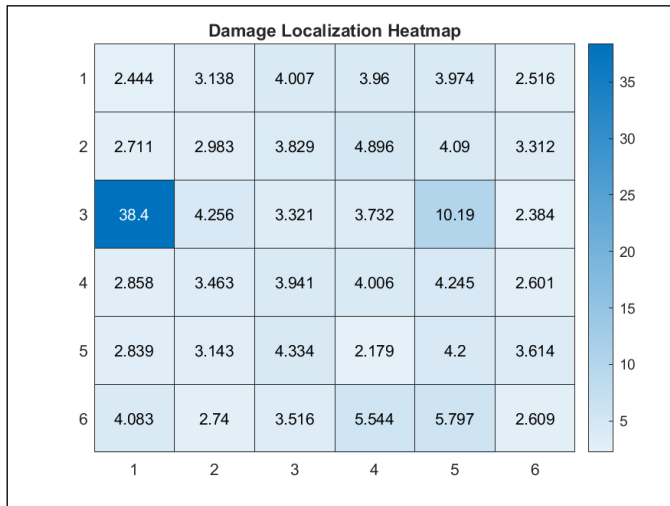
The RMSD-based heatmap successfully identified the damaged structural region. Maximum heatmap intensity was observed near Sensor 3, confirming accurate damage localization capability of the EMI technique. The RMSD based heatmap effectively visualized the spatial distribution of structural impedance variation throughout the monitored structure. Higher heatmap intensity was observed near Sensor 3, confirming localized structural sensitivity close to the damaged region. The gradual reduction in heatmap intensity away from the damaged location validated the near-field sensing capability of the EMI technique. The obtained results further demonstrated spatial damage localization, localized energy concentration, and impedance sensitivity variation across different structural regions

Fig 13: RMSD-Based Structural Damage Localization Heatmap

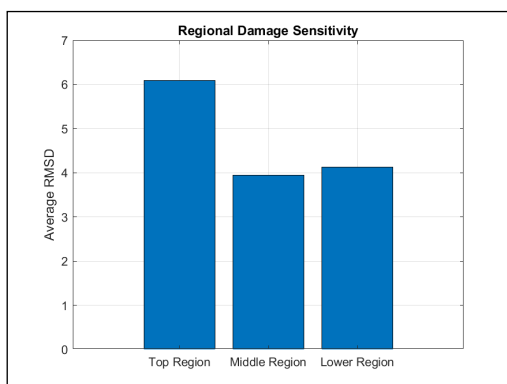
The top structural region exhibited higher RMSD values compared to middle and lower regions because the damage was located near the top sensors. The top structural region exhibited comparatively higher RMSD values due to localized modal participation and enhanced electromechanical coupling behavior near the damaged region. The gradual reduction in RMSD values toward the lower structural region confirmed the spatial sensitivity distribution of the bonded PZT sensors.

The analysis confirmed that sensors closer to the damaged region showed greater sensitivity.

Fig 14: Regional Damage Sensitivity Graph

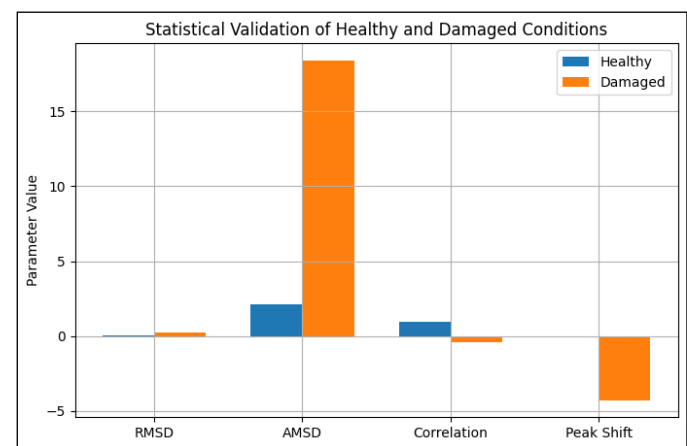
Threshold-based validation and confidence interval analysis confirmed the reliability of the obtained experimental results. The damaged condition values significantly exceeded healthy threshold limits, validating the effectiveness of the EMI-based SHM methodology. Threshold-based statistical validation was

performed using healthy baseline impedance signatures to distinguish healthy and damaged structural conditions. The experimentally obtained RMSD and AMSD values under damaged conditions significantly exceeded healthy threshold limits, confirming successful structural damage identification with improved reliability and reduced false indication probability.

The statistical validation confirmed clear differentiation between healthy and damaged structural conditions.

Fig 15: Statistical Validation Graph
