# Establishing Benchmark and Elevation Profile Mapping for Flood Modeling and Flood Inundation Studies

**Abstract-**Establishing benchmark and elevation profile mapping for flood modeling and flood inundation study is targeting Puthenvelikara Gram panchayat. Since 2018, the flood in 2 ordered years the diversity and geographical conditions of the Puthenvelikara meets a forceful worst modification. Additionally, to the present situation it's one in every of the recurrent event flood prone space. By considering all this state of affairs, the aim of this study is to implement a disaster mitigation set up. This set up ought to facilitate the natives from the frequent global climate change affects like flood, drought and therefore the recurrent event flood problems and thereby give a far better survival for them. For additional development of this set up the mean water level ought to be determined. To knowing this level a field survey ought to be conducted. This paper includes the character and disaster history of the Puthenvelikara, bench mark and its restoration for shifting MSL, details regarding the field survey and profile mapping. There are many study area unit progressing relate

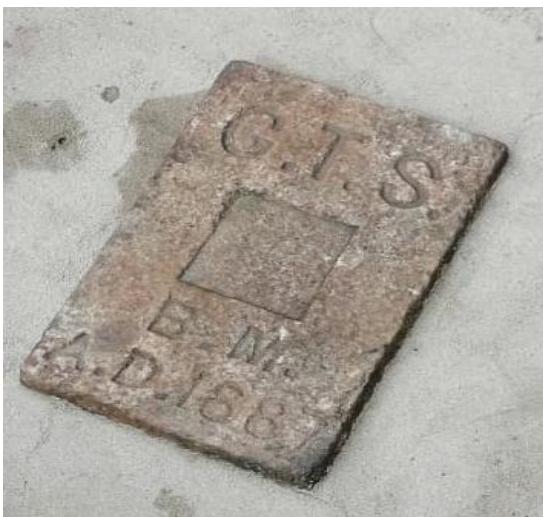
Fig.1. Bench mark at Cheraman Juma Masjid.

The field survey is kick started from the ground control point marked at Cheraman Juma Masjid in 1887 in the Great Trigonometrical survey conducted under the auspices of the East India company to scientifically measure the Indian sub-continent. It denotes the height as 4.40 meters above the mean sea level been the nearest such benchmark to Puthenvelikara should be used as the base point for the disaster mitigation measures like flood inundation mapping. Also it helps to installing the tidal gauge because the panchayat is badly hit by saline water intrusions during tidal flooding. The route for the survey is selected with the help of google map. The determined route is from Cheraman Juma Masjid to Station kadavu bridge via Kottapuram and Thiruthupuram. It exactly covers 7.7 km which includes 2 bridges and 52 curves.

For collecting the data required for the project a field survey is conducted in the study area. Bench mark at Cheraman Juma Masjid is taken as base point for the survey. With respect to this point the survey is started from the base station at Cheraman Juma Masjid. The instrument used for the survey is total station. For verifying the data taken with the total station, auto levels are also used along with the survey. The destination of the survey meets at station kadavu bridge through Kottapuram and Thiruthipuram which includes state highway 56. while conducting the survey instrument is shifted 51 times. During the survey the historical and religious spots are considered for marking level which may be useful for the future studies. Some of them are Thiruvanjikulam temple, Cheraman prambu, Thiruthipuram church, Puthenvelikara Police Station and VCHSS school Puthenvelikara. The two bridges which are covering during the survey are Kottabridge and Thiruthipuram bridge and also randomly covered 2018 flood levels near kottabridge and ST Thomas Shrine chapel. The survey is also extended to the Puthenvelikara Gram Panchayat for the future events conduct associating with this survey.

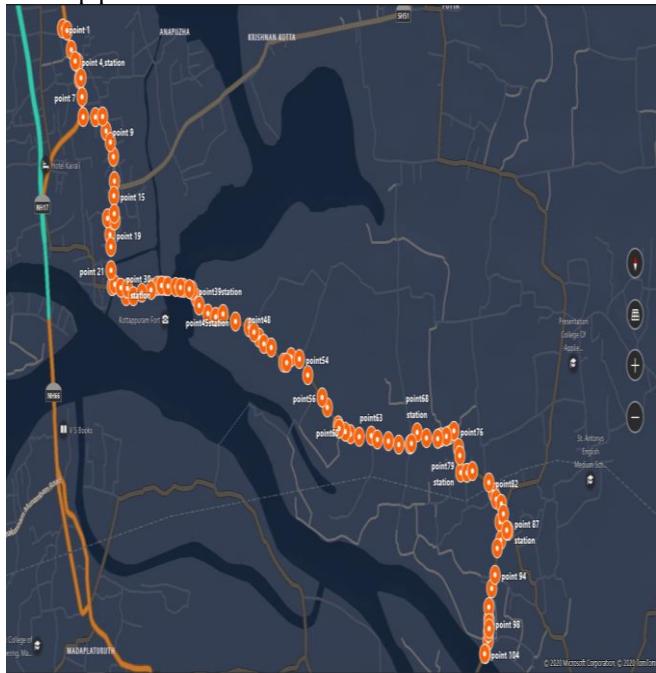
Fig.2.Map in. kml file.

The resultant data acquired from the field survey is again exported into excel sheets. The excel sheet contain reduced level of the staff stations and their respective locations i.e. latitude and longitude. These excel sheets are converted into .csv file for the mapping purposes. These .csv files are imported into. kml file. After importing these data into. kml file, a map is generated with reduced levels respective to each point and its locations in the .csv file. The Fig 2 shows the map plotted in the. kml file.

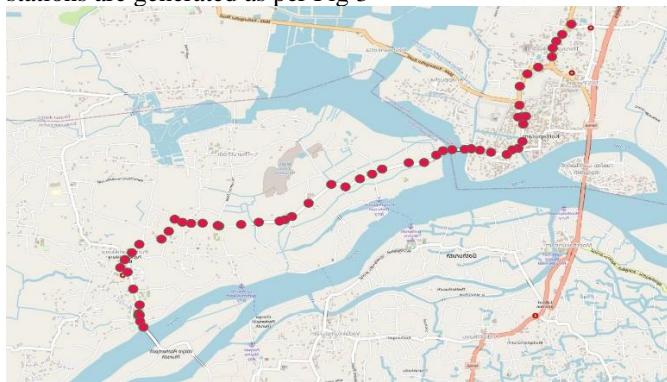
Fig.3. Map in QGIS software with reduced level.

The further mapping process including profile mapping are carried out in QGIS software. The .kml file is then open in QGIS software, then the map with reduced levels of each stations are generated as per Fig 3

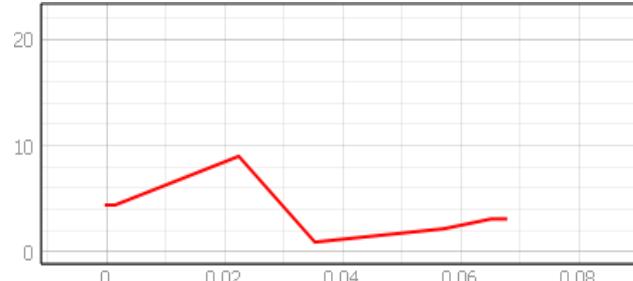
Fig.4. Profile map of the study area.

Then these files are again interpolated with these marked points in the map with the help of profile tool in the QGIS software which generate elevation for line features to getting the profile map of the study area as shown in fig 4. The x axis shows the places from Cheraman Juma masjid to Station Kadavu and y axis shows the RL of each point.

By analyzing the profile map, the regions with low altitude and high altitude can be effectively determined. Thus it helps in distinguishing the low lying and high altitude region of the panchayat. From Cheraman Juma Masjid to Cheraman prambu the variation in RL is almost 1 meter. After Cheraman prambu to the starting of Thiruthipuram bridge including the kotta bridge the RL is reducing i.e. from 5.070 meter to 1.680 meters which containing a variation of 4 meter. Then the RL at the bridge and it reducing to the end of bridge. Then the RL has almost constant nature with a variation of 1 meter to 0.5 meter. Then the RL is reducing to 0.885 meters at the Bakery padi which is one of the low lying

and sensitive region of the Puthenvelikara Gram panchayat. Then the region preceding from to Bakery padi to 1.5 kilo meters having slight variation. From here to a 300 meter of regions having a different nature in RL. The RL is suddenly increasing to 5.615 meters and then it is decreasing to 2.180 meters. This region is nearer to the Sree Dhandidayudha Paani temple. Then from this region to station kadavu bridge having low altitude. Thus the topography of the Puthenvelikara is mixture of high and low altitude region.

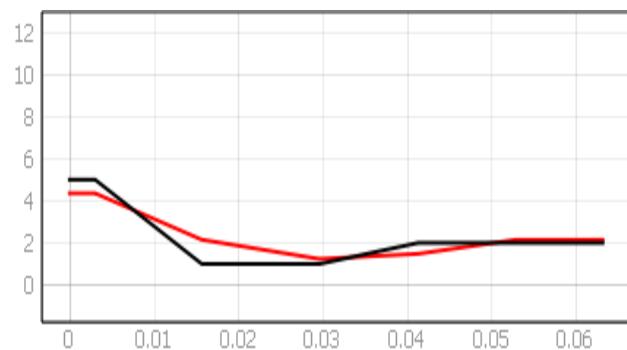
Fig.5.Profile map which compares the RL of field survey and google earth of the study area.

The fig 5 shows the profile of the region which is plotted against both the reduced levels from the field survey and the google earth. The red line indicates the RL from the field survey and black line shows the RL from the google earth.

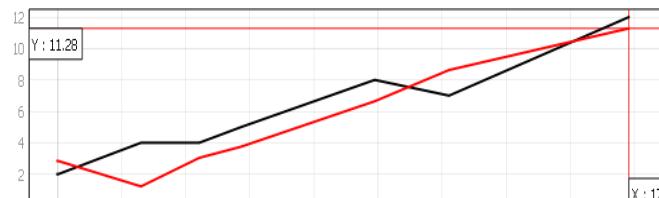
Fig.6. Profile map compares the RL of the field survey and google earth of the various railway stations.

By analyzing the table, we came to a conclusion that there always occurs a variation in the data obtained from the google earth with the actual data. For example, consider the railway station at Ernakulam district, the actual RL of the station in records is the 1.22 meters and the RL from google earth is 4.00 meters. so there occurs a variation of 2.780 meters. This is due to the undulation of the earth surface and this variation is sometimes greater than the actual value and vice versa which is clearly depending on the topography of the considering region. As per the result of this analyses we conclude that the data obtained through field survey is more accurate than the advanced data from the google earth. So the further study is continuing by considering the field data. From the field survey, the resulted RL meets with many undulations in many regions and somewhere it shows a consistent nature also. In some places it shows steep rise and somewhere it shows a decreasing nature. The intermediate stations included in the survey shows different nature in RL. This survey covers the most sensitive regions in the time of flood in previous years this sensitivity to flooding is a result of the undulation in the region.
