Experimental Study on the Shear Transfer of Composite Pre-Slabs with H.S.C Top Layer Using Different Shear Dowels Percentage

Abstract - The aim of research is to study the influence of concrete strength, case of loading, percentage and distribution of shear connectors on shear transfer of one way composite pre-slabs composed of two concrete layers with different compressive strength the first layer (normal strength concrete and the second layer high strength concrete). An experimental program has been performed to investigate the research point, where fourteen specimens were supported on two edge supports to represent the case of one way simply supported slab and tested under the case of uniformly distributed loads, one concentrated line load and two concentrated line loads. Specimens were grouped into four groups to study the influence of dowel distribution, percentage and surface condition between two slab layers. It was concluded that increasing of shear connectors ratio with uniform distribution leads to increasing in ultimate load and shear strength, decrease in dowels' strain, decrease in horizontal slippage in case of roughening the interface surface and increasing in ducti

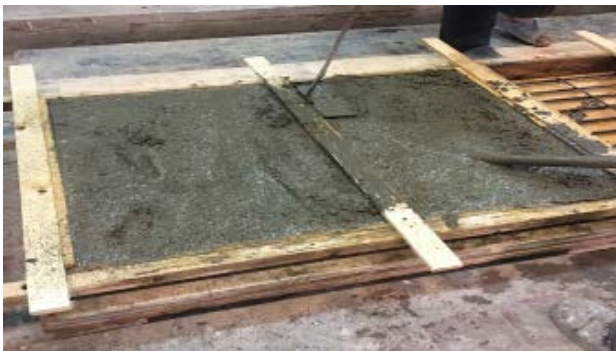
Figure 1: Monolithic slab specimen

Experimental program was carried out on six monolithic slabs and eight composite pre-slabs; Both the monolithic and pre-slabs had been supported on two edge supports to represent the case of one way simply supported slab. Firstly, the monolithic slab consists of one concrete layer with dimensions 1060*800*100 mm with main bottom reinforcement of 10Φ12 mm and secondary reinforcement of 6Φ6 mm as shown in Figure 1. Secondly the composite slab consists of two concrete layers; the first layer was slab with dimensions 1060*800*50 mm with main bottom reinforcement of 10Φ12 mm, secondary reinforcement of 6Φ6 mm and its $F_{cu}=35$ N/mm². The second layer had the same dimensions as the first layer 1060*800*50 mm without reinforcement and its $F_{cu}=60$ N/mm² as shown in the figure 2.

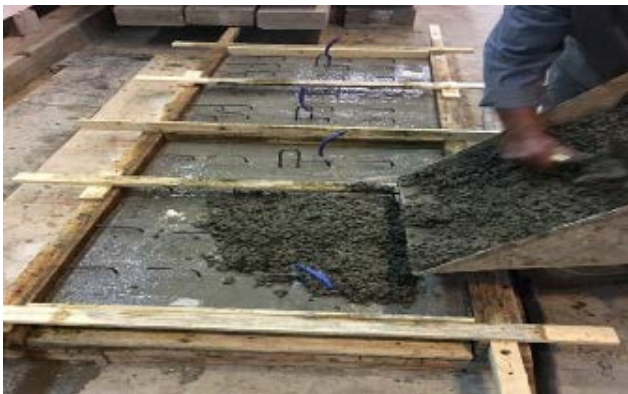
Figure 2: Pre-slab specimen

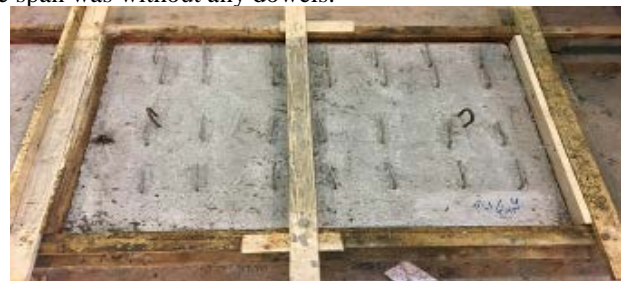
Figure 3: uniform dowels 0.1% distribution

0.1%-U: composite slab tested under the effect of uniformly distributed load had uniform dowels distribution of ratio equals to 0.1%.

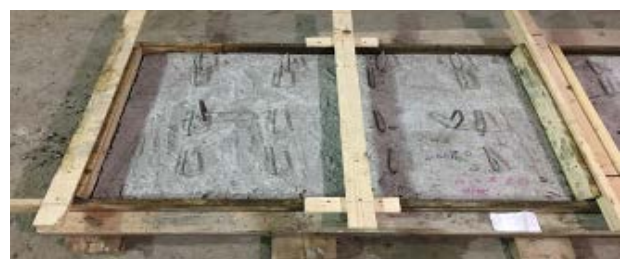
Figure 4: uniform dowels 0.06% distribution

0.06%-U: composite slab tested under the effect of uniformly distributed load had uniform dowels distribution of ratio equals to 0.06%.

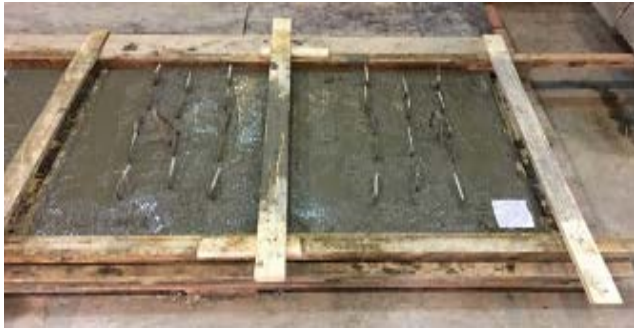
Figure 5: concentrated dowels 0.1% distribution

0.1%-T: composite slab tested under the effect of two-line load acts at a distance of 20% of the span from the two edges, dowels with ratio equals to 0.1% and 50% of dowels area put in each one quarter of the outside span while the middle part of the span was without any dowels.

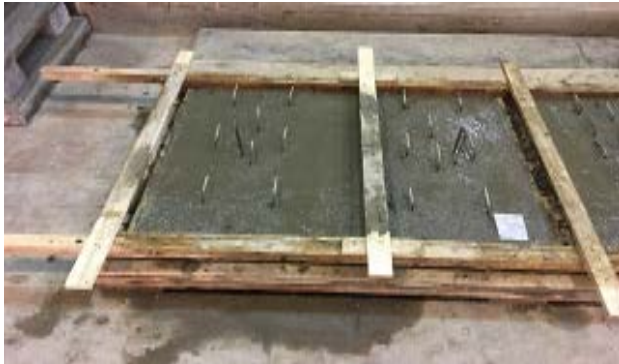
Figure 6: concentrated dowels 0.06% distribution

0.06%-T: composite slab tested under the effect of two-line load acts at a distance of 20% of the span from the two edges, dowels with ratio equals to 0.06% and 50% of dowels area put in each one quarter of the outside span while the middle part of the span was without any dowels.

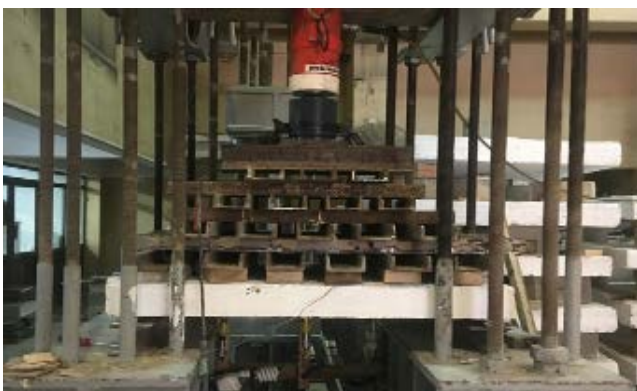
Figure 7: Uniformly distributed load

The specimens were tested under the effect of three types of loading; the first case of loading was the effect of uniform distributed load through a whiffed tree arrangement, the second case of loading was the effect of one-line load while the third case of loading was the effect of two-line loads.

The preloading due to the own weight of specimens, hydraulic jack, loadcell and steel joists had been taken into consideration in the analyses. The different load arrangements are shown in figure 7 through figure 8.

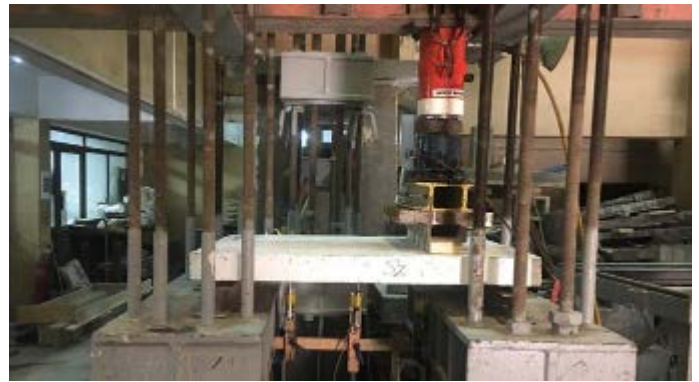
Figure 8: One-line load

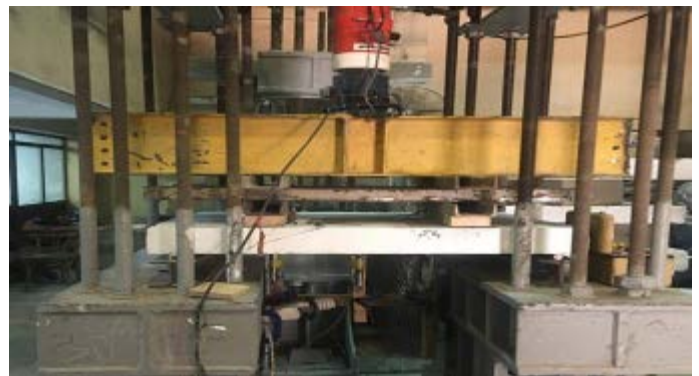
Figure 9: Two-line loads

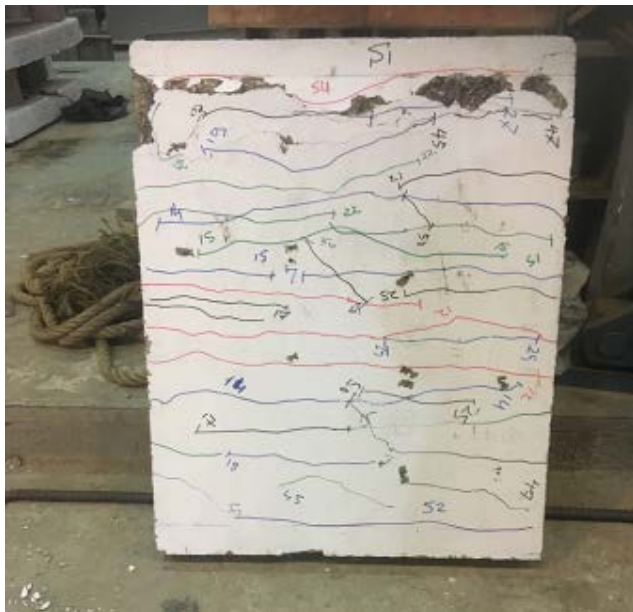
Figure 10: Cracks pattern of specimen (R-N-U)

This slab was a monolithic slab with normal compressive strength subjected to uniformly distributed loads, the first crack was observed at load of 12 ton (15 t/m^2) on the bottom surface at the section of maximum moment, nearly to the middle of the span. After this load level, another bottom cracks appeared as the increasing of load. From **figure 10** it can be noticed that the bottom cracks were symmetrically about the axe passing through the mid-span of the slab.

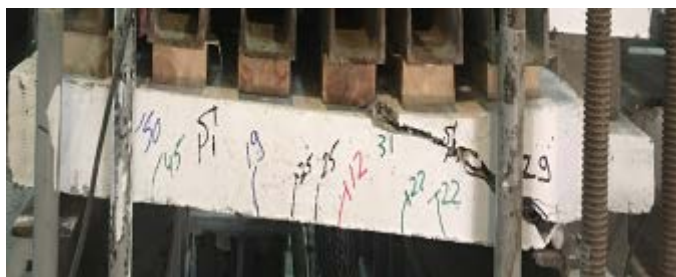
Figure 11: Shear failure of specimen (R-N-U)

The skew shear crack started to appear at load 29 ton (36.25 t/m^2), it was near the support from the two sides. Increasing the load after the skew shear crack appeared led to increase in the skew shear crack width and beginning of new shear cracks between the two main skew shear cracks till the specimen had a complete shear failure as shown in figure 11

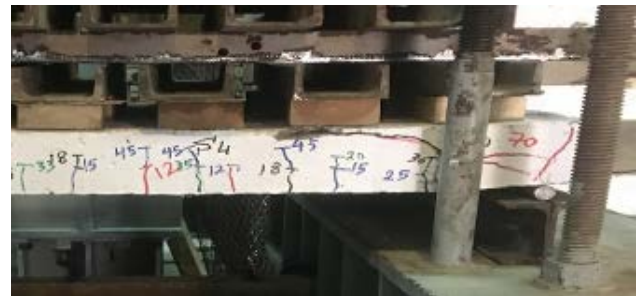
Figure 12: Shear cracks of specimen (R-H-U)

This slab was high strength concrete monolithic slab and subjected to uniformly distributed loads, the first crack was observed at load of 18 ton (10 t/m^2) on the bottom surface at the section of maximum moment, nearly to the middle of the span. After this load level, another bottom cracks appeared as the increasing of load. From figure 4.4 it can be noticed that the bottom cracks were symmetrically about the axe passing through the mid-span of the slab. The skew shear crack started to appear at load 35 ton (43.75 t/m^2), it was near the support

from the two sides. Increasing the load after the skew shear crack appeared led to increase in the skew shear crack width and beginning of new shear cracks between the two main skew shear cracks till the specimen had a complete shear failure as shown in figure 12.

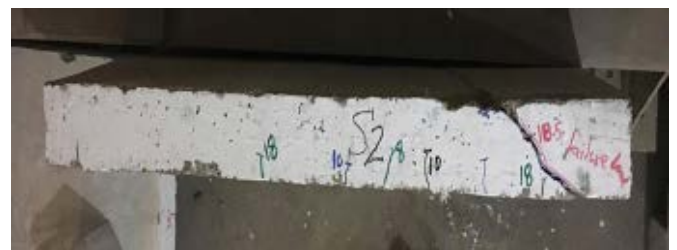
Figure 13: Shear cracks of specimen (R-N-O)

This slab was a monolithic slab with normal compressive strength subjected to one-line load, the first crack was observed at load of 7.5 ton (9.375 t/m line load) on the bottom surface at the section of maximum moment, nearly to the location of applied line load. After this load level, another bottom cracks appeared adjacent to the applied line load as the increasing of load. The skew shear crack started to appear at load 15 ton (18.75 t/m line load), it was near the support under the applied line load, increasing the load after the skew shear crack appeared led to increase in the skew shear crack width and beginning of new small skew shear cracks as shown in figure 13.

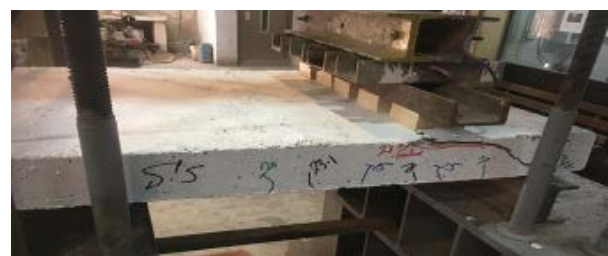
Figure 14: Shear cracks of specimen (R-H-O)

This slab was high strength concrete monolithic slab and subjected to one-line load, the first crack was observed at load of 12.5 ton (15.625 t/m line load) on the bottom surface at the section of maximum moment, nearly to the location of applied line load. After this load level, another bottom cracks appeared adjacent to the applied line load as the increasing of load. The skew shear crack started to appear at load 21.5 ton (26.875 t/m line load), it was near the support under the applied line load, increasing the load after the skew shear crack appeared led to increase in the skew shear crack width and beginning of new small skew shear cracks as shown in figure 14.

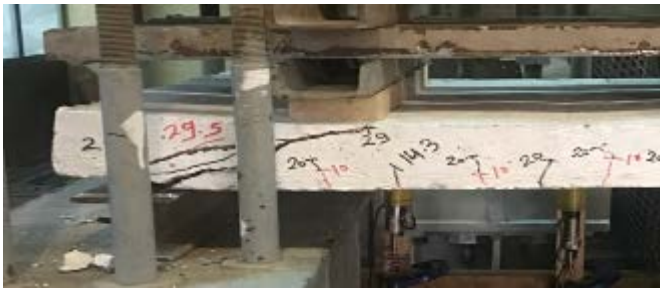
Figure 15: Shear cracks of specimen (R-N-T)

This slab was a monolithic slab with normal compressive strength subjected to uniformly distributed loads, the first crack was observed at load of 10 ton (6.25 t/m for each line load) on the bottom surface at the section of maximum moment, nearly to the middle of the span. After this load level, another bottom cracks appeared on the both sides from the first crack as the increasing of load.

The skew shear crack started to appear at load 25 ton (15.63 t/m for each line load), it was near the support under the applied line loads. Increasing the load after the skew shear crack appeared led to increase in the skew shear crack width and beginning of new small skew shear cracks till the specimen had a complete shear failure as shown in figure 15.

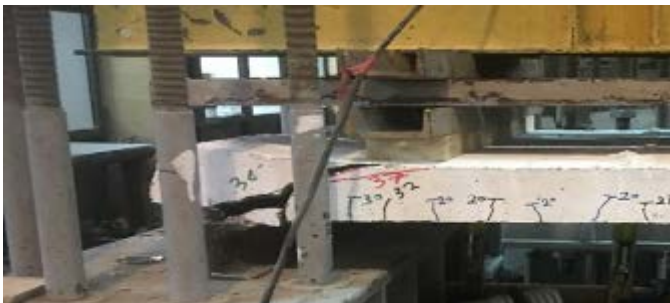
Figure 16: Shear cracks of specimen (R-H-T)

This slab was high strength concrete monolithic slab subjected to uniformly distributed loads, the first crack was observed at load of 15 ton (9.375 t/m for each line load) on the bottom surface at the section of maximum moment, nearly to the middle of the span. After this load level, another bottom cracks appeared on the both sides from the first crack as the increasing of load. The skew shear crack started to appear at load 36 ton (22.5 t/m for each line load), it was near the support under the applied line loads. Increasing the load after the skew shear crack appeared led to increase in the skew shear crack width and beginning of new small skew shear cracks till the specimen had a complete shear failure as shown in figure 16.

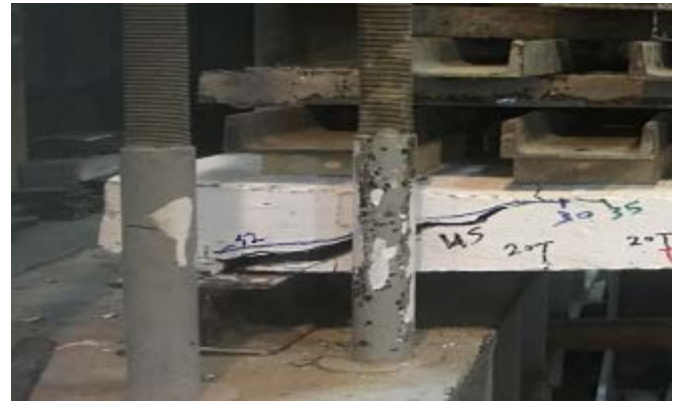
Figure 17: Shear cracks of specimen (0.06%-U)

This slab was composite (normal strength at bottom -high strength concrete at the top) slab and subjected to uniformly distributed loads with uniform dowels distribution of ratio equals to 0.06% and the dowel length equals to 20ϕ . The first crack was observed at load of 12.5 ton (15.625 t/m²) on the bottom surface at the section of maximum moment nearly to

the midsection of the span. After this load level, another bottom cracks appeared as the of incrementing load.

The skew shear crack started to appear at load of 30 ton (37.5 t/m²), it was near the support. Increasing the load after the skew shear crack appeared led to increase in the skew shear crack width and creation of new shear cracks between the two main skew shear cracks till the specimen had complete shear failure at load of 52 ton (65 t/m²) as shown in figure 17.

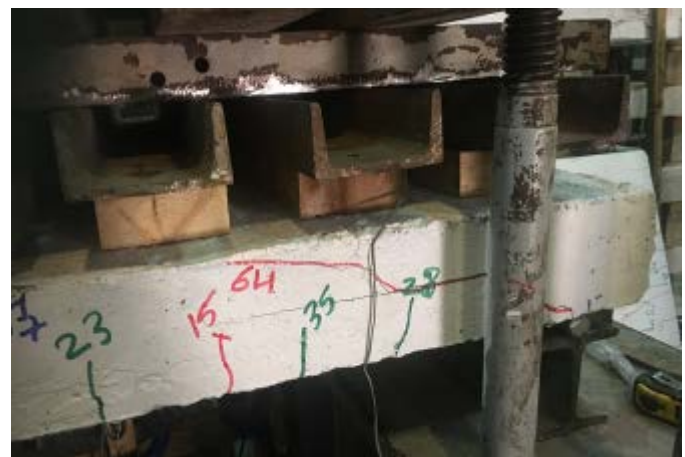
Figure 18: Shear cracks of specimen (0.1%-U)

This slab was composite (normal strength at bottom -high strength concrete at the top) slab and subjected to uniformly distributed loads with uniform dowels distribution of ratio equals to 0.1% and the dowel length equals to 20ϕ . The first crack was observed at load of 15 ton (18.75 t/m²) on the bottom surface at the section of maximum moment nearly to the midsection of the span. After this load level, another bottom cracks appeared as the increasing of load. The skew shear crack started to appear at load of 50 ton (62.5 t/m²), it was near the support. Increasing the load after the skew shear crack appeared led to increase in the skew shear crack width and creation of new shear cracks between the two main skew shear cracks till the specimen had complete shear failure at load of 64 ton as shown in figure 18.

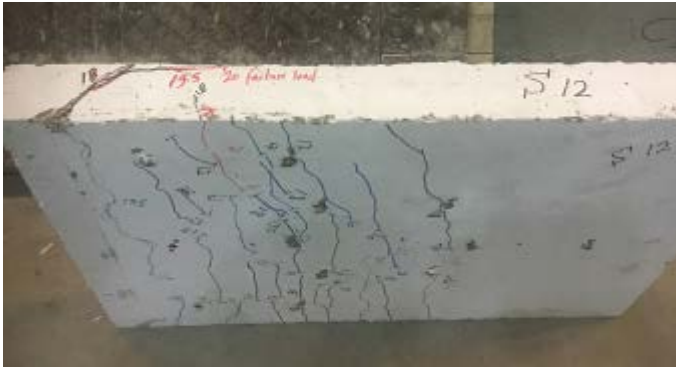
Figure 19: Shear cracks of specimen (0.06%-O)

This slab was composite (normal strength at bottom -high strength concrete at the top) slab and subjected to uniformly one-line load with uniform dowels distribution of ratio equals to 0.06% and the dowel length equals to 20ϕ . The first crack was observed at load of 7 ton (8.75 t/m line load) on the

bottom surface at the section of maximum moment nearly to the location of applied line load. After this load level, another bottom cracks appeared adjacent to the applied line load as the increasing of load.

The skew shear crack started to appear at load of 18 ton (22.5t/m line load), it was near the support under the applied line load. Increasing the load after the skew shear crack appeared led to increase in the skew shear crack width and creation of new shear cracks between the two main skew shear cracks till the specimen had complete shear failure at load of 19.5 ton (24.375 t/m line load) as shown in figure 19.

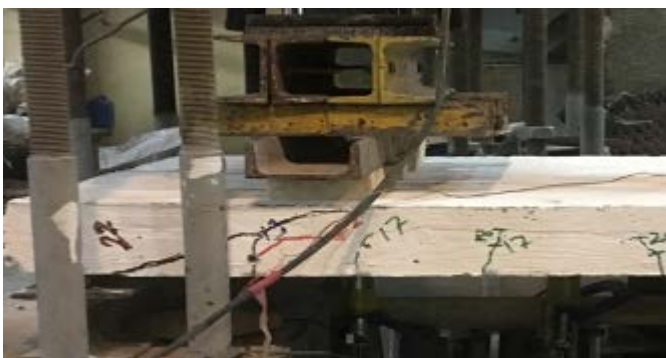
Figure 20: Shear cracks of specimen (0.06%-O-R)

This slab was composite (normal strength at bottom-high strength concrete at the top) slab and subjected to uniformly one-line load with uniform dowels distribution of ratio equals to 0.06%, the dowel length equals to 20ϕ and had roughening on the interface area between the two concrete layers. The first crack was observed at load of 7.5 ton (9.375 t/m line load) on the bottom surface at the section of maximum moment nearly to the location of applied line load. After this load level, another bottom cracks appeared adjacent to the applied line load as the increasing of load.

The skew shear crack started to appear at load of 19 ton (23.75 t/m line load), it was near the support under the applied line load. Increasing the load after the skew shear crack appeared led to increase in the skew shear crack width and creation of new shear cracks between the two main skew shear cracks till the specimen had complete shear failure at load of 22 ton (27.5t/m line load) as shown in figure 4.20.

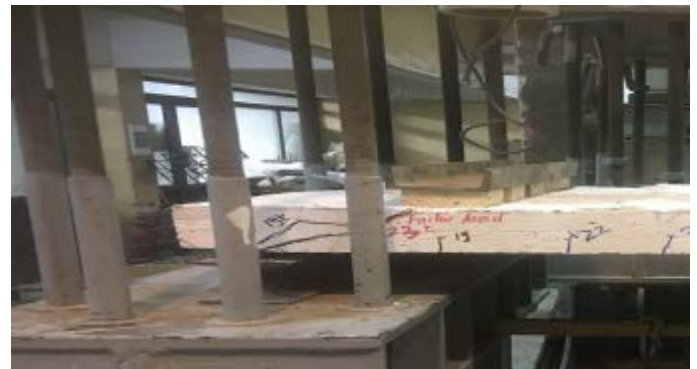
Figure 21: Shear cracks of specimen (0.1%-O)

This slab was composite (normal strength at bottom -high strength concrete at the top) slab and subjected to uniformly one-line load with uniform dowels distribution of ratio equals to 0.1% and the dowel length equals to 20ϕ . The first crack was observed at load of 7 ton (8.75 t/m line load) on the bottom surface at the section of maximum moment nearly to the location of applied line load. After this load level, another bottom cracks appeared adjacent to the applied line load as the increasing of load. The skew shear crack started to appear at load of 19 ton (23.75t/m line load), it was near the support under the applied line load. Increasing the load after the skew shear crack appeared led to increase in the skew shear crack width and creation of new shear cracks between the two main skew shear cracks till the specimen had complete shear failure at load of 23 ton (28.75 t/m line load) as shown in figure 21.

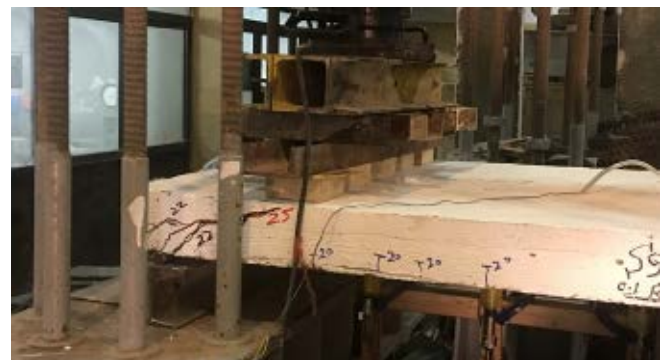
Figure 22: Shear cracks of specimen (0.1%-O-R)

This slab was composite (normal strength at bottom -high strength concrete at the top) slab and subjected to uniformly one-line load with uniform dowels distribution of ratio equals to 0.1%, the dowel length equals to 20ϕ and had roughening on the interface area between the two concrete layers. The first crack was observed at load of 8.5 ton (10.625 t/m line load) on the bottom surface at the section of maximum moment nearly to the location of applied line load.

After this load level, another bottom cracks appeared adjacent to the applied line load as the increasing of load. The skew shear crack started to appear at load of 22 ton (27.5 t/m line load), it was near the support under the applied line load. Increasing the load after the skew shear crack appeared led to increase in the skew shear crack width and creation of new shear cracks between the two main skew shear cracks till the specimen had complete shear failure at load of 25 ton (31.25 t/m line load) as shown in figure 22.

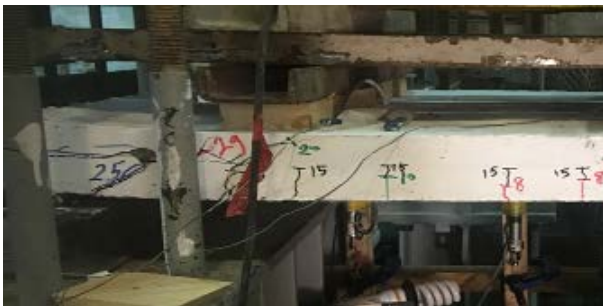
Figure 23: Shear cracks of specimen (0.06%-T)

This slab was composite (normal strength at bottom -high strength concrete at the top) slab and subjected to uniformly two-line loads with concentrated dowels distribution of ratio equals to 0.06% and the dowel length equals to 20ϕ . The first crack was observed at load of 8 ton (5 t/m for each line load) on the bottom surface at the section of maximum moment nearly to the middle of the span. After this load level, another bottom cracks appeared on the both sides from the first crack as the increasing of load.

The skew shear crack started to appear at load of 25 ton (15.62 t/m for each line load), it was near the support under the applied line loads. Increasing the load after the skew shear crack appeared led to increase in the skew shear crack width and creation of new shear cracks between the two main skew shear cracks till the specimen had complete shear failure at load of 29 ton (18.125 t/m for each line load) as shown in figure 23.

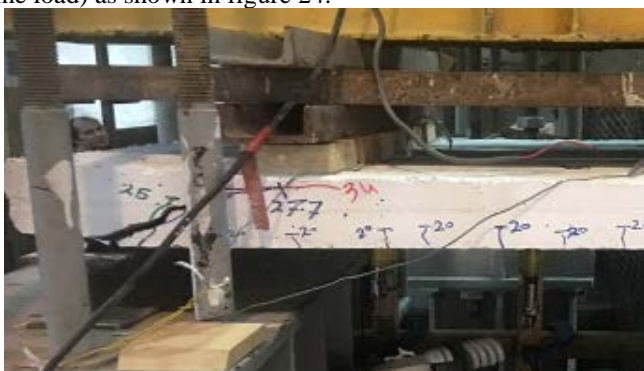
Figure 24: Shear cracks of specimen (0.1%-T)

This slab was composite (normal strength at bottom -high strength concrete at the top) slab and subjected to uniformly two-line loads with concentrated dowels distribution of ratio equals to 0.1% and the dowel length equals to 20ϕ . The first crack was observed at load of 11.5 ton (7.18 t/m for each line load) on the bottom surface at the section of maximum moment nearly to the middle of the span. After this load level, another bottom cracks appeared on the both sides from the first crack as the increasing of load. The skew shear crack started to appear at load of 25 ton (17.31 t/m for each line load), it was near the support under the applied line loads. Increasing the load after the skew shear crack appeared led to increase in the skew shear crack width and creation of new shear cracks between the two main skew shear cracks till the specimen had complete shear failure at load of 34 ton (21.25 t/m for each line load) as shown in figure 24.

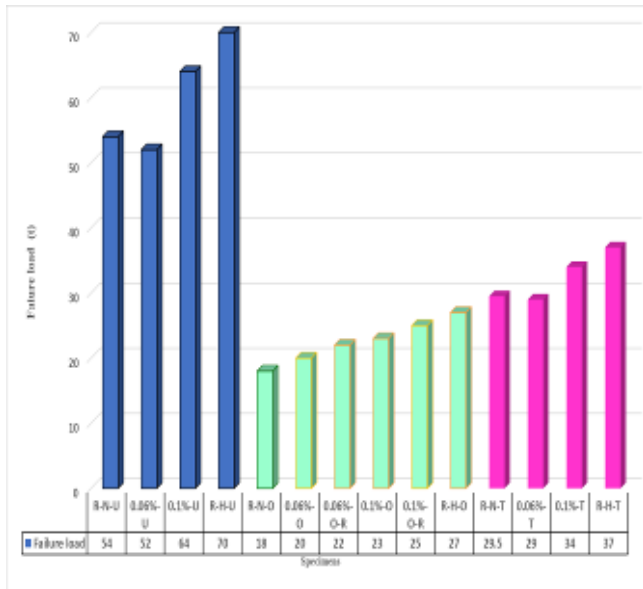
Figure 25: Failure loads of tested specimens

Referring to Figure 25, shows the failure loads for the tested monolithic and pre-slabs, it can be noticed that the failure load of composite pre-slab is linearly proportional as the shear connectors ratio increases.

For group 1 under uniformly distributed loads, the failure load of composite pre-slab (0.06%-U) with shear connectors area equals to 0.06% from the interface area and uniform dowels distribution was about 97% of the corresponding monolithic slab (R-N-U), and about 75% of the monolithic slab (R-H-U), while the failure load for composite pre-slab (0.1%-U) was about 118.5% of the corresponding monolithic slab R-N-U and 91.5% of the corresponding monolithic slab (R-H-U).

For group 2 under uniformly one-line loads, the failure load of composite pre-slab (0.06%-O) was about 111.11% of the corresponding monolithic slab (R-N-O), while was 74% of the corresponding monolithic slab (R-H-O). The failure load of the composite pre-slab (0.1%-O) was about 127.7% for the corresponding monolithic slab (R-N-O), while it was about 85% of the corresponding monolithic slab (R-H-O).

For group 3 under uniformly one-line loads, the failure load of the composite pre-slab (0.06%-O-R) with the interface area (Rough) was about 122.2% for the corresponding monolithic slab (R-N-O), while the failure load was about 81.5% for the corresponding monolithic slab (R-H-O). The failure load of the composite pre-slab (0.1%-O-R) with the interface area (Rough) was about 138.8% for the corresponding monolithic slab (R-N-O), while it was about 92.5% of the corresponding monolithic slab (R-H-O).

For group 4 under uniformly two line loads, the failure load of composite pre-slab (0.06%-T) with shear connectors area equals to 0.06% from the interface area and concentrated dowels distribution was about 98% of the corresponding monolithic slab (R-N-T), was about 78% for the corresponding monolithic slab (R-H-T), while the failure load of the composite pre-slab (0.1%-T) for the corresponding monolithic slab (R-N-T) was about 115.25% and also the failure load for composite pre-slab (0.1%-T) about 92% of the corresponding monolithic slab (R-H-T).

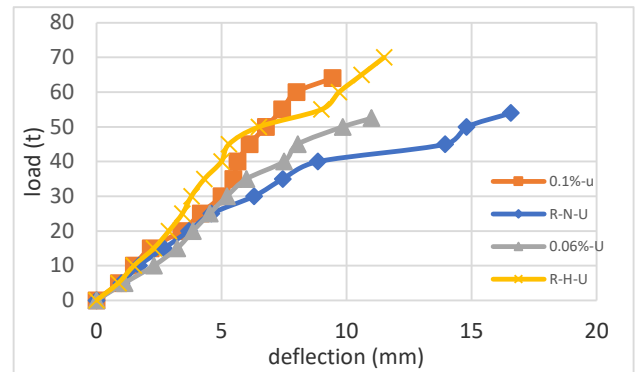
Figure 26: Vertical deflection at mid span (group 1)

1-Figure 26 shows load deflection curves for group 1, which study influence of changing percentage of shear dowels on deflection in case of uniform distribution load. It could be

noticed that, for all specimens the more the percentage of shear dowels the less the mid span deflection. In addition, it could also be noticed that specimen (0.1%-U) showed a stiffer behavior than the reference specimen (R-N-U) which means that pre-slab (0.1%-U) had an increase in the maximum deflection about 43% of that of the monolithic(R-N-U), also the other specimen (0.06%-U) showed less stiffness compared to reference specimen (R-N-U). This could be attributed to that percentage of shear dowels 0.1% are sufficient to increase in the ultimate capacity of the section which behave as if the specimen was casted as one layer.

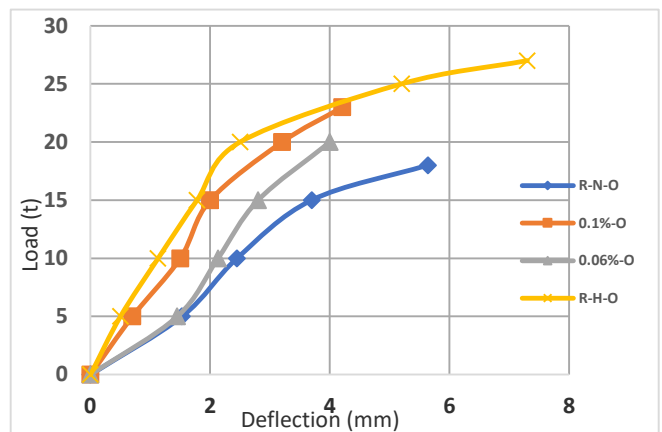
Figure 27: Vertical deflection at 0.2L (group 2)

2. Figure 27 shows load deflection curves for group 2, which study influence of changing percentage of shear dowels and condition of the interface area between the two layers as casted surface on deflection in case of one-line load. When comparing the load deflection curves of the composite specimens (0.1%-O, 0.06%-O) and monolithic specimens (R-N-O and R-H-O), it can be noticed that composite slabs (0.1%-O, 0.06%-O) had an increase in the maximum deflection by about 42% and 14.5% respectively of that of the monolithic slab (R-N-O). On the other hand, when the monolithic slab (R-H-O) compared to these pre-slabs it can be noticed that, it had an increase in the maximum deflection by about 22% and 47 % of that of the composite pre-slabs (0.1%-O, 0.06%-O) respectively.

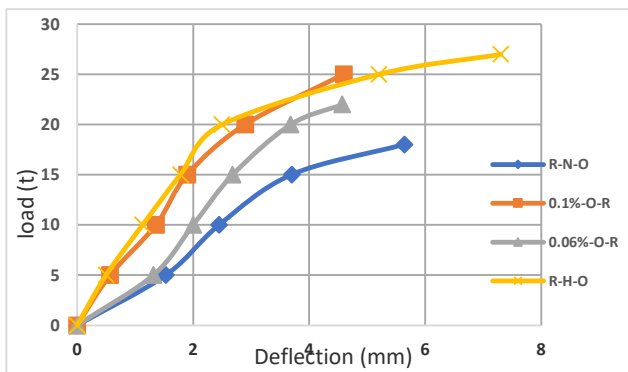
Figure 28: Vertical deflection at 0.2L (group 3)

Also, Figure 28 shows the results of specimens in group 3 (0.1%-O-R) and (0.06%-O-R) it can be noticed that, they had an increase in the maximum deflection by about 47% and 33% respectively of that of the monolithic slab (R-N-O). On the other hand, when these pre-slabs compared to monolithic slab

(R-H-O) it can be noticed that it had an increase in the maximum deflection by about 14% and 32 % respectively of that of the both composite pre-slabs (0.1%-O-R) and (0.06%-O-R). Figure 29 shows load deflection curves for group 4, which study influence of changing percentage of shear dowels and their concentration on deflection in case of uniformly two-line loads. For the load-deflection curve of the pre-slabs (0.1%-T, 0.06%-T) and the monolithic slabs (R-N-T, R-H-T), it can be noticed that the pre-slab the pre-slab (0.06%-T) had approximately the same deflection curve of the monolithic slab (R-N-T). While the other pre-slab (0.1%-T) had an increase in the maximum deflection by about 20% of that of the monolithic slab (R-N-T). Also, it had a maximum deflection less about 41% than the maximum deflection of the monolithic slab (R-H-T).

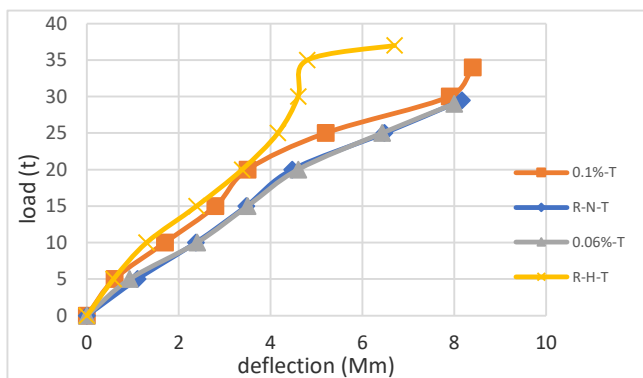
Figure 29: Vertical deflection at 0.2L (group 4)

The deflection of the tested monolithic and composite slabs was measured at 0.2L, 0.5L and 0.8L and the maximum deflection plotted against the applied load from zero loading up to failure as shown in figure 26 through figure 29. It can be noticed that the relation between the load and the deflection was approximately linear up to cracking load then it was nonlinear distribution due to excessive cracking in the concrete.

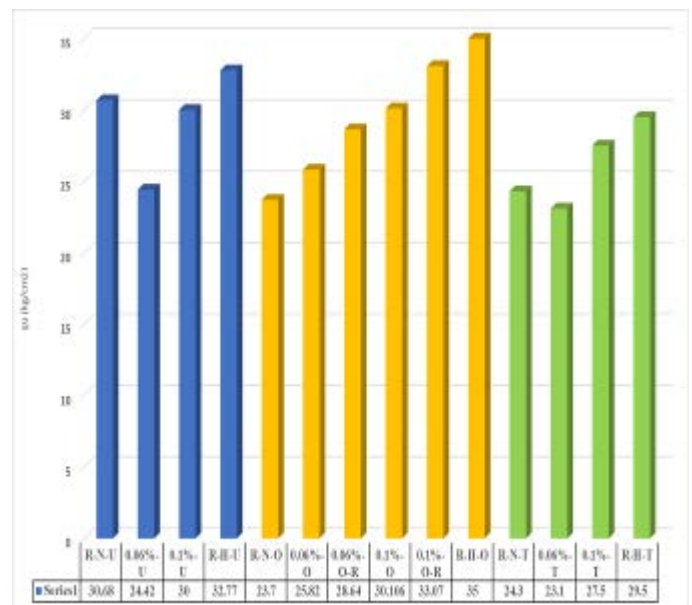
Figure 34: Ultimate shear strength at interface of the tested pre-slabs

Table 2 and Figure 34 shows the shear strength q_u values which were calculated at the failure load for both monolithic and pre-slabs. it can be noticed that

4. For (group 2&3) using Roughness in composite pre-slabs (0.06%-O-R ,0.1%-O-R) at the interface area between the two layers (normal and high strength concrete) led to increase the shear transfer strength compared with the composite pre-slabs (0.06%-O, 0.1%-O) was about 10%.

5. From result of group 4 under uniformly two-line loads, it can be noticed that concentration of shear dowels led to increase in the shear strength of the composite pre-slab 0.1%-T which had been reached the shear strength of the corresponding monolithic slab R-N-T was about 12%.

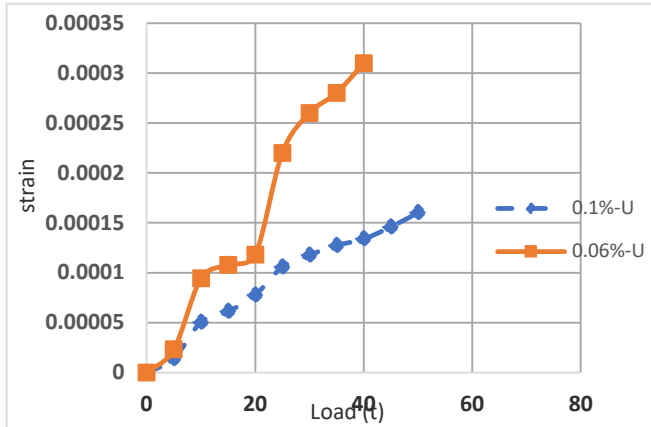
Figure 39: Maximum strain in dowels (group 1)

- a- The increase in shear connectors ratio of the dowels led to decrease in the dowel's strain because of the large dowel's cross-sectional area at the location of the maximum shear stress along the interface.
- b- Using roughness in both pre-slabs (0.1%-R) and (0.06%-R) lead to decrease in the dowel's strain because of increasing the ultimate shear transfer strength and decrease both slip and crack width at all level of loading.

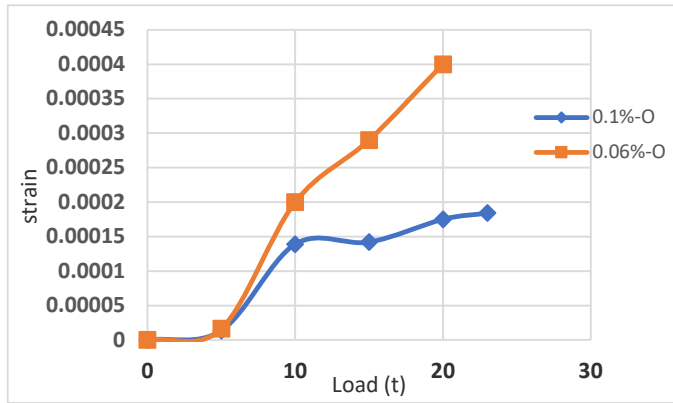
Figure 40: Maximum strain in dowels (group 2)

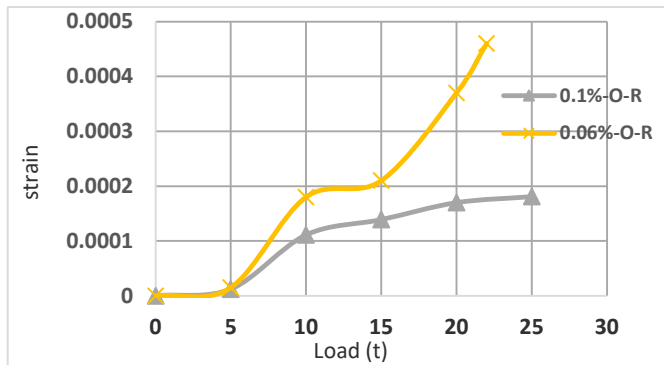
Figure 41: Maximum strain in dowels (group 3)

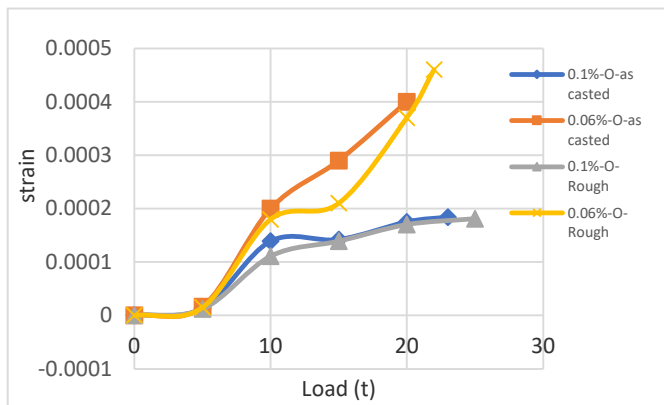
Figure 42: Maximum strain in dowels (group 2&3)

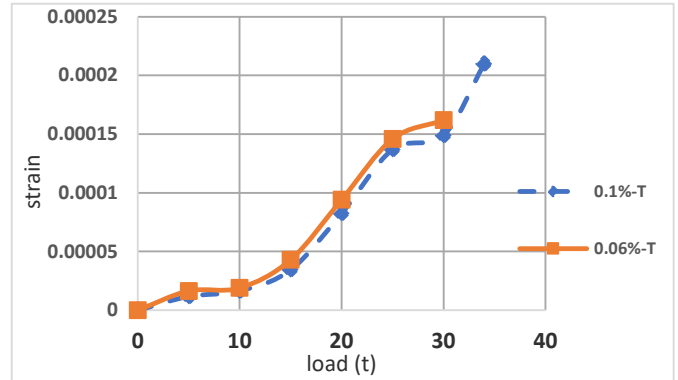
Figure 43: Maximum strain in dowels (group 4)

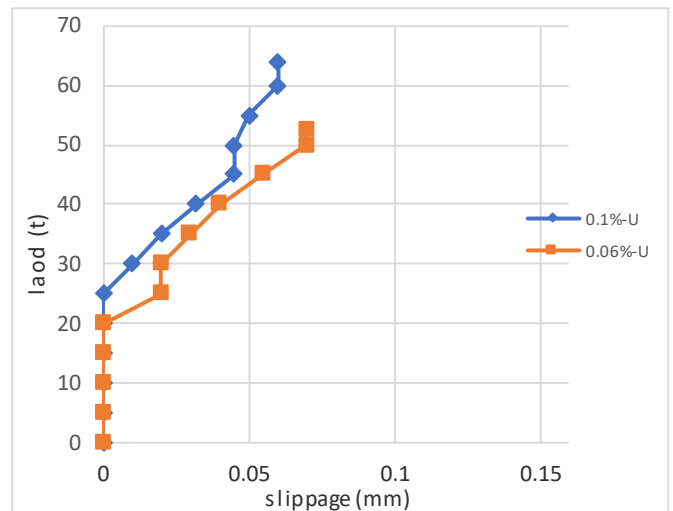
Figure 44: Slippage of tested pre-slabs (group 1)

The horizontal slippage of the tested pre-slabs was measured and plotted against the applied loads as shown in figure 44 through figure 47, it can be noticed that increasing shear dowels percentages in all pre-slabs to 0.1% led to a decrease in horizontal slippage comparing with the pre-slab with shear dowels percentage equals to 0.06%; also, the horizontal slippage happened slightly before reaching the ultimate load. It can be also noticed that that maximum slippage equals to 0.11 mm occurred for specimen (0.06%-T) which was tested under the effect of two-line loads.

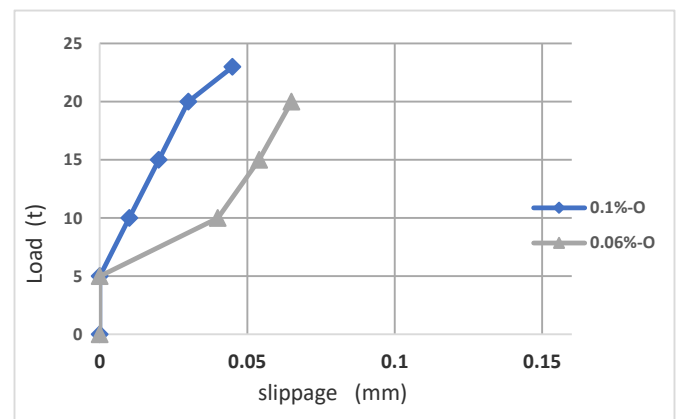
Figure 45: Slippage of tested pre-slabs (group 2)

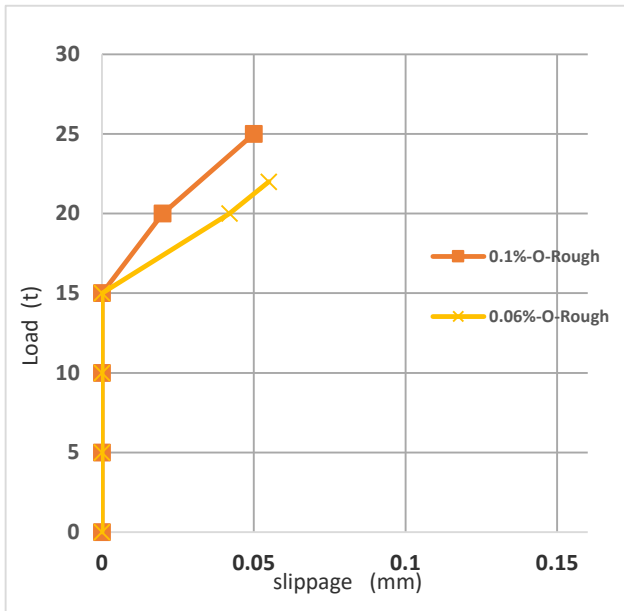
Figure 46: Slippage of tested pre-slabs (group 3)

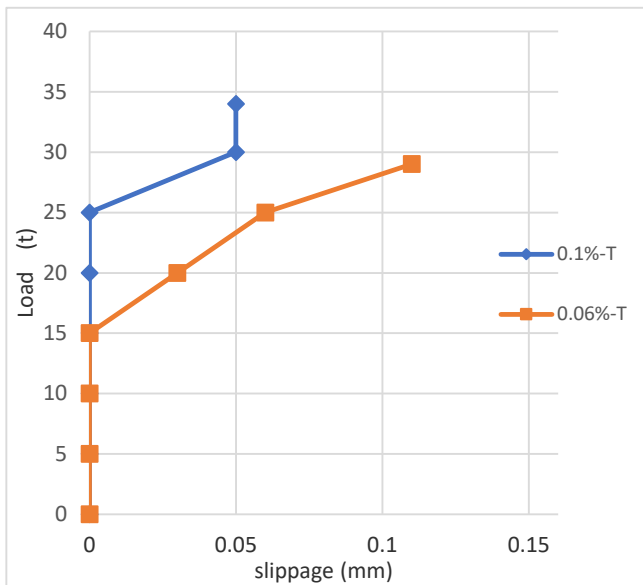
Figure 47: Slippage of tested pre-slabs (group 4)
