Field Investigation and Finite Element Analysis of Smooth Bore Tank Gun Muzzle End Behavior with Sand Ingress During High Energy Fragmentation Shell Firing

II. METALLURGICAL CHARACTERISTICS INVESTIGATION OF EARLIER MUZZLE END FAILURES OF 125 MM BARREL

IV. NUMERICAL SIMULATION OF SAND INGRESS INFLUENCE IN GUN BARREL AT MUZZLE END

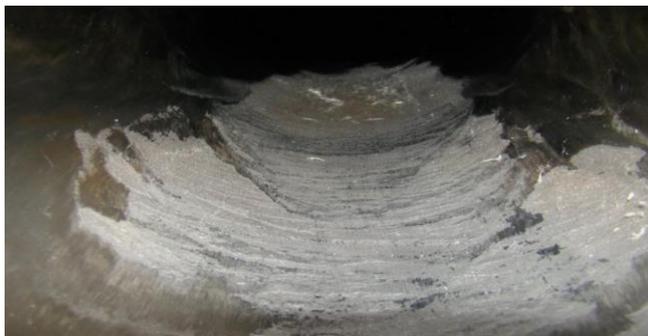
Fig 1. Defective barrel showing sintered sand particles

The following Fig 1 show the sintered state Si content at the defective location of muzzle end of the affected barrel. These pictures have been captured during in-situ investigation immediately after the barrel failures at fields.

Weight % on the sand sticking barrel bore revealed through EDX examination	[5] Percentage of elements found in normal dessert sand
SiK - 24.94%	Quartz SiO ₂ - 21.26%
CaK - 15.05%	Dolomite CaMg(CO ₃) ₂ - 14.58%
NaK - 6.23%	Calcite CaCO ₃ - 14.21%
OK - 44.32%	Smectite - 9.10%
	Halite NaCl - 7.99%
	Kaalinite Al ₂ Si ₂ O ₅ (OH) ₄ - 7.89%

During the investigation, two samples viz. one at defective location and the other at non defective / non affected location has been collected and the above stated parameters have been tested. Metallurgical investigation of all the muzzle end barrel failure cases found no metallurgical deficiencies or process lapses and flaws in the barrel material and mainly concluded as over load failure. Also, investigation shows that most of the affected barrels have presence of foreign material deposit in sintered state at the defective location. This foreign material has been tested with EDX. As shown in the above table, EDX examination revealed peak of Si, Al, Ca & O with respective weight %, which has good agreement with standard desert sand composition.

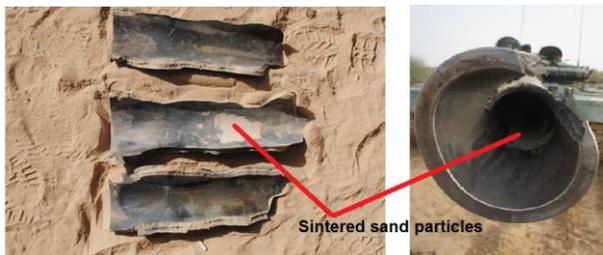
Fig 2. Failed gun barrel showing presence of sintered sand particles

Apart from the above, these defects have been in-situ investigated and confirmed the presence of sand / foreign particles deposited at the defect location in majority of cases. The Fig.2 above clearly depicts presence of sand / foreign particles inside the barrel bore at burst / bulge location.
