Geotechnical Investigations and Slope Stability Analysis of a Landslide

Central Soil and Materials Research Station
New Delhi, India

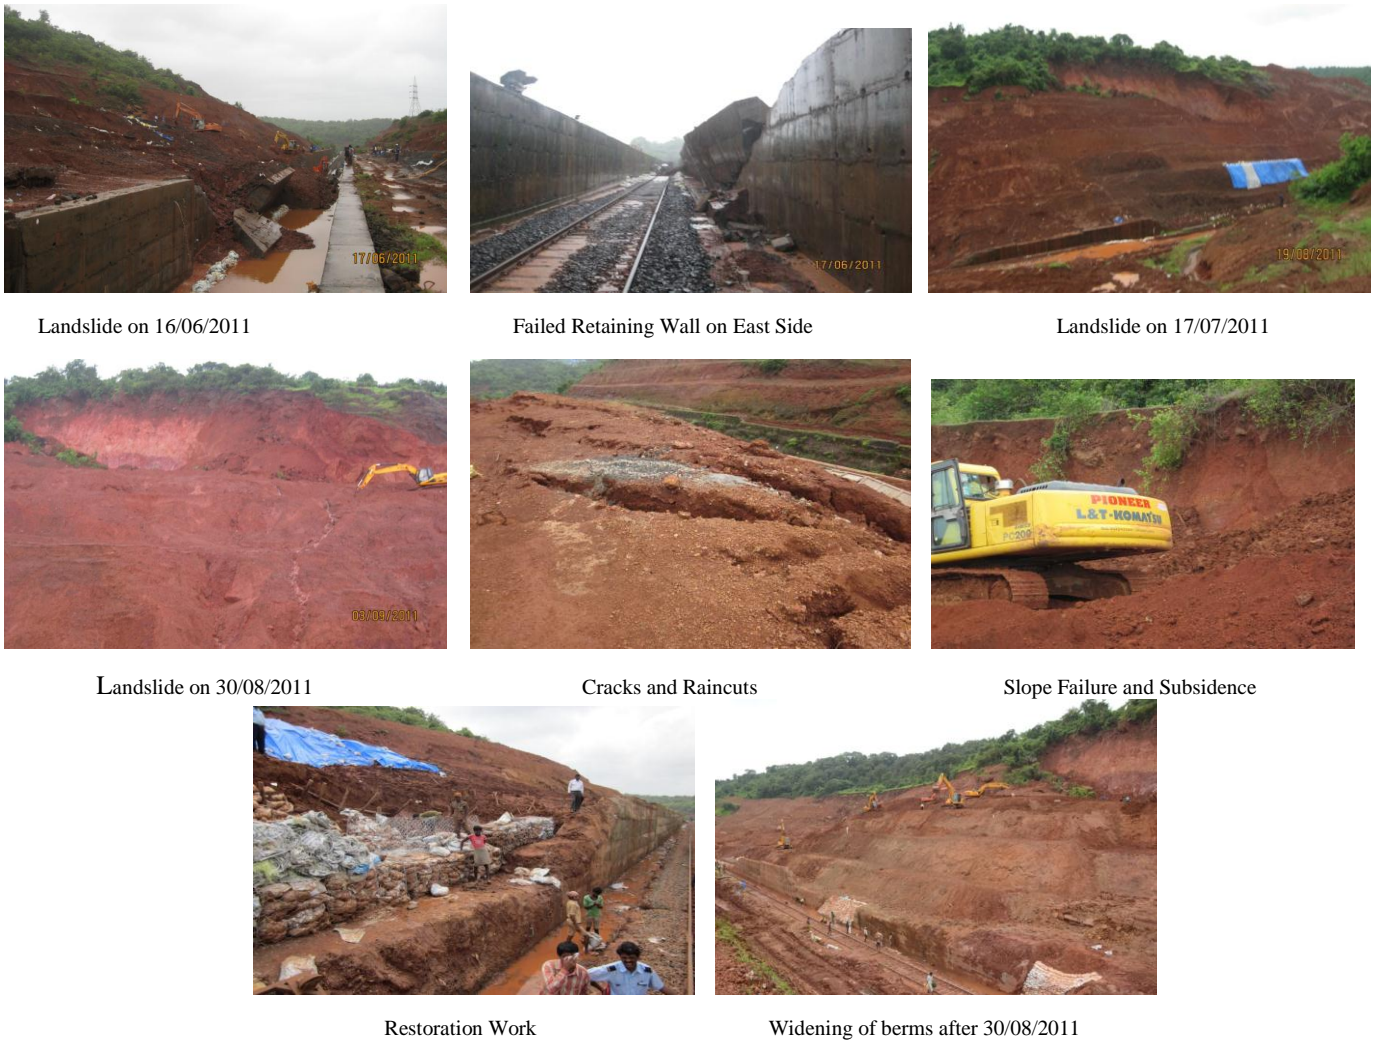
Fig. 6. Landslide during June – August 2011

Three landslides were reported during June to August 2011 due to a heavy rainfall of intensity 683 mm in 10 days period and interrupted the traffic thrice. On 16th June 2011 itself, the rainfall recorded was 206 mm. The hill from East side started sliding towards track due to which heaving of different berms took place and cracks developed in about 60 m length of the East side retaining wall. The retaining wall started tilting towards track at 14:30 hrs of 16/06/11. Tilt was kept under observation and within next 16 to 17 hrs, tilt was increased up to 1.0 m and finally the retaining wall (km 208/990 and 209/005) collapsed at 07:30 hrs on 17/06/2011 for a length of 15 m. After 4 hours, about 45 m more length of retaining wall also collapsed and soil fell on track. It was informed that about 5000 m³ of soil and 600 m³ of mass concrete of retaining wall (about 60 m long) fell on track.

Temporary protection measures were adopted and many excavators were deployed at the problem area and the loosened soil mass was removed. The soil mass were very slushy and had very little shear strength. There was subsidence in hill slope having a size of about 120 m wide and 6 m deep at a distance of 98 m from center line of track on East side. The natural ground settled by 6 m to a maximum of 10 m during these 2011 landslides. During the visit, cracks and rain water gullies were noticed in slope adjoining the failed areas. Operational catch water drains were seen in the areas which were not disturbed. Weep holes were provided on retaining wall and water was draining out from the lower most layers of weep holes. Fig. 5 presents the location plan of Pomendi cutting. The site conditions of the landslides during June – August 2011 is depicted in Fig. 6.

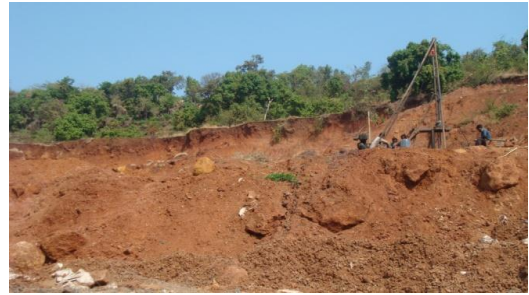
Fig. 7. Locations Of investigation area at Pomendi Cutting

A total of 5 undisturbed soil samples and 5 disturbed soil samples were collected from 5 different trial pits excavated in the problem areas of the Pomendi cutting. Fig. 7 shows the locations of the investigation areas of the problem areas at the Pomendi cutting. All the collected soil samples were subjected to the Mechanical Analysis and the Atterberg limits tests and the results are presented in Table II.

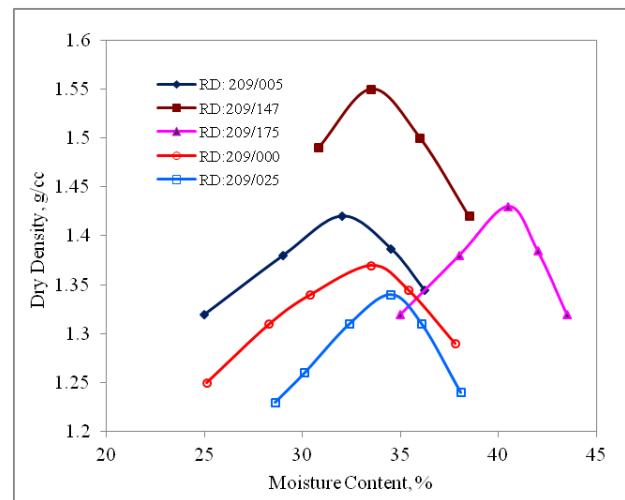
Fig. 9. Proctor Compaction Curves

The Maximum Dry Density and the Optimum Moisture Content values of the tested soil samples vary from 1.34 g/cc to 1.55 g/cc and 32.0 % to 40.5 % respectively. The total shear strength parameters total cohesion (c) and total angle of shearing resistance (ϕ) of the tested soil samples vary from 0.19 kg/cm² to 0.32 kg/cm² and 14.8° to 23.1° respectively. The effective shear strength parameters effective cohesion (c') and effective angle of shearing resistance (ϕ') of the tested soil samples vary from 0.06 kg/cm² to 0.23 kg/cm² and 21.6° to 32.2° respectively. The results of the tested undisturbed and disturbed soil samples are presented in Tables IV and V. The graphical representation of the dry density and the moisture content obtained from the standard proctor compaction curves of the tested soil samples are presented in Fig. 9.
