# Hot Strip Mill Process Flow, Cobble Generation & Preventive Action

**M Ajay Kumar**

Department Of Mechanical Engineering  
Rao Bahadur Y Mahabaleswarappa Engineering College  
Cantonment, Ballari – 583104, Karnataka

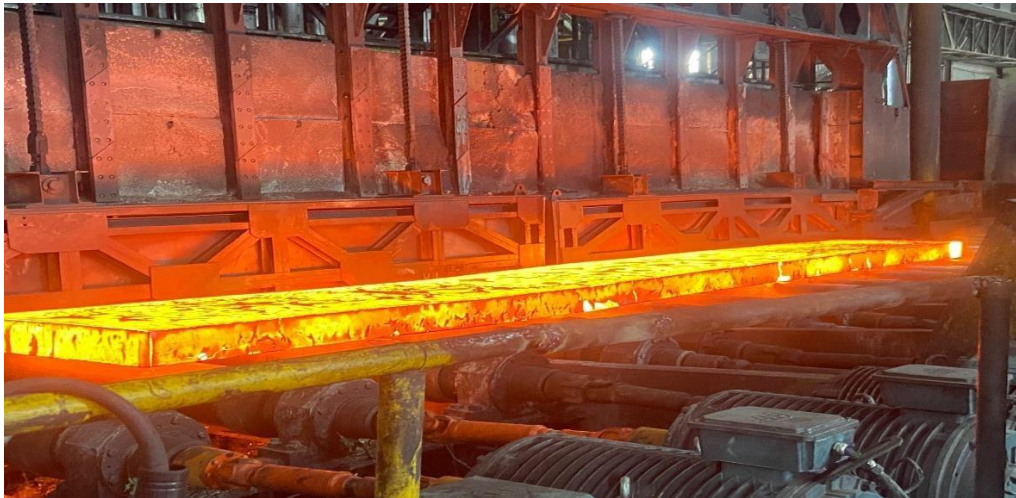
Cobble due to HE hit to F6 entry center tong and material head end got fold.

Slab Discharging.

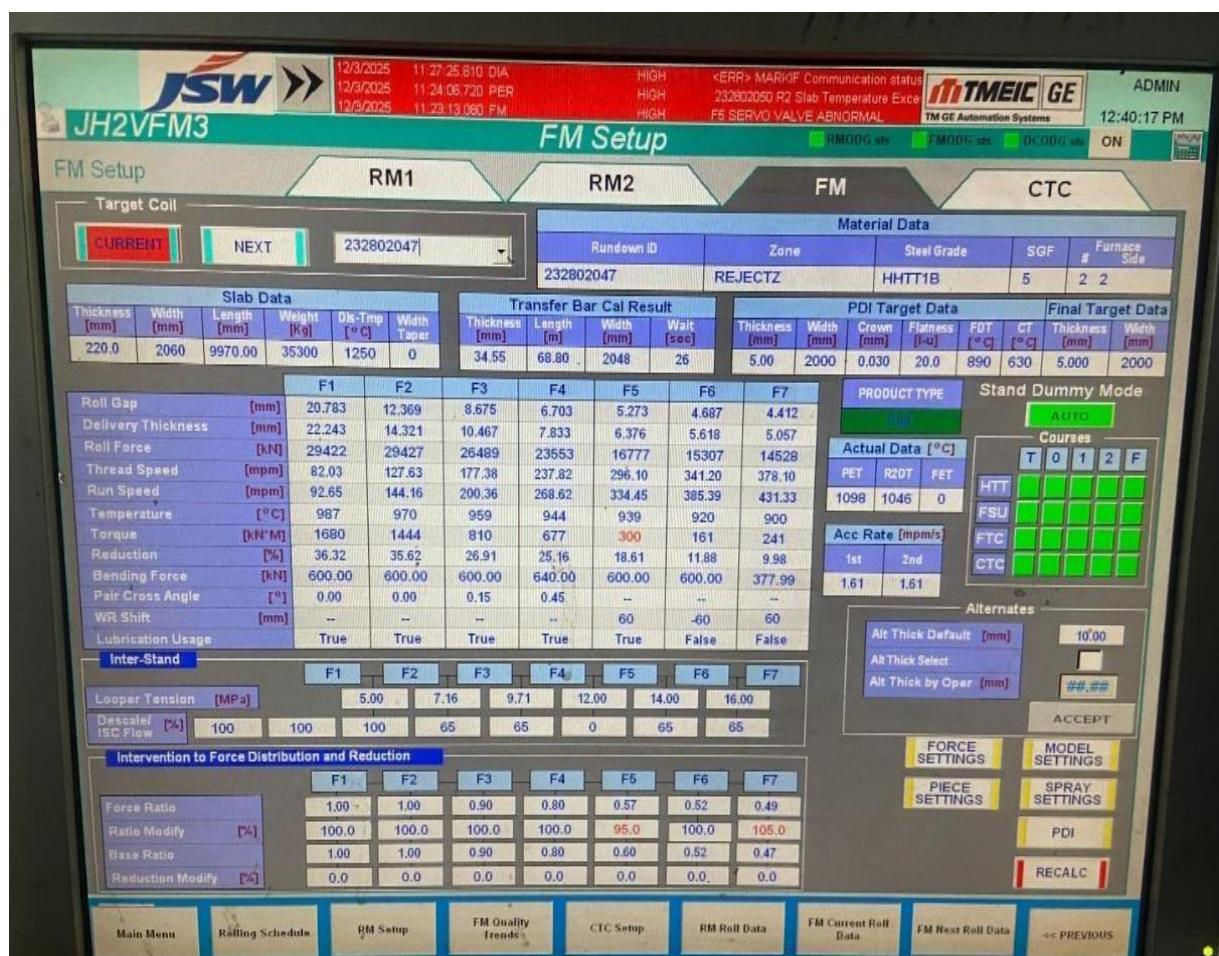
Finishing Mill Setup which is abnormal.
