Integrated Design and Restoration of Ground Drainage System at DIET College

Abstract : Institutional campuses, particularly in regions of high seasonal rainfall and clayey soil conditions, require effective drainage infrastructure for the continued structural, safety-related and functional operation. Poorly designed and insufficient drainage system leads to stagnation of water which erodes the pavement, weakens foundations and affects the academic activities. The context of the current study is integrated ground level drainage design and rectification on a college campus experiencing waterlogging during monsoon every year. A comprehensive field survey was carried out to delineate low-lying area, existing drain status and catchment attributes. Storm peak discharge determined by Rational Method and the appropriate drain sizes devised for the calculated discharges. The model structure combines the surface drains, subsurface perforated PVC pipe networks, nonwoven geotextile filters, graded gravel media and groundwater recharge structures such as soak pits. Performance evaluation showed that the results were decreased the duration of water stagnation, improved runoff conveyance capacit

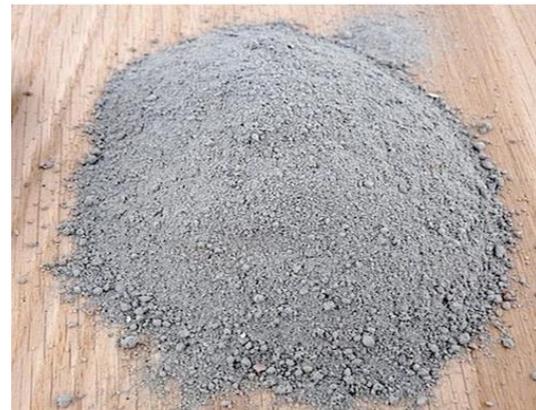
FIG 3.1- CEMENT

3.1 Cement: Ordinary Portland cement of 53 grade conforming to IS: 169-1989 has been used for this investigation. The result of tests included on cement are as follow.

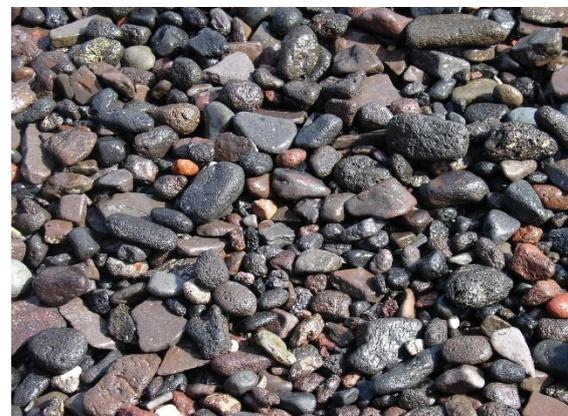
FIG 3.2 A - GRAVEL

3.2 Gravel Course Sand : Gravel consists of crushed stones used as a drainage layer. It provides high permeability and prevents water stagnation.

Inherent clogging prevention by the use of gravel/courser sand (filter media layers, hence improved water movement into the subsurface pipe).

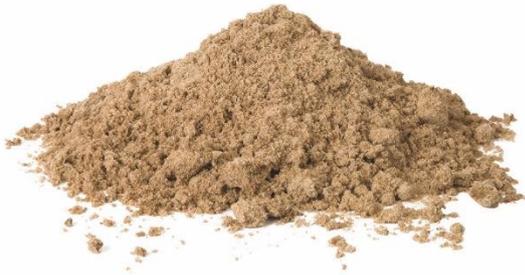
FIG 3.2 b- COURSE SAND

Coarse sand is placed above gravel to act as a filtering layer. It prevents fine soil particles from

entering the gravel and pipe, thus avoiding clogging.

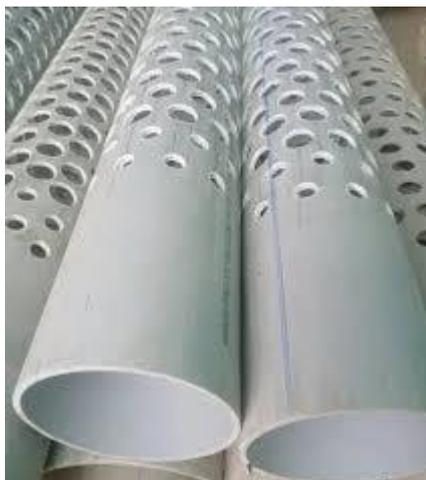
FIG 3.3- PVC PERFRATED PIPES

3.3 Pvc Perforated Pipes: PVC perforated pipes are lightweight plastic pipes with small holes along their surface. These holes allow water to enter the pipe and get discharged safely. They are widely used in subsurface drainage systems because they are corrosion-resistant, easy to install, durable, and cost-effective.

Perforated PVC pipes, wrapped in geotextile and backfilled with graded filter media for the removal of excess groundwater under water prone areas.

In order to overcome this problem, an integrated drainage system consisting of sub-surface perforated PVC pipe drains was proposed to be implemented in the stagnation zone identified. Similar to transport, 150 mm diameter pipes were laid at a depth of 1.1 m below ground and spaced out approximately every 10 m with the other end connected to a collector drain removing collected water through outlet. Filter media layers of gravel and coarse sand surround the subsurface pipes to facilitate movement of water through them while preventing their clogging.

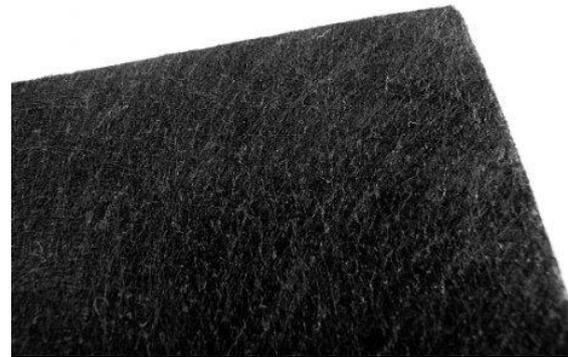
FIG 3.4- NON WOVEN GEOTEXTILE

3.4 Non-Woven Geotextile : Non-woven geotextile is a synthetic fabric used in drainage systems for separation and filtration. It prevents soil from mixing with gravel while allowing water to pass through. It increases the life and efficiency of the drainage system.
