Integrated Techniques To Identify Consequences Of Sinkhole Hazards For Constructing Housing Complexes On Carbonate Karst Terrains In Perak, Peninsular Malaysia

Riyadh R. Yassin, Ros Fatimah Muhammad, Samsudin Hj Taib

Department of Geology, Faculty of Science, University of Malaya, 50603 Kuala Lumpur, Malaysia.

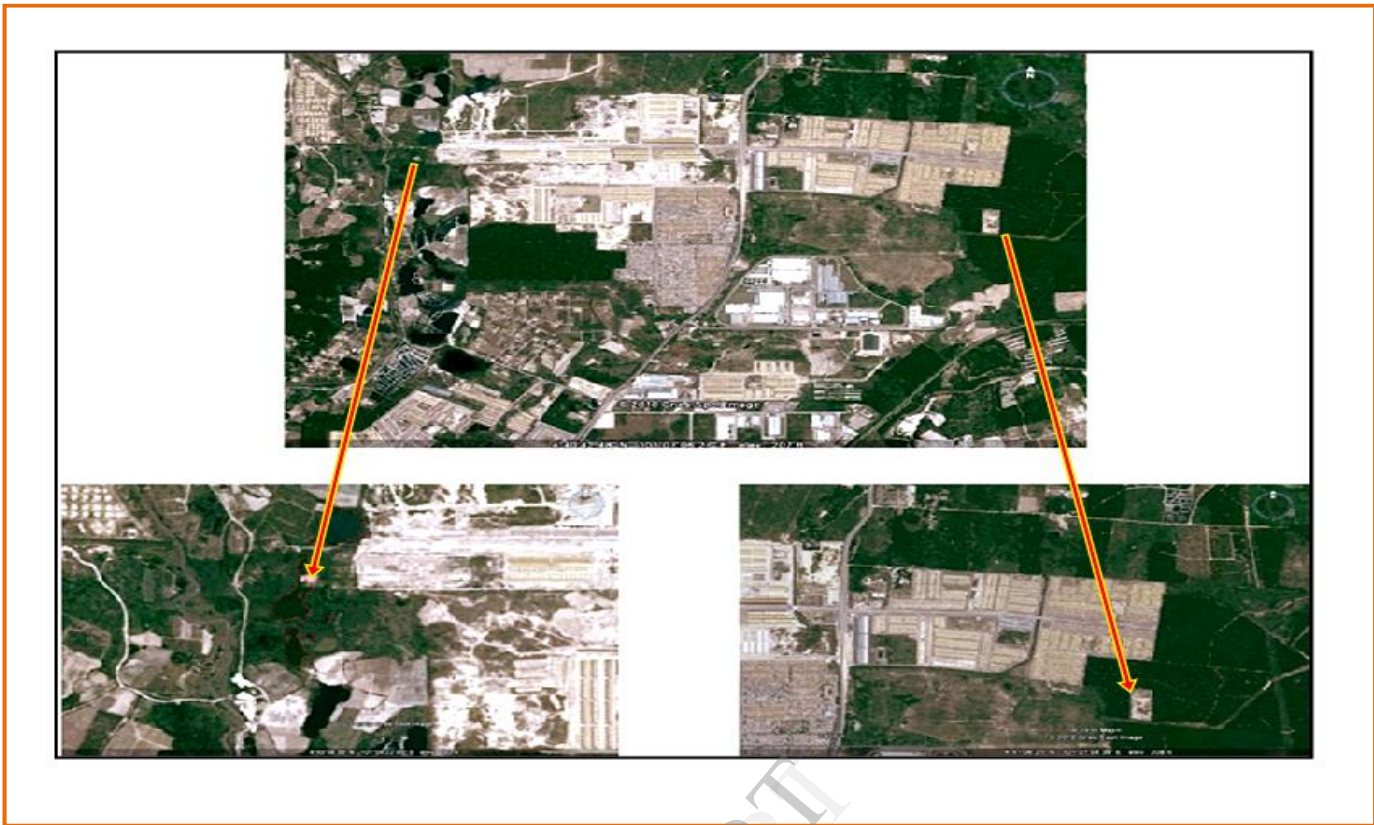
Figure 3: Google earth Satellite spot image (2010) showing the location of construction site #1 and site #2 in Klebang Raya north of Ipoh city (Kinta valley)

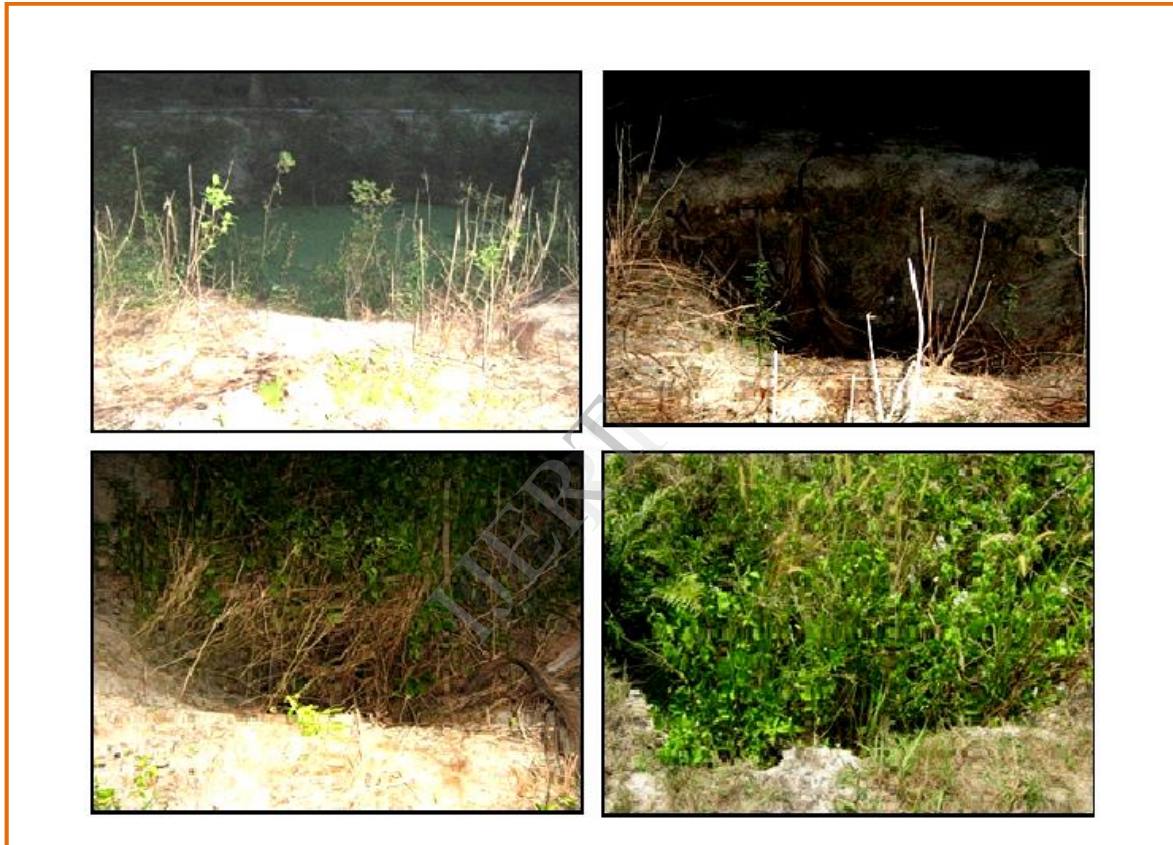
mining area, most of these features were packed with sand and other material and among them three area with deposits of grey swamp clay in circular shape were acknowledged. The clay seems to sink down due to numerous causes which will be explained shortly, figure 6; viewing land Photographs viewing the positions of three big black spots were recognized in aerial photographs, that may include sinkholes under the depositional of gray swampy clay construction site #1

Figure 5: land Photographs viewing several positions that recognized in aerial photographs in construction site #1, which identified as the depositional of grey swamps clay

This area identified and demonstrated as an area that might include a medium to large sinkhole extended in the subsurface along this site of visually uncertain depth. This might point to the presence of clay or water in-filled karstic sinkhole or cavities that could intimidate the probability of this site.

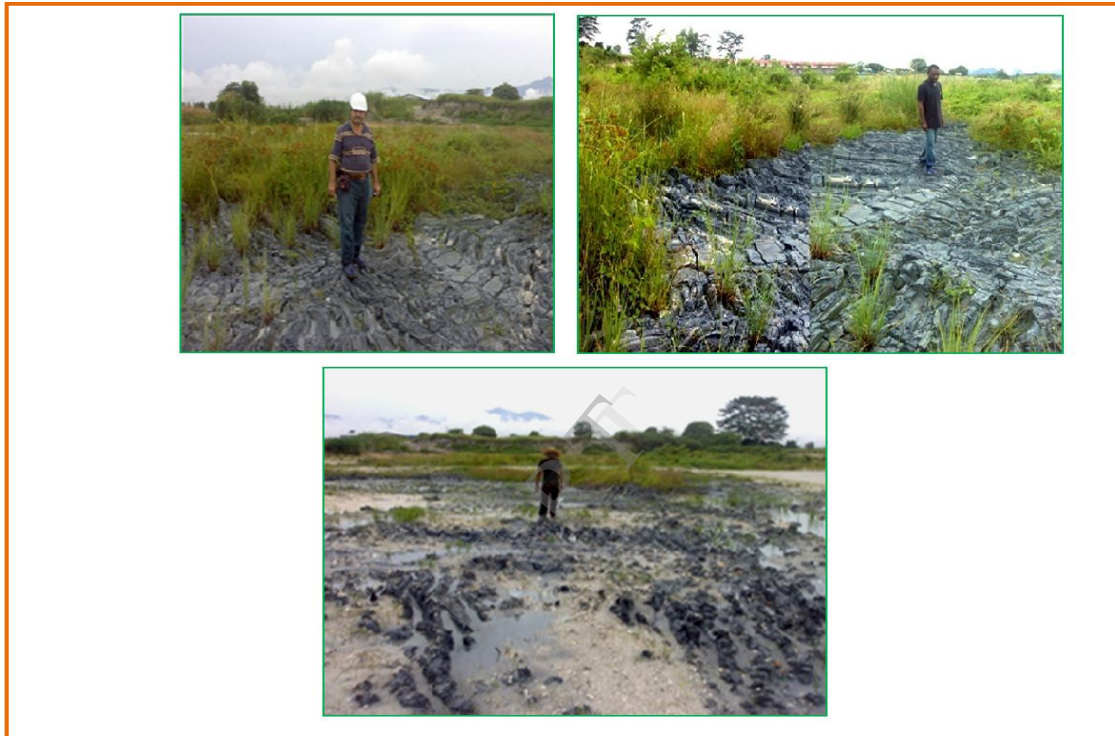
During the ground inspection at site #2, two sinkholes was established, but not recognized in aerial photographs and satellite images, because of being enclosed by adjacent small plants. One of these sinkholes with a diameter of ~7m-10m, water in-filled, of visually undetermined depth, recognized and demonstrated as sinkhole

with a narrow showing throat, positioned in the south west flank of this site. The other sinkhole with a diameter of ~35m- 40m. positioned in the north east side of this site, was in-filled with wet clay and other material of sediments due to karst activity, raised a thought that this sinkhole might be linked in the subsurface to one or more of large tabular conduits or channels and my presence of cavities or voids of undetermined depth. Clay or air in-filled karstic sinkhole or cavities were present that could intimidate the veracity of this site. The south section of this site can observe many soil cover collapse with only some meter width and depth.

Figure 6 : Land Photographs viewing a number of sinkholes that identified as water in-fill, empty and covered with vegetation was determined as small and narrow in construction site #2

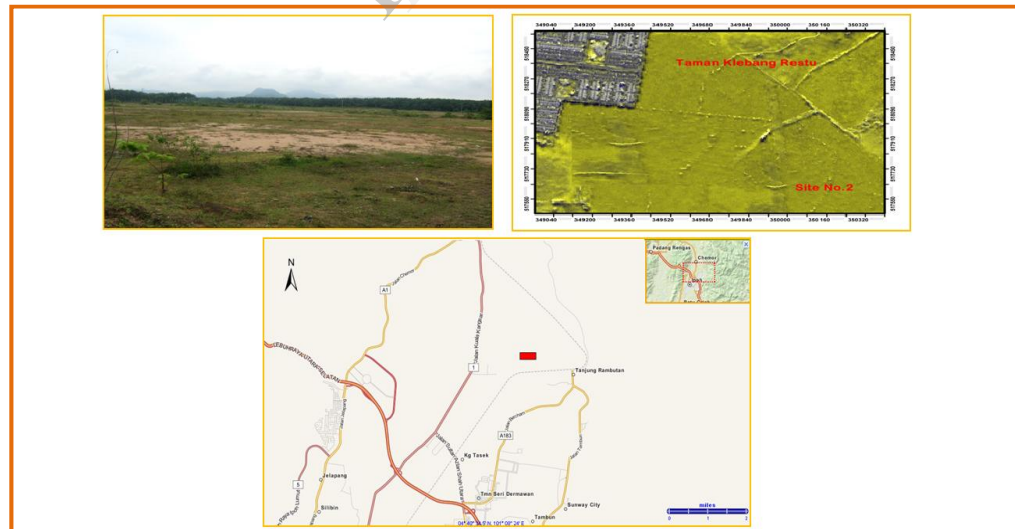
Figure 8: Location Map, Satellite images and land photograph viewing the location the study area in construction site #2

Site #2 is situated at Medan Klebang Restu- Klebang Damai to the north of Ipoh city (Kinta Valley), positioned approximately at latitude $N4^{\circ}40'35.04''$ - $N4^{\circ}41'0.96''$, longitude $E101^{\circ}07'52.32''$ - $E101^{\circ}08'18.24''$ as appeared in Figure 7. It locates to the west of the main series of Cameron Highlands.

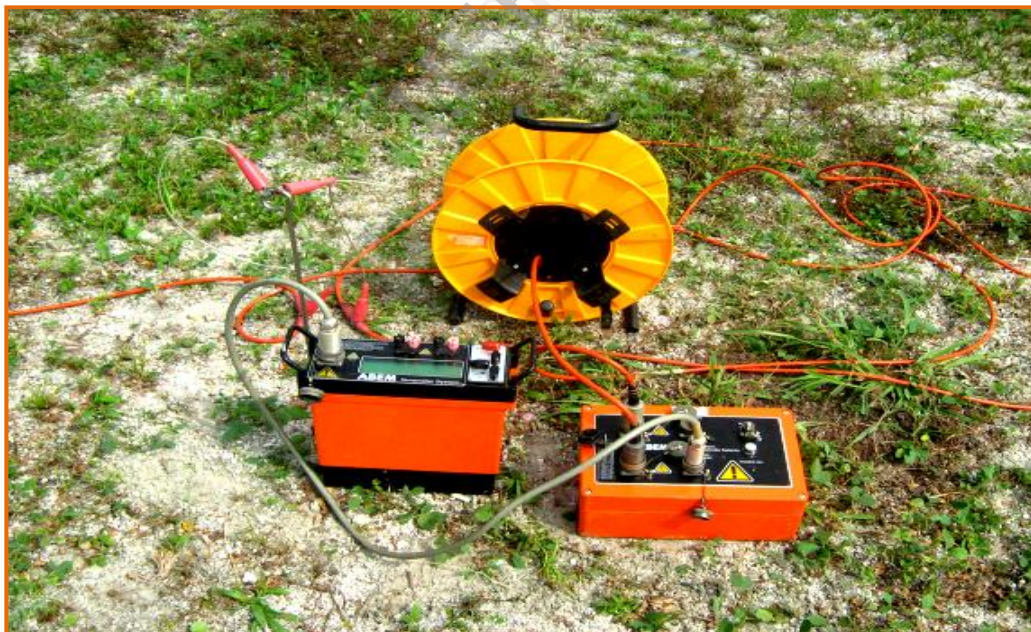
The survey was conveyed using SAS1000 resistivity meter which has an inherent microprocessor to select the appropriate four electrodes for each measurement automatically. The two dimensional (2D) - electrical imaging/tomography surveys are typically carried out employing a large number of electrodes, 41 or 61 electrodes along a straight line, coupled to a multi-core cable (Griffiths and Barker 1993), in common at a constant spacing of 5m or 10m between adjoining electrodes. When the succeeding measurements were taken, they were configured in a Wenner array and other survey parameters such as the electrical current used is normally converted into a text file which can be read by a computer program. After reading the control file, the computer program then automatically detects the suitable electrodes for each quantity. A laptop computer was engaged to set the RES2DINV inversion software to develop the resistivity model.

Figure 9: viewing the instrument type SAS1000 applied in geophysical survey

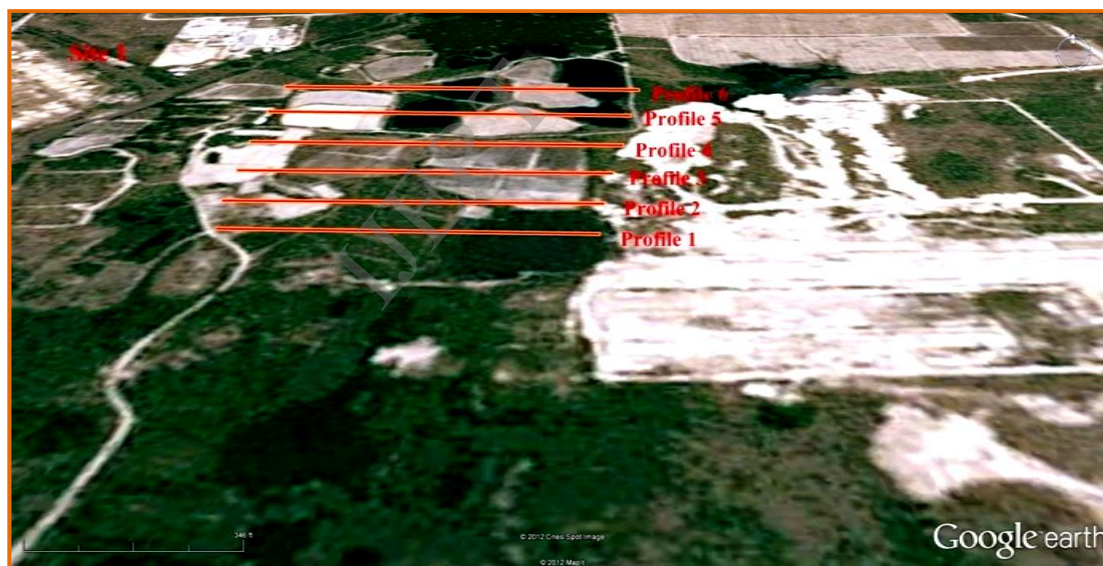
Six electrical resistivity traverses or profiles, Profile-1 to Profile-6 were controlled over and along the survey area, in site #1. The direction of these profiles in (N90°W) and the level of those lines are shown in the location map illustrated in Figure 10.

Electrical resistivity data accumulated along two dimensional (2-D) electrical resistivity profiles, using a 41-channel array in Wenner configuration. The length of each profile was 200.0 m., with an electrode spacing of 5.0m. The space intervals were on average 25.0m between each profile. The total length of all profiles in this site was 1200m and cover an area of 30000m², 190 data points were composed for each (41-electrode) in one profile, and on average about 1140 data were composed for total six profiles in this site.

Figure 10: Google earth satellite images viewing the location of resistivity profiles in construction site #1

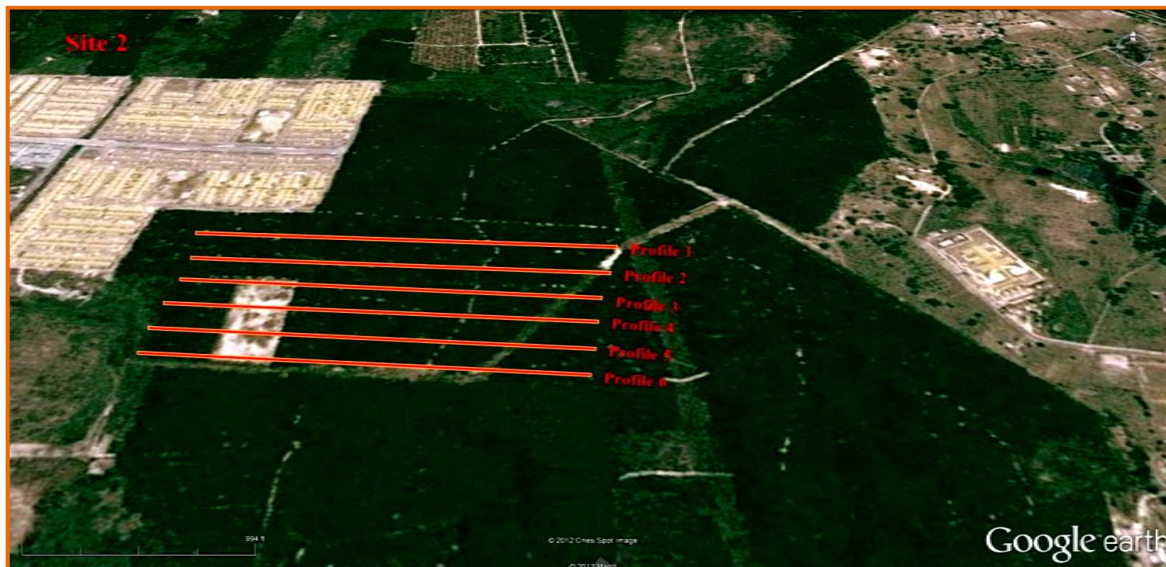
Electrical resistivity data were acquired and accumulated to map this site along two dimensional (2-D) electrical resistivity profiles in excess of or beneath to sinkhole, using a 61-channel array in Wenner design. The measurement lengthwise of each

profile was 300.0 m. with an electrode spacing of 5.0m. The space intervals were on average 25.0m between each profile. The total length of all profiles in this site was 1800m, with a cover area of 60000m², 320 data points were composed for each (61-electrode) in one profile. On average about 1920 data were collected for total six profiles in this site.

Figure 11: Google earth satellite images showing the location of resistivity profiles in construction site #2
