Laboratory Investigations on the Causes of Road Failures Constructed Along Asendabo to Deneba Road Section

Tarekegn Kumela Shere¹, Antene Worku², Asanti Keno³
Jimma University, Jimma Institute of Technology,
Jimma, Ethiopia

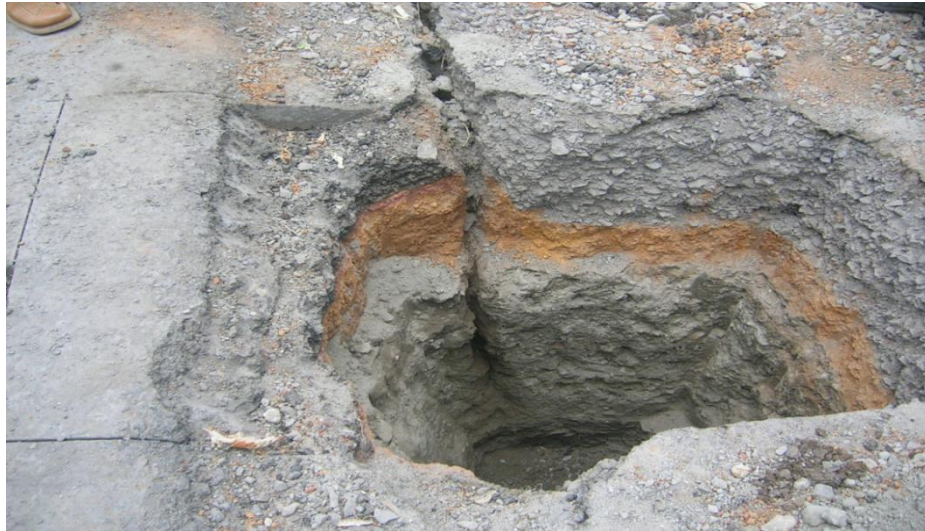
Figure 2.3 Sample pit hole at study area

From figure 2.3, tested materials were taken not only this but also depth of each pavement layers was taken from such test pit types.

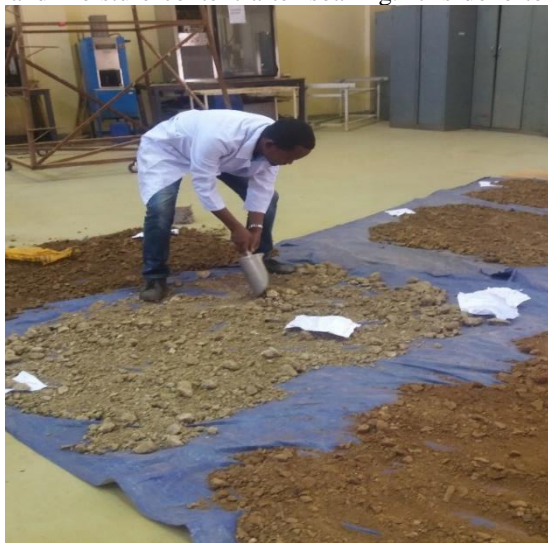
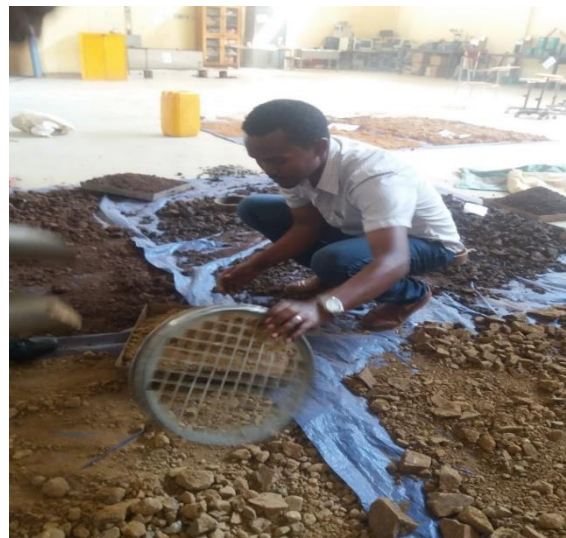
Figure 2.4 Sample preparation for gradation and CBR tests.

The objective was to determine strength of soil, subgrade, subbase and base course materials in terms of CBR and to know the bearing capacity of each layer. The strength of a sub grade, sub base and base course materials are expressed in terms of their CBR value. To observe the effect of rain on soil and percent of swell and to know the bulk and dry density, these tests were mandatory.

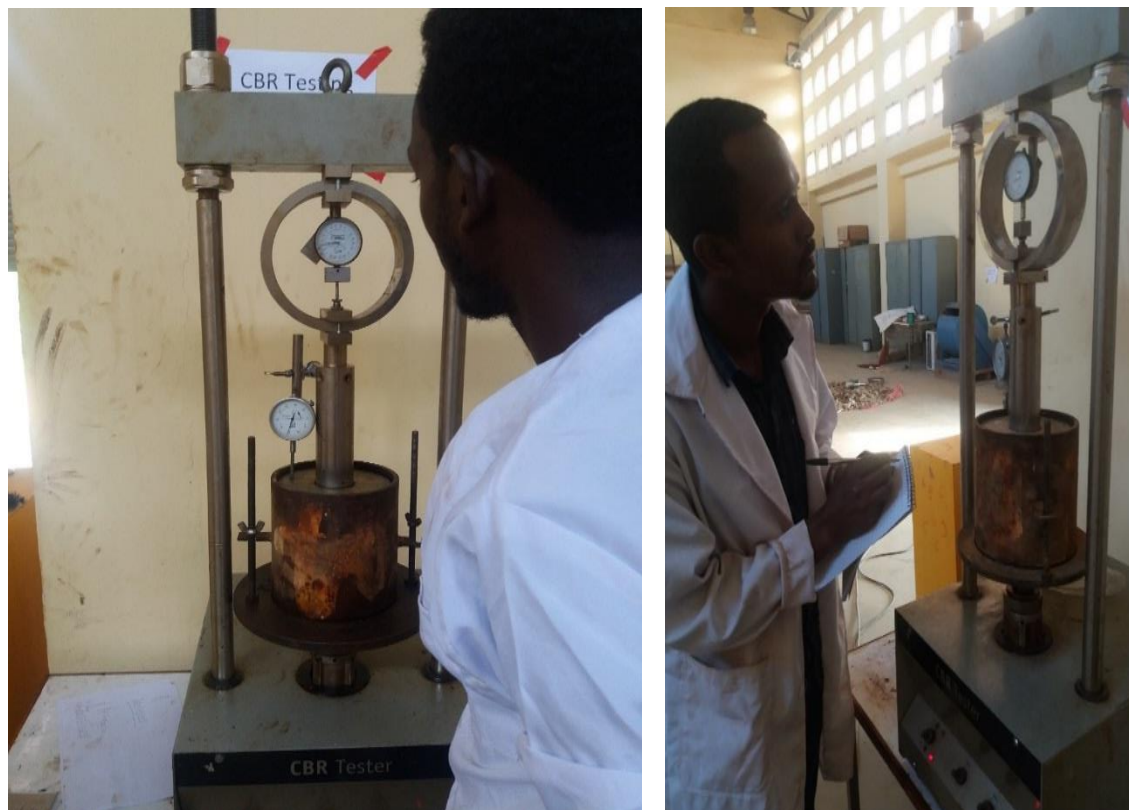
Figure 2.5 Taking values and measuring soaked CBR with its machine.

The CBR is a method of compressive measure of the strength resistance of a soil. It was done to provide the relative bearing values of each layers and their swelling

potential. While this test was proceeding there were different checking parameters, like; penetration, soaking condition, swell test.

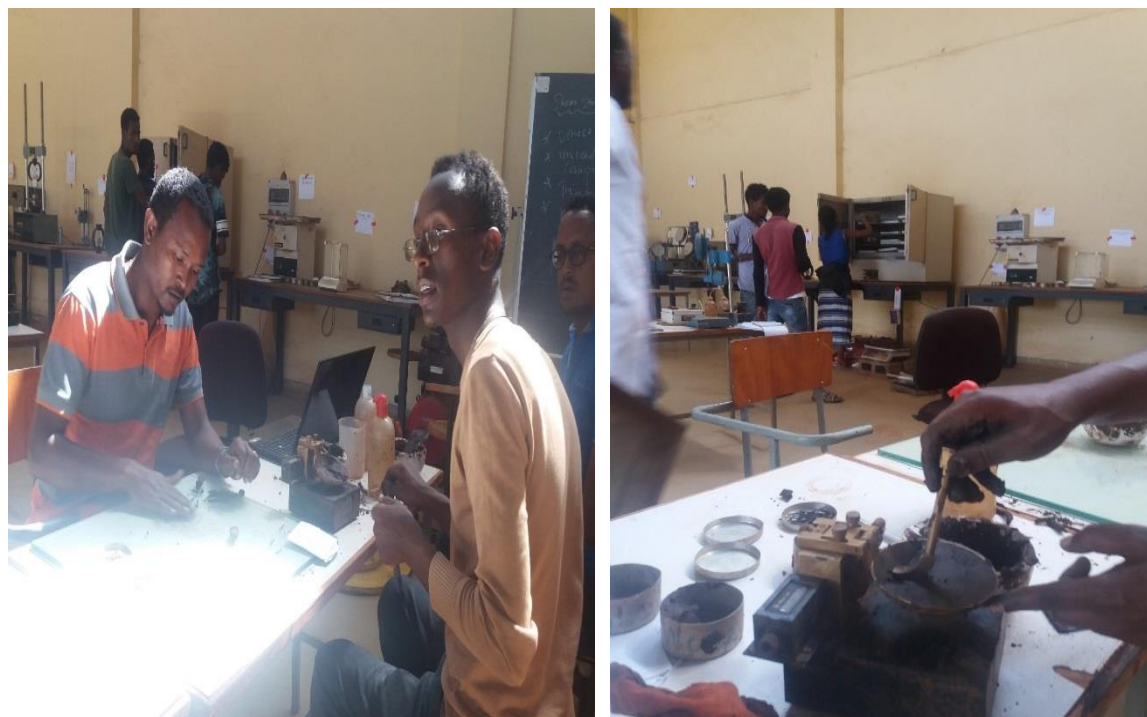
Figure 2.6 Atterberg limit test process in the laboratory.

Atterberg limit tests are important classification criteria for soils' engineering properties. The Atterberg Limits, Linear Shrinkage, Volumetric Shrinkage and

Plasticity Index values of the representative soil samples were done.

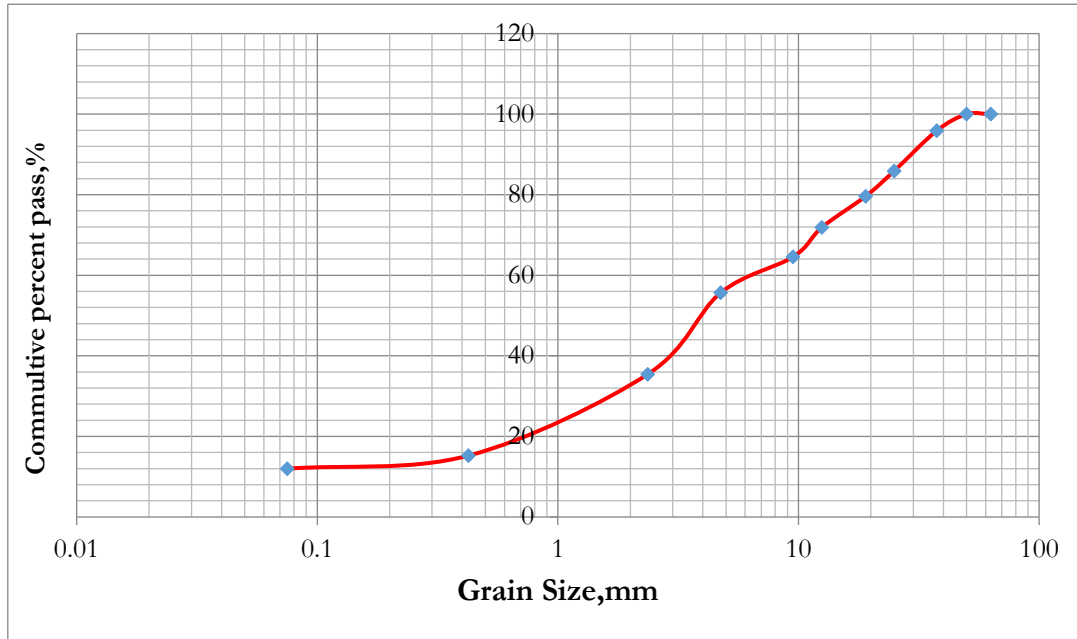
Figure 3.1 Average grain sizes for sub bases.

The result of the particle size analysis indicates that the soil's clay content for all sub-base samples. According to the Federal Ministry of Works and Housing (1997) specification, the clay content for sub- base materials must

not exceed 35%. The high clay content could be responsible for instability of road pavement in the area.so from test results for all sub-base materials are fulfilling the FMWH specification.

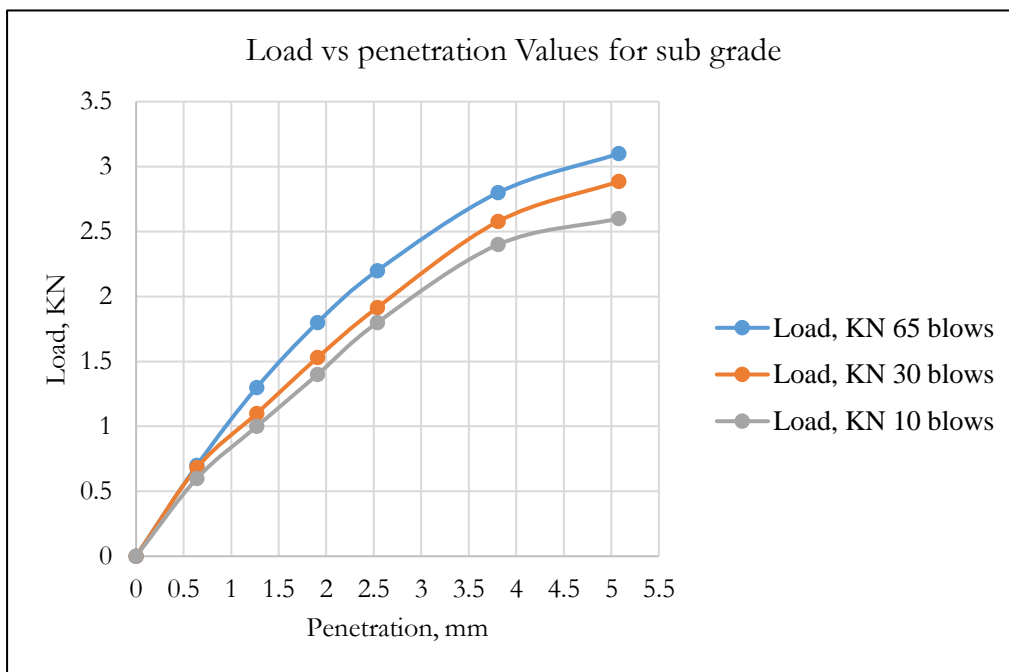
Figure 3.2 Applied load in newton vs penetration in mm.

From the figure 3.2, the load versus penetration at each blow shows that as the applied piston load increased the penetration values were also increased.

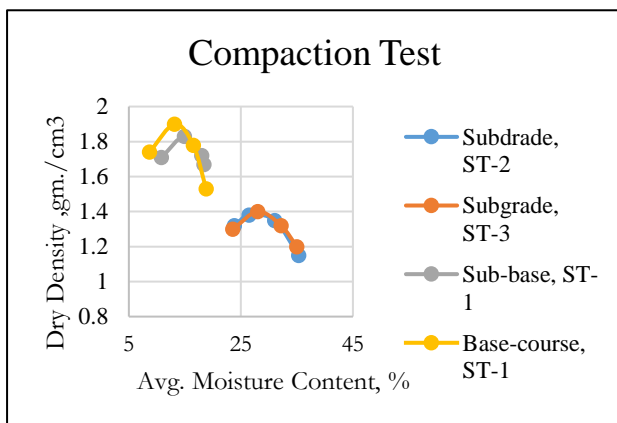
Figure 3.4 Compaction test result for each pavement layers.

The base course used for the extremely damaged road section has the average OMC value of 13.16% and MDD of 1.90 gm/cc³ and on the other hand the field test results for moisture content are ranging from 10 gm/cc³ – 15 gm/cc³ and the maximum dry density was ranging from 1.40% to 1.90%. The percentage compaction for the base course was in between 74.30% and 78.30%, which is much lower than 95%.

The sub-base material for the same has an average OMC of 14.92 % and an average MDD of 1.83gm/cc. The field dry density results are ranging between 1.23gm/cc and 1.41gm/cc and the moisture content is ranging from 18.86% to 29.41%. The percentage compaction is ranging between 71.92 % and 82.46%, which is the lowest of all. From the test results the natural sub-grade has high swelling pressure and swelling potential.
