Lamb Wave Technique for Non-Destructive Evaluation of Structures

Abstract — In recent years there is a continuous rise in construction activities in the field of civil engineering. The life of a structure depends on initial strength and the maintenance of construction. Hence there is necessity of nondestructive evaluation (NDE) is emphasized worldwide. In this role, the PZT patches act as actuators and sensors and employ ultrasonic vibrations to find out a characteristic admittance 'signature' of the structure. Typically, their sensitivity is high enough to capture any structural damage at the incipient stage. The admittance signature encompasses vital information governing nature of the structure, and can be analyzed to predict the onset of structural damages.

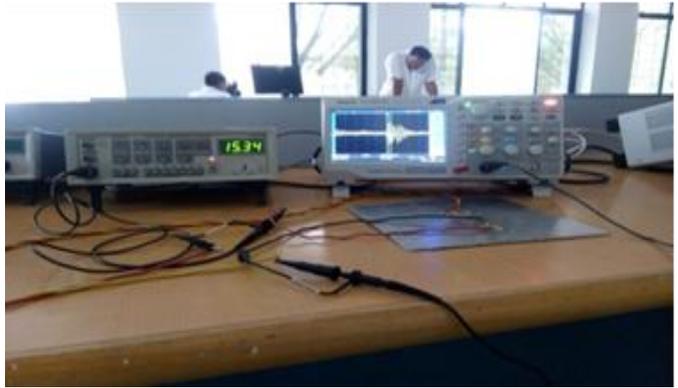
Figure 1: Experimental Set Up

Experiments were conducted with a four different structure. In this specimen's aluminium, steel, hollow beam, concrete structure were used to obtain result. For every structure PZT sensors were used as sender and receiver of lamb wave. One of the PZT (sender) is connected to the function generator and another PZT (receiver) is connected to the oscilloscope. The PZT actuator was excited by a signal constructed and transferred to an arbitrary function generator. This function generator could read the digital signal and output the corresponding analogue signal to the actuator. The measured signals were obtained with a digital oscilloscope for A/D conversion. Considered following cases.

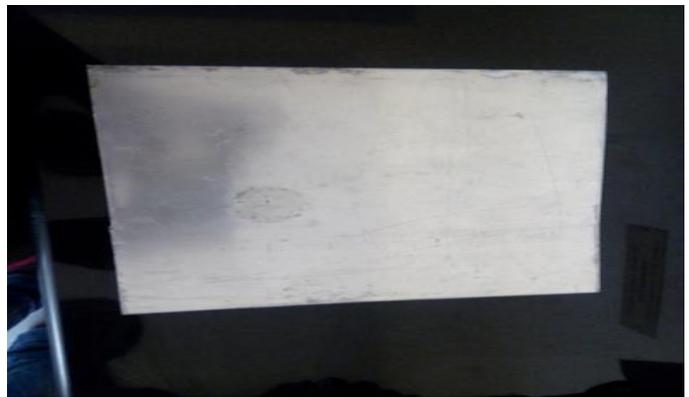
This signature is considered as baseline signature. Then damaged to the structure by drilling machine of Ø-5mm drill. This drill are gradually increased from incipient to severe near PZT sensors. Measured signals which obtained from DSO[39]. Compare the changes occurred in signature at different parameters as above mentioned for damage indication. Experimental set up is showed in fig.3.6. In fig. 3.7 shows aluminium plate structure for (a) undamaged condition and (b) damaged condition respectively.

(a) Without damage

(b) With damage

As mentioned above in experimental set up, there first observed a baseline signature for in situ state of aluminium plate then damaged the plate by drilling machine to obtained damaged state of response. Compared the both response for dry condition as well as humid condition. Then observed changes occurred in signature for humidity, and also to study for protective measures taken to decrease electric permittivity of PZT patches for decrease in noise obtained in response.
