Mitigation the Geohazard of Carbonate Karst Features in Construction Sites by Applying of Combined Techniques in (Kinta Valley) Perak - Peninsular Malaysia

Abstract:- This research study focuses on the combination of geological, geophysical, aerial photographs and satellite images techniques as identification techniques to assess, mitigate and monitor the potential geo-hazard of various classes of carbonate karst features extend in the surface and subsurface of construction sites. These techniques have coupled with the engineering surface and subsurface remediation techniques and performed across five(5) selected construction sites distributed over a region of carbonate karst environment in north and south of Ipoh city (Kinta valley), Perak state, Peninsular Malaysia.

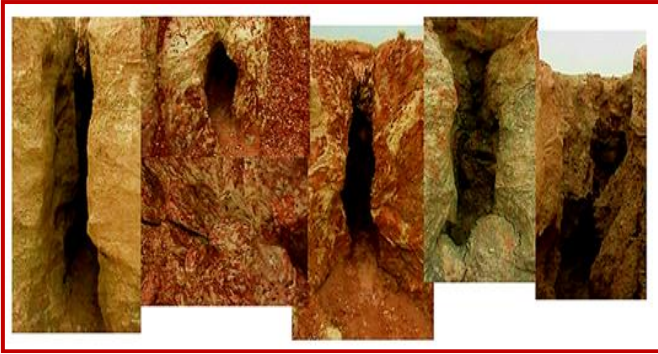
Figure10: Land Photographs viewing several types of features observed in the clayey soil over carbonate karst environment in one of the construction sites under study due to the effects of heavy and long period of rain full

Several types of features observed in the clayey soil over carbonate karst environment in one of the construction sites under study due to the effects of heavy and long-time rain full display in the land Photographs figure10.

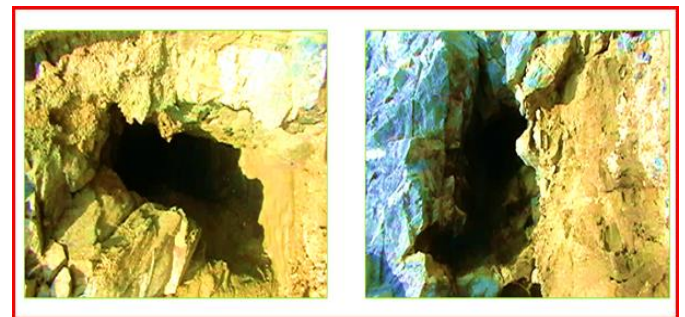
Figure 11: Display the collapse of underground cavity, only became existence when the top soils are removing

The Collapse of underground Cavities only became existence when the topsoils are removing displayed in figure 11.

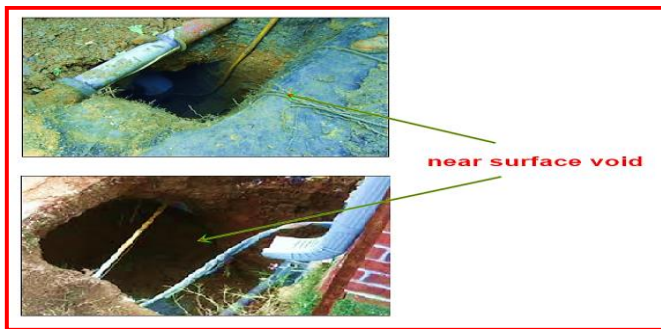
Figure 12: Near surface large voids are observe in construction site

The Construction in karst areas includes the risk of come upon voids in the underlying material. Structures built above voids can experience significant settlement and extensive structural damage. In the most severe cases, the voids may open to the surface, cause catastrophic failure of the structure, and endanger the public. For commercial projects with tight deadlines, identifying potential subsurface voids early in the pre-development stage is critical in being able to provide time for further assessment and for remedial activities to be employed.

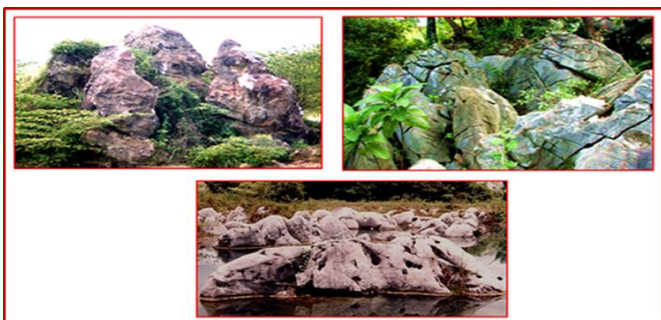
Figure 13: Display the Rockhead Pinnacles partially exposed in the study region (Kinta valley)

Generally, the difficulty involve of opening hole for a driven of concrete bearing piles or bored piles in the rockhead Pinnacles. Rockhead Pinnacles partially exposed in the study region (Kinta valley) display in figure8-3.

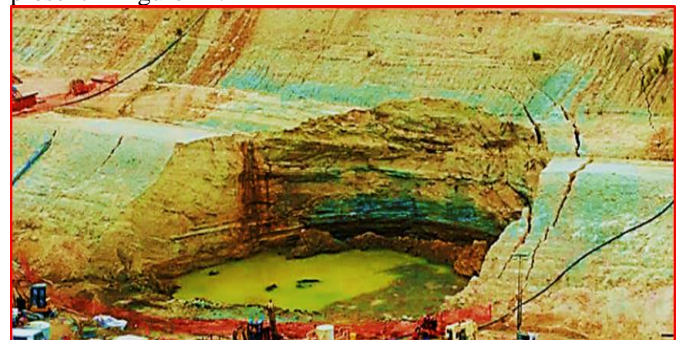
Figure 14: present subsidence due to the settlement of the ground surface in construction site over the karst region in study area

Subsidence due to the settlement of the ground surface in one construction site over the karst region in study area present in figure 14.

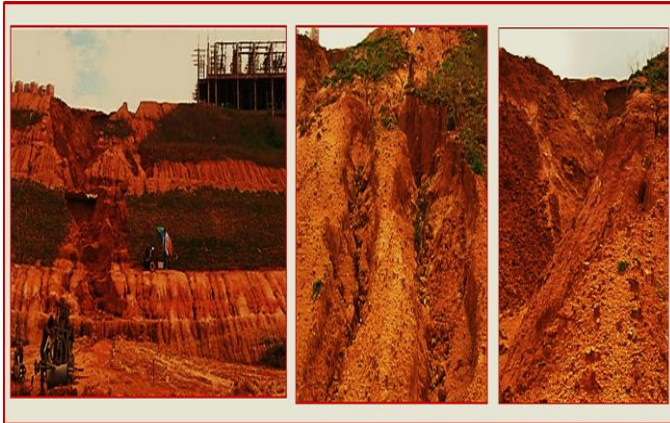
Figure 15: present subsidence due to heavy rainfall period in construction site over the karst region in study area

Furthermore, the subsidence of the ground surface in the construction site occurring due to heavy rainfall period. The settlement of the ground surface due to heavy rainfall period in the construction site over the karst region in study area present in figure 15.

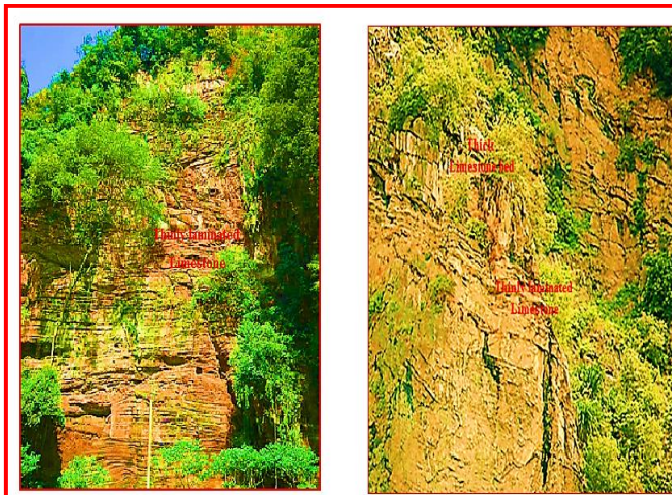
Figure 17: Slumps zone can see in about two thirds of the way up on the cliff face. In addition, series of thicker beds, up to 2 m thick, within a sequence of thinly bedded limestone in Chemor, Perak

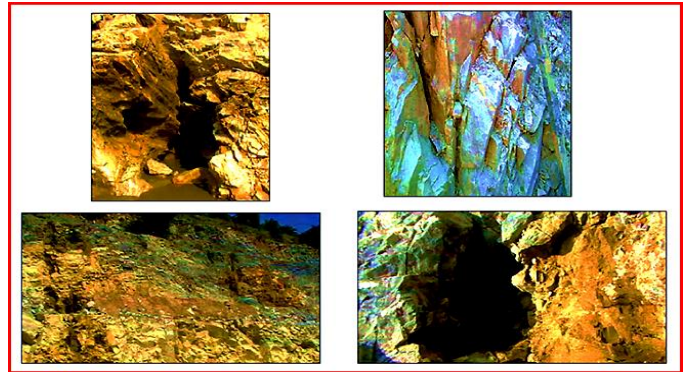
Figure 18: Display the vertical joints and cavities that exposed in Ipoh limestone and marblized limestone rocks (Kinta valley)

Vertical joints and cavities exposed in Ipoh limestone and marblized limestone rocks in Kinta valley, Perak state shown in figure 18.

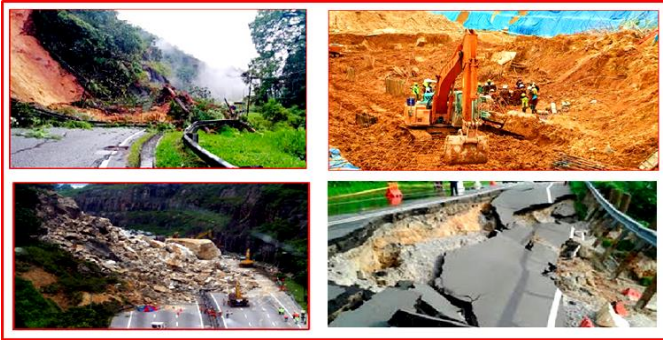
Figure 19: Displays the incidents of landslides problems associated with hillside or hill slope in Ipoh

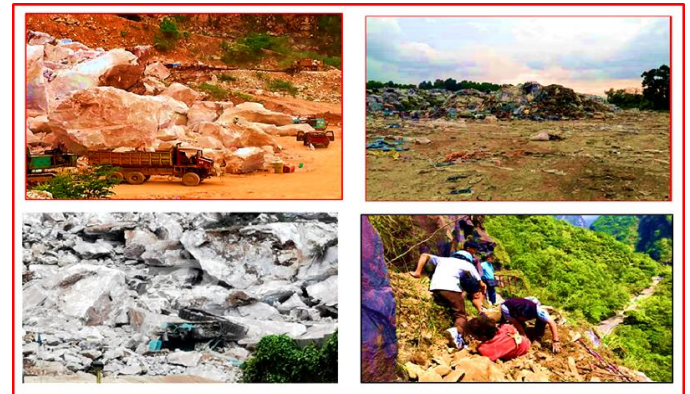
Figure 20: Displays the incidents of rock falls of the entire cliff face are quite common, resulted in loss of life as well as damage to properties, in Ipoh region

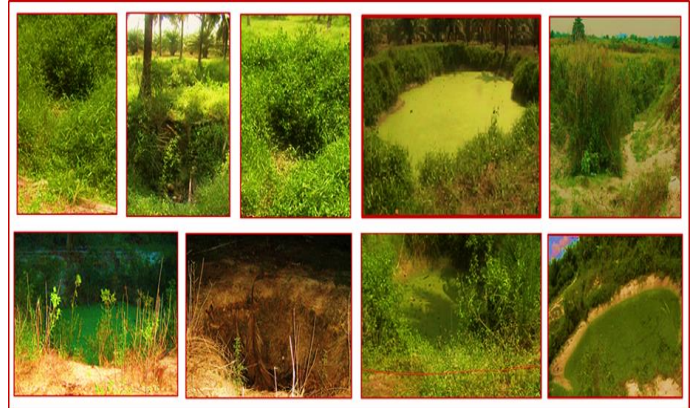
Figure 24: Land Photographs viewing several types of sinkholes observed in the construction sites under studies, such as soil covers collapse, subsidence, and pipes that identified as, water in-fill, empty, or covered with plants

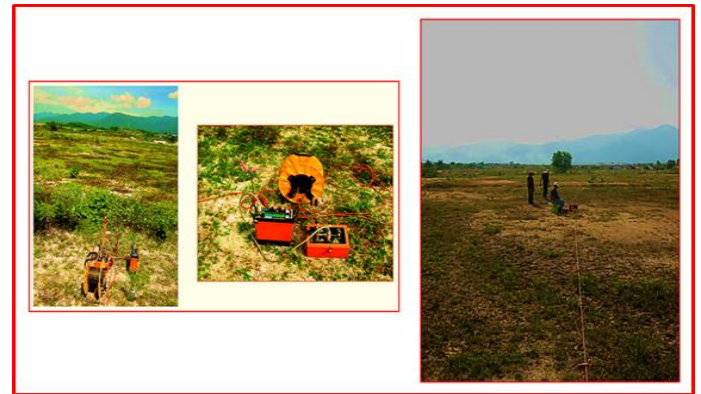
Figure 25: Geo-technical field operations by applying the electrical Resistivity imaging/tomography (ERT), in the north of Ipoh city Perak, Malaysia. The instrument type SAS1000 used in this survey and the typical setup for 2-D electrical imaging/tomography surveys, with a number of electrodes along a straight-line attached to a multi-core cable

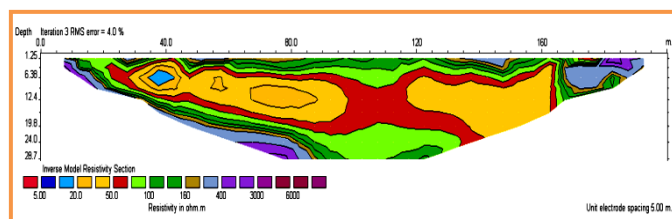
(Figure31 - A) The Inverse model of electrical resistivity section for Traverse no.1 (Taman Batu Gagah Perdana)

The interpretation of the inverse model section in construction site #1 indicated that the area has been affected by an irregular tabular channel that contain stiff, non-stiff moisturized clay, and sandy clay over karstified marbleized limestone. The interpretation of the inverse model section in construction site #2 indicated that the area has been affected by a thick covering of alluvium deposits containing several sinkholes and lenses, filled with both stiff and non-stiff clay that is highly moisturized, rendering the area hazardous over karstified marbleized limestone. The interpretation of the inverse model section in construction site #3 indicated that the area has been affected by many channel pipes, with soil cover collapse sinkholes containing both stiff and sandy clay, and sand over karstified marbleized limestone and cavities. The interpretation of the inverse model section in construction site #4 is indicative of the fact that the area has affected by various fractures in bedrocks that contain both stiff sandy clay and sand. The interpretation of the inverse model section in construction site #5 indicated that the area has been exaggerated by a massive sinkhole, thus containing stiff and non-stiff clay that is saturated with water, rendering the area hazardous to any projects.

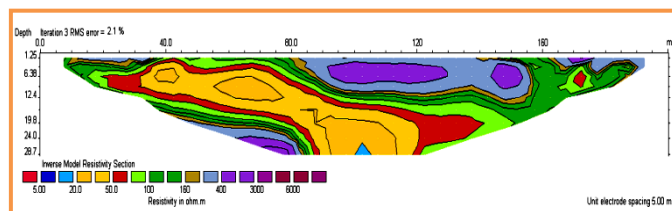
(Figure31 - B) The Inverse model of electrical resistivity section for Traverse no.2 (Taman Batu Gagah Perdana)

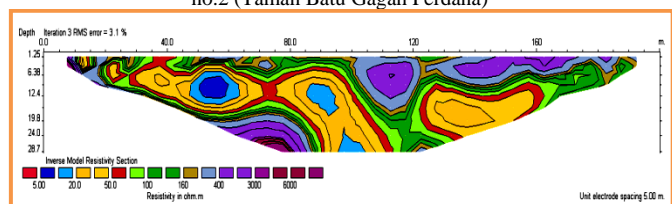
(Figure31 - C) The Inverse model of electrical resistivity section for Traverse no.3 (Taman Batu Gagah Perdana)

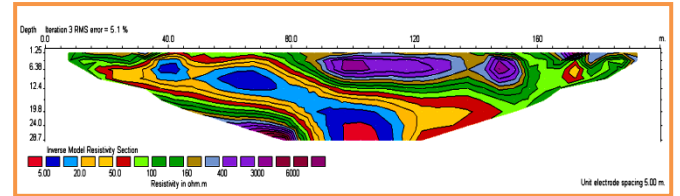
(Figure31 - D) The Inverse model of electrical resistivity section for Traverse no.4 (Taman Batu Gagah Perdana)

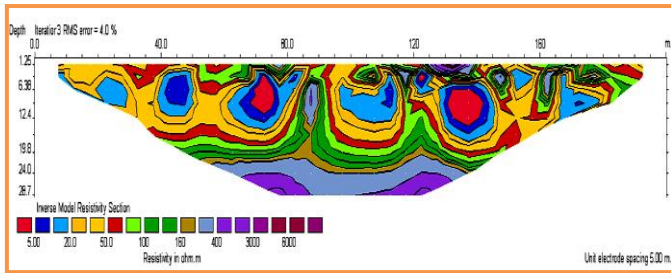
Figure(32 - A) The inverse model of electrical resistivity section for Traverse no.1 (Gunung Rapat)

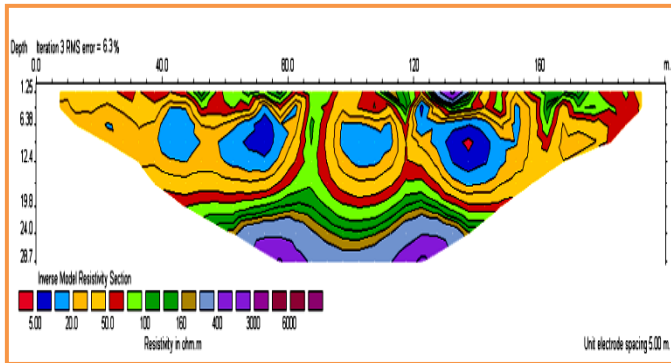
Figure(32 - B) The inverse model of electrical resistivity section for Traverse no.2 (Gunung Rapat)

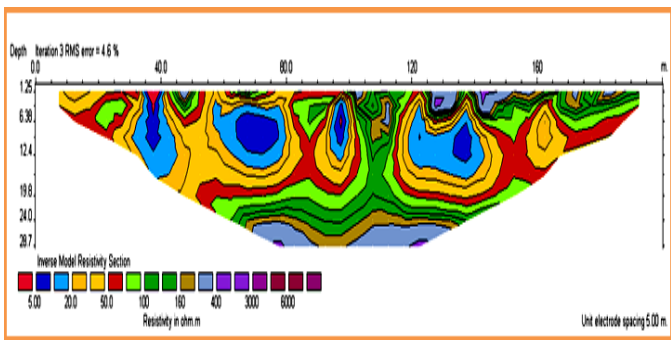
Figure(32 - C) The inverse model of electrical resistivity section for Traverse no.3 (Gunung Rapat)

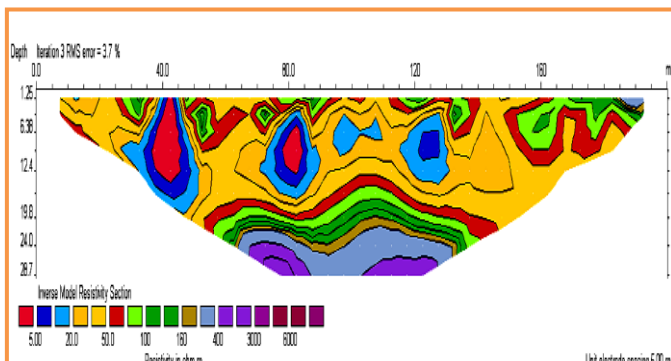
Figure(32- D) The inverse model of electrical resistivity section for Traverse no.4 (Gunung Rapat)

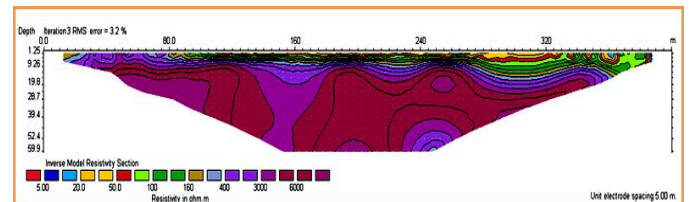
Figure (33 - A): The inverse model of electrical resistivity section for Traverse no. 1 (Tesco Ipoh City)

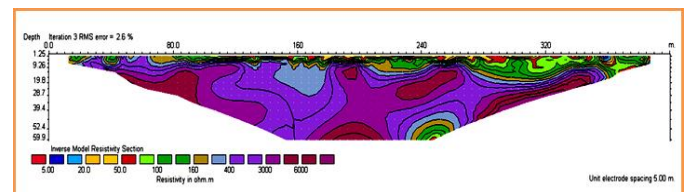
Figure (33 - B): The inverse model of electrical resistivity section for Traverse no. 2 (Tesco Extra- Ipoh City)

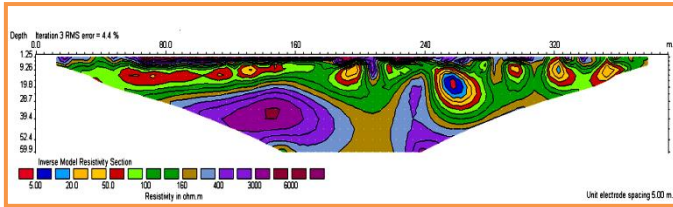
Figure (33 - C): The inverse model of electrical resistivity section for Traverse no. 3(Tesco Extra- Ipoh City)

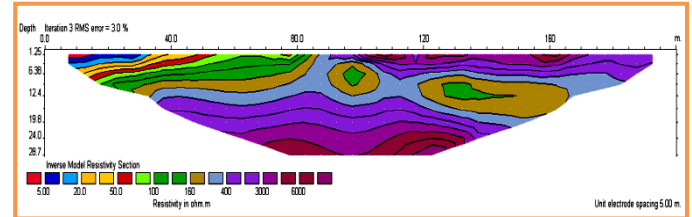
Figure (34 - A): The inverse model of electrical resistivity section for Traverse no. 1 (Taman Tasek Jaya)

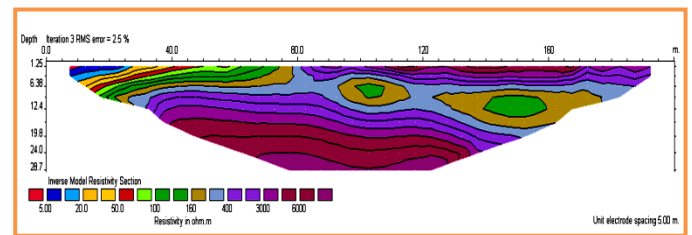
Figure (34 - B): The inverse model of electrical resistivity section for Traverse no. 2 (Taman Tasek Jaya)

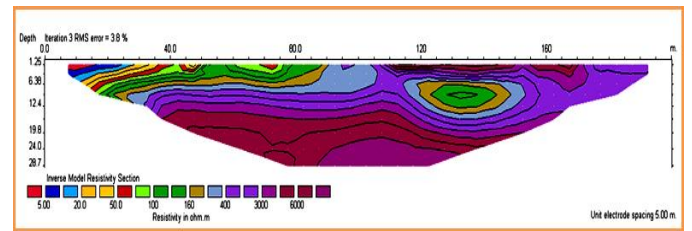
Figure (34 - C): The inverse model of electrical resistivity section for Traverse no. 3 (Taman Tasek Jaya)

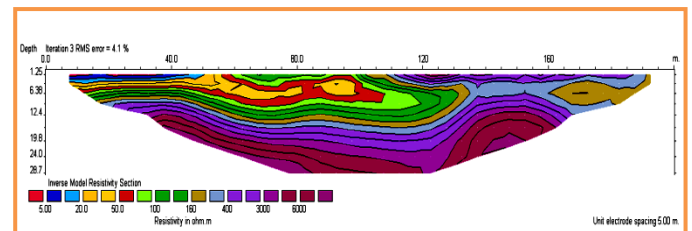
(Figure34 - D): The inverse model of electrical resistivity section for Traverse no. 4 (Taman Tasek Jaya)

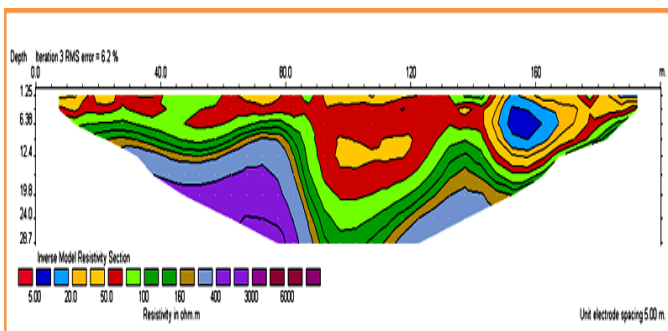
Figure (35 - A): The inverse model of electrical resistivity section for profile no. 1 (Klebang Putra)

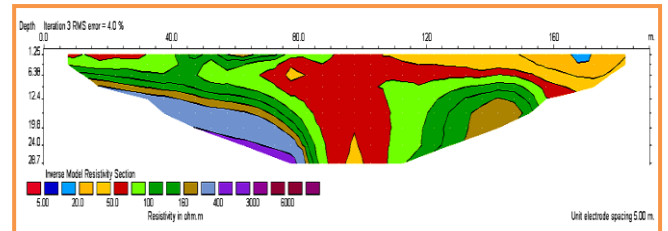
Figure (35- B): Inverse model of electrical resistivity section for profile no. 2 (Klebang Putra)

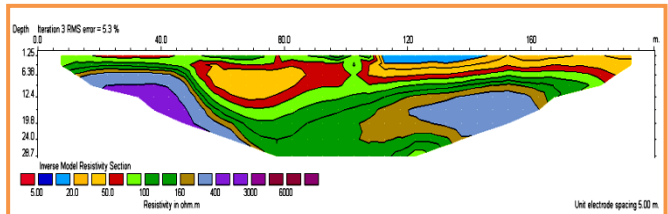
Figure (35- C): Inverse model of electrical resistivity section for profile no. 3 (Klebang Putra)

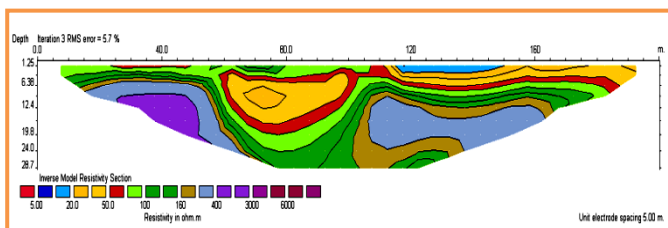
Figure (35- D): Inverse model of electrical resistivity section for profile no. 4 (Klebang Putra)

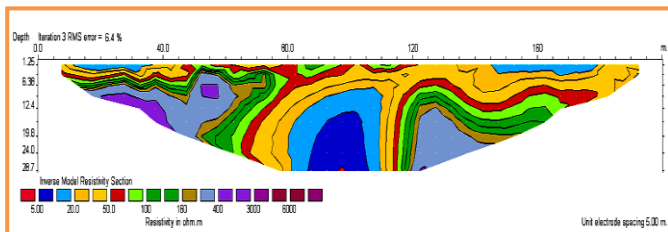
Figure (35- E): Inverse model of electrical resistivity section for profile no. 5 (Klebang Putra)

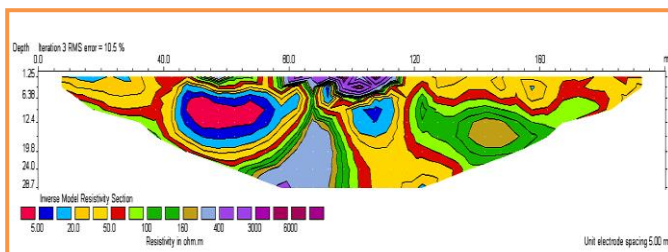
Figure (35 - F): Inverse model of electrical resistivity section for profile no. 6 (Klebang Putra)

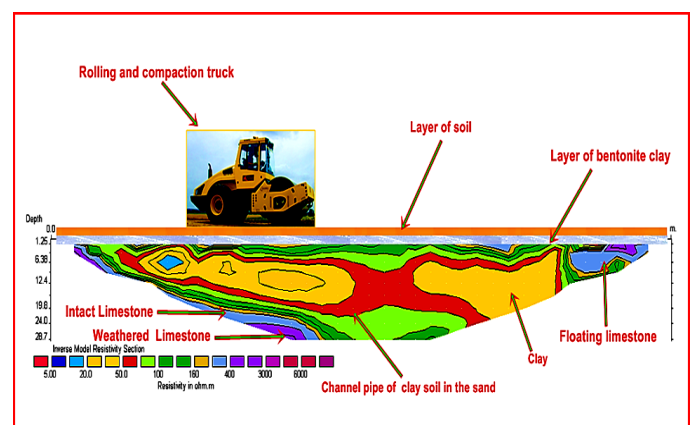
Figure 36: presenting the improving the ground surface by rolling and compaction process to increase the stiffness in construction site#1

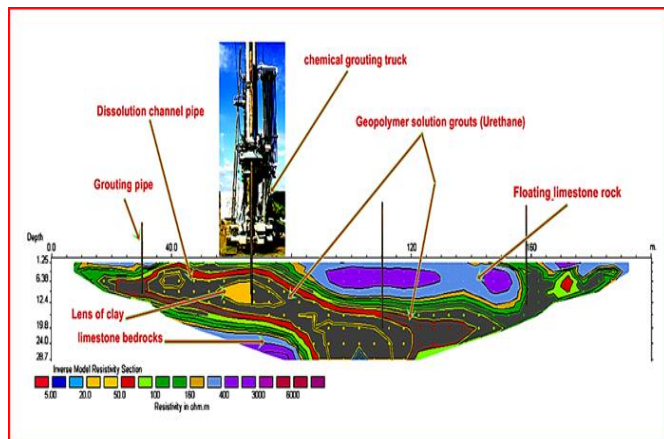
Figure 37: Filling the channel pipe by using of chemical compaction grouting process with geo-polymer solution form (urethane) in construction site#1

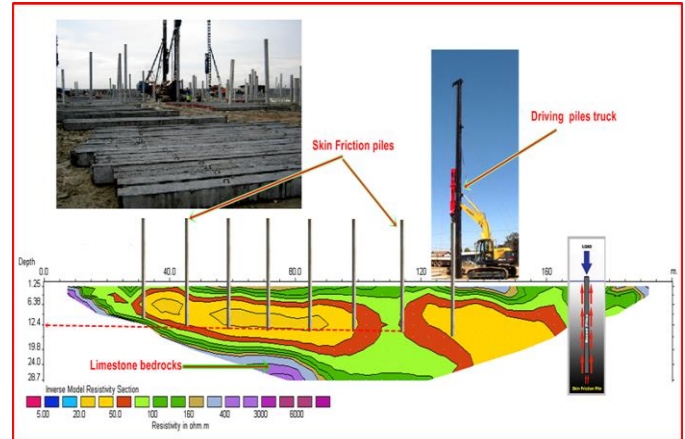
Figure 38: Presenting the Skin Friction Piles driven into softer materials (silty, clayey and sandy soils) without encountering intact layer bedrock (with depth > 30 m) in construction site#1

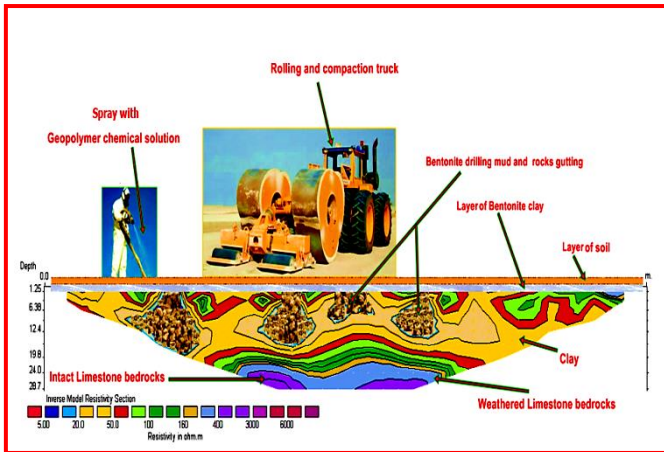
Figure39: Small sinkholes remediation by using of Bentonite drilling mud and the rock gutting from the drilling operation of (oil and gas industry) in construction site#2

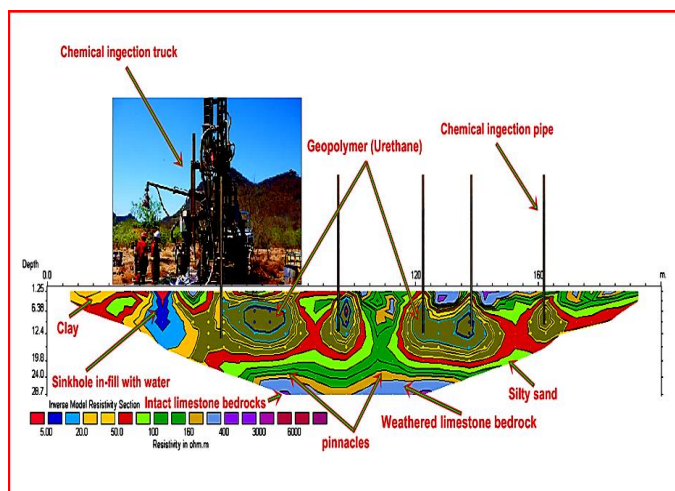
Figure 40: presenting the deep grouting by injection of chemical solution in construction site#2

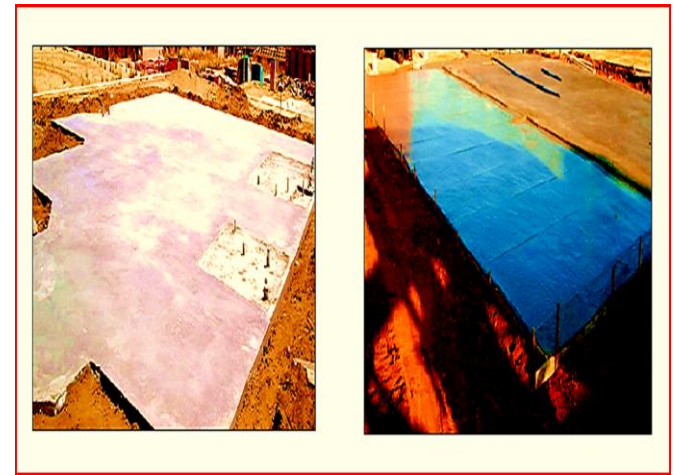
Figure41: Presenting the Raft, Mat foundations or floating foundations that were convenient in construction site#2

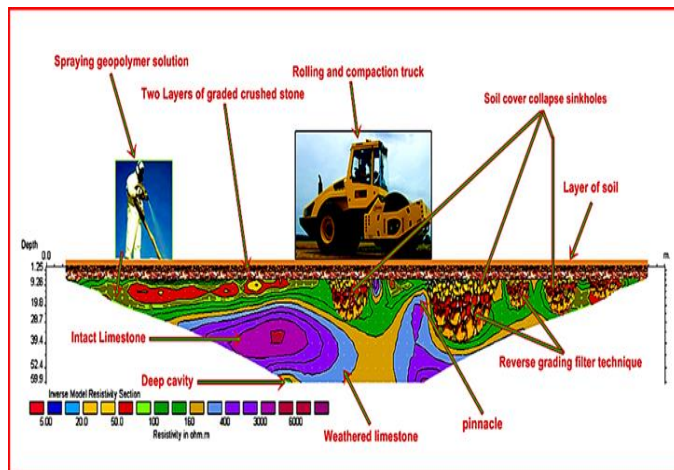
Figure 42: presenting the sinkholes remediation by using of the reverse graded filter technique in construction site # 3

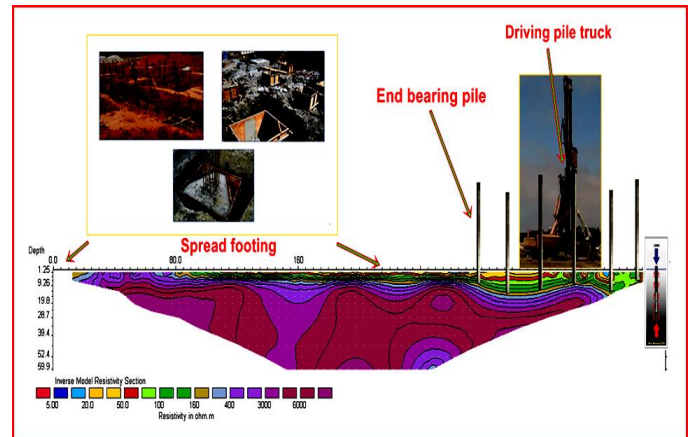
Figure 43: End Bearing Piles that driven across Limestone layer (bedrock) and typical spread footings under Construction in construction site#3

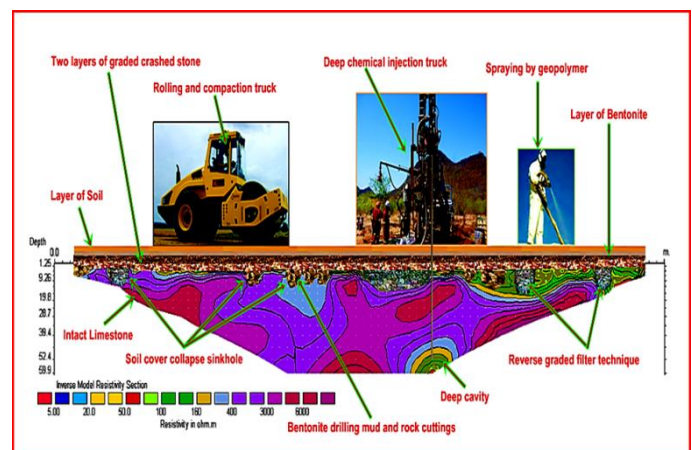
Figure 44: The deep grouting by injection of chemical solution in construction site#3

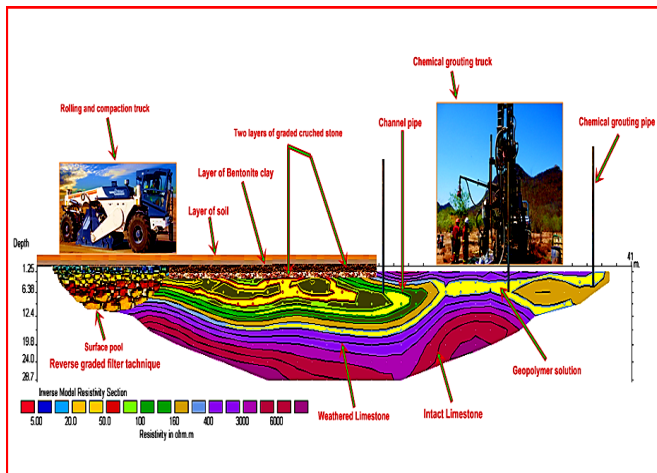
Figure 45: Deep grouting by injection of chemical solution forms in construction site # 4

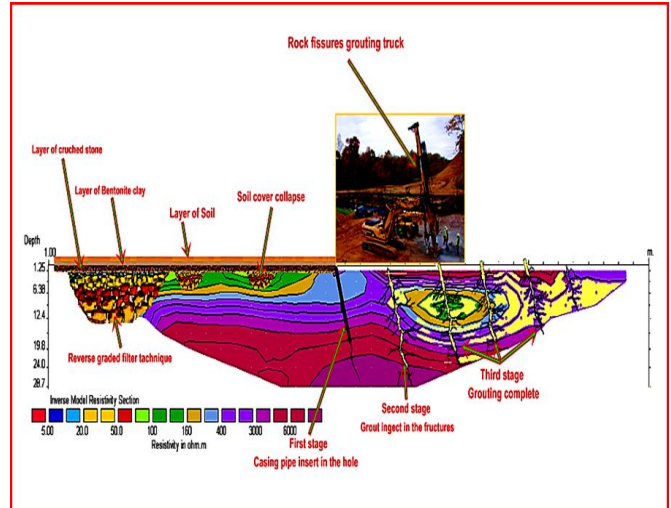
Figure 46: Rock fissures grouting technique in progress to fill the open joints and fissures in construction site#4

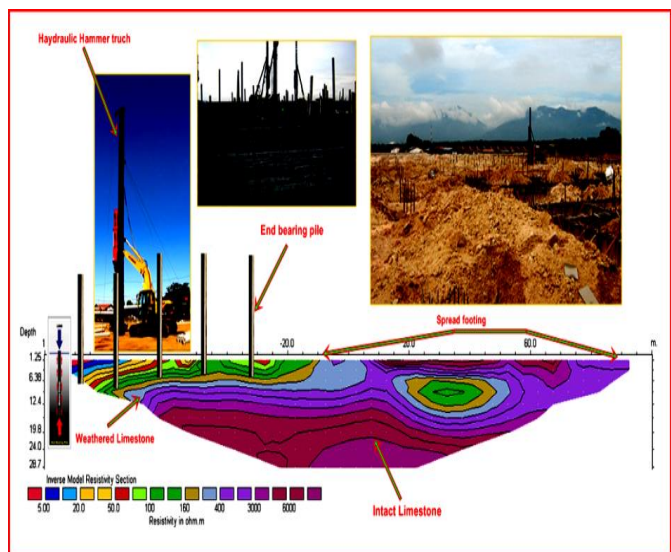
Figure 47: End Bearing Piles that driven across Limestone bedrock and spread footings or pad footings foundations under construction in construction site#4

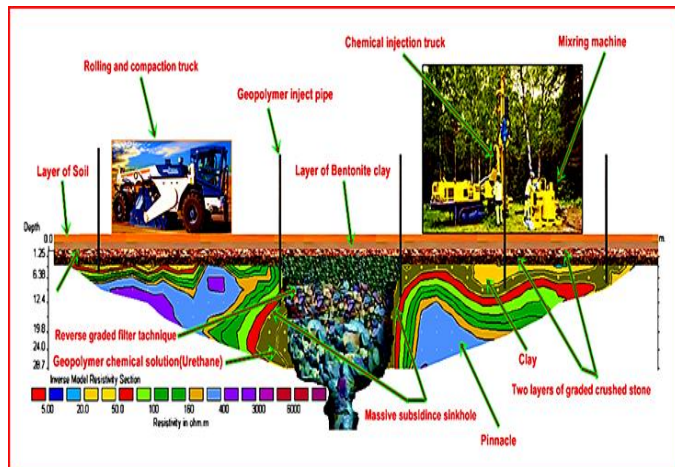
Figure 48: Sinkhole remediation completed by utilizing the reverse graded filter technique in construction site # 5

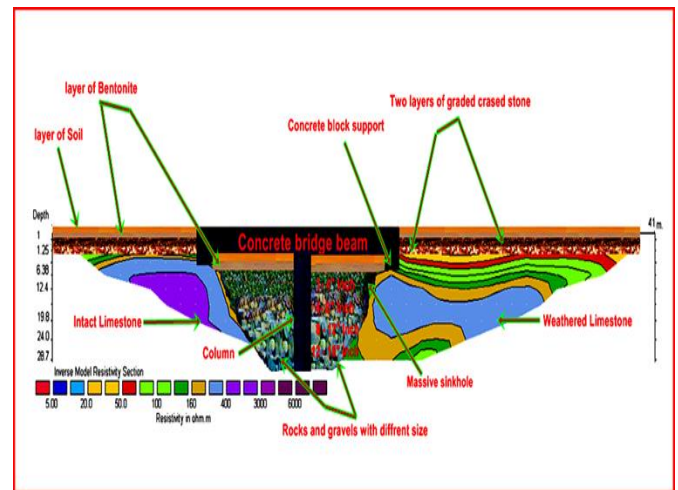
Figure 49: present the sinkhole remediation by using of concrete bridge beam in construction site#5

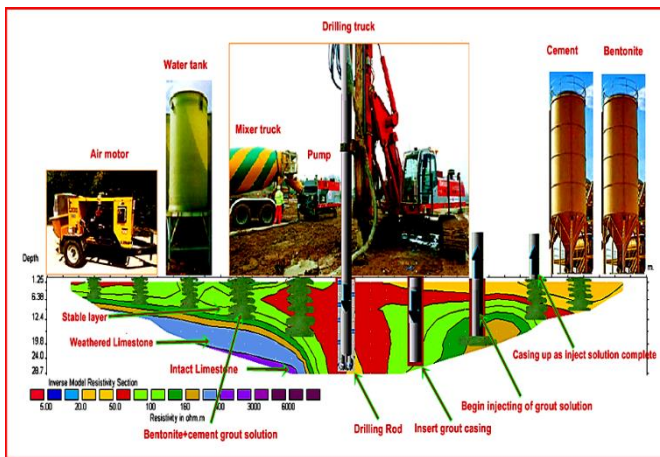
Figure 50: The soil stabilization by using of Bentonite / Cement grouting technique in construction site #5
