Road Improvement Based on The Results of Road Deflection Test on Brigjend. Pol Imam Bachri HP Road Kediri City

Abstract— Roads are vital infrastructure that support community mobility and economic growth. Road damage can reduce comfort, safety, and service life. Over time and with increasing service age, road quality generally deteriorates, as indicated by damage to the pavement structure. Roads with high traffic volumes tend to experience faster surface quality degradation. This condition can lead to discomfort and pose safety risks for road users. One of the damaged road sections in Kediri City is Brigjend. Pol. Imam Bachri Hadi Pranoto Street. The damage includes 30 potholes, which have caused accidents along this road. This road serves as a strategic route for distribution and tourism access to Mount Kelud. This study aims to determine the necessary road improvement efforts based on the results of the Benkelman Beam deflection test. The analysis is conducted to formulate repair actions based on the 2024 Road Pavement Design Manual. The analysis results recommend the implementation of a 70 mm thick overlay to enhance the strength of the existing pavement structure.

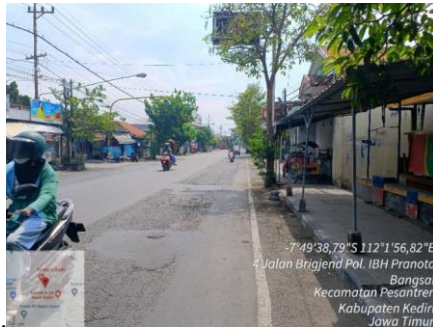
Figure 1 Road Condition

The image illustrates the locations of damage along Brigjend. Pol. Imam Bachri Hadi Pranoto Road in Kediri City. The observed damage can be categorized into several levels of severity. Minor damage, such as small potholes on the road surface, is present at various points along the roadway. In addition, moderate damage is identified in the form of longitudinal hairline cracks on the asphalt surface, indicating potential structural deterioration within the surface layer. Furthermore, severe damage is also evident, characterized by changes in asphalt elevation such as surface depressions or heaving that pose risks to road user comfort and safety. To address these issues, a road improvement analysis using overlay thickness is required.

Brigjend. Pol. Imam Bachri Hadi Pranoto Road is a critical roadway that plays a vital role in facilitating access and supporting the economic activities of the people in Kediri City. In addition to serving as a primary route to the Gunung Kelud tourist area, it also functions as a major distribution corridor for sand materials from Mount Kelud. According to a report by Radar Kediri (2025), Brigjend. Pol. Imam Bachri Hadi Pranoto Road in Kediri City has experienced damage characterized by the presence of potholes

at 30 locations. These potholes have contributed to traffic accidents along the road, with the damage worsening during the rainy season. This condition has led to a decline in the level of service provided by this road segment.

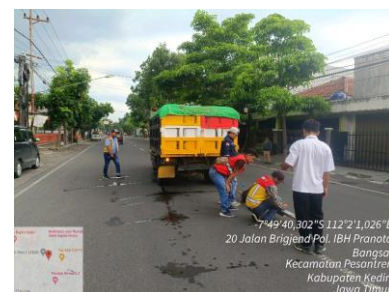
Figure 3 Road Deflection Survey

The road deflection test data in this study were obtained using the Benkelman Beam (BB) method. This test was conducted to determine the magnitude of elastic deflection caused by traffic loads on the pavement. The following are several documentation images taken during the road deflection survey using the Benkelman Beam (BB).

The Benkelman Beam test is used to measure deflection on the asphalt surface. The testing device is placed between the left/right dual wheels of a truck with an 8.2-ton rear axle load. Dial gauge readings are taken twice: once when the truck moves forward by 0.2 meters, and again when it moves 6 meters away from the Benkelman Beam device.

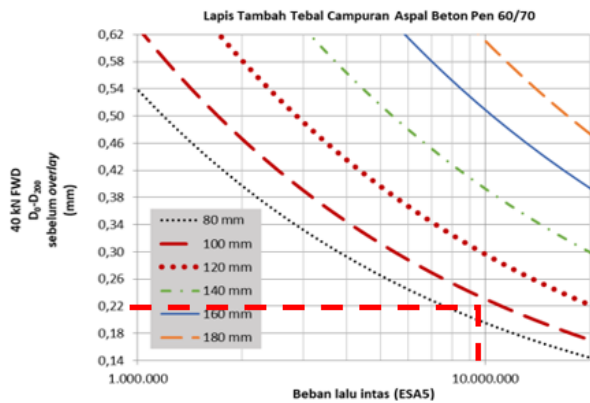
Figure 5 Determination of Overlay Thickness (Thick)
Source: Researcher Analysis, 2025

Based on the overlay thickness determination graph, an overlay thickness of 100 mm was initially identified. However, to enhance the structural capacity of the existing pavement to adequately support the anticipated traffic loads, the implementation of an overlay is required. The analysis results indicate that an overlay thickness of 70 mm satisfies both structural criteria—resistance to permanent deformation and fatigue cracking—as well as the minimum thickness requirement to reduce the International Roughness Index (IRI) value. Therefore, the recommended minimum overlay thickness for the pavement design is 70 mm.

These values are then plotted into the overlay thickness determination graph, as shown in Figure 4 and Figure 5 below.
