Road Safety Audit of Existing National Highway-44 in the City of Delhi

Harshal Mistry

Department of Civil Engineering
YMCA University of Science & Technology
Haryana, India

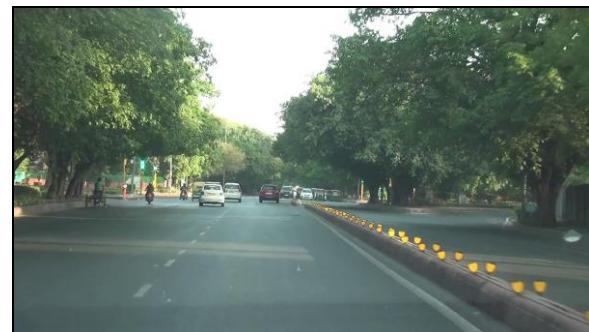
Fig 2. Start Point of Project stretch of NH-44 near India Gate (Junction of Zakir Hussain Marg & Subramaniam Bharti Marg)

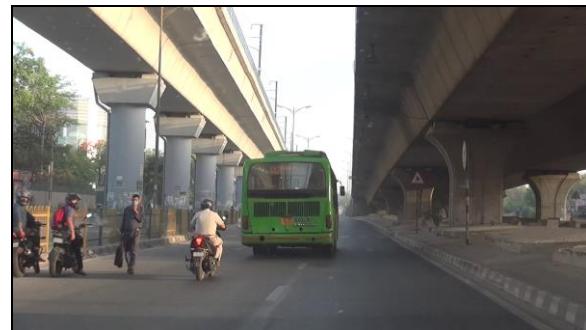
Fig 3. End Point of Project stretch of NH-44 near Badarpur Border
