Simulation of Cracks Development due to Rebar Corrosion in the Cement Paste Ring

Eng. Lwitiko Humphrey Kalenga
Department of Structural and Construction Engineering,
College of Engineering and Technology,
University of Dar es salaam
Dar es salaam, Tanzania

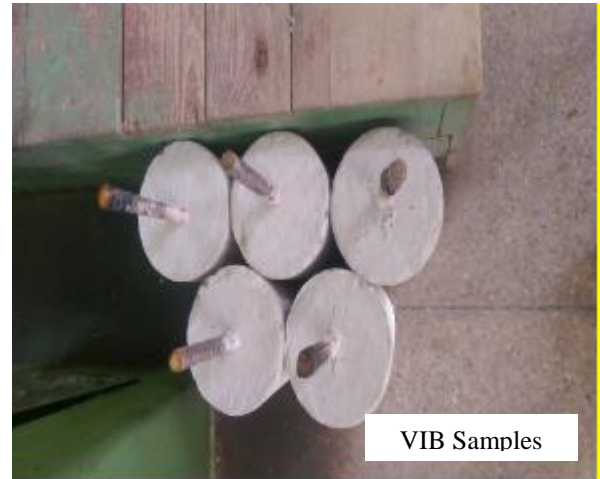
Figure 1: Concrete cylindrical samples (RS and VIB) after 14 days of curing.

The tests were performed on both the reinforced concrete cylinder (RCC) samples shown in Figure I to determine their behavior. The sample details are shown on Table I.

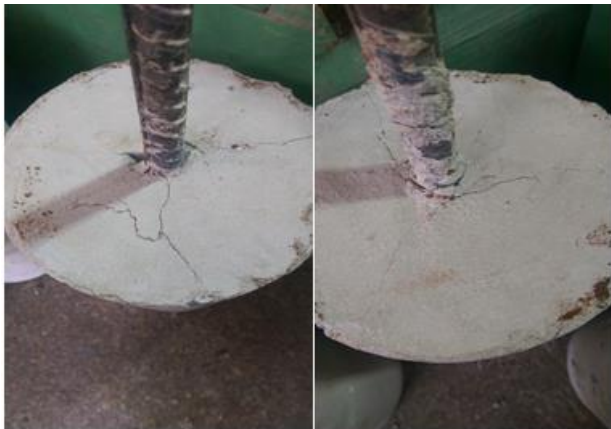
Figure 2: RS concrete samples showing visible cracks after the test

Figures 2 and 3 are photos of the concrete samples after the test was conducted

- i. It was observed that cracks formed on the RS sample are less wide from Table II (b) and form a clearer and disconnected cracks patterns around the reinforcement.
- ii. The RS samples form a non-continuous network of micro cracks (cracks), unlike normal vibrated (VIB) samples as shown in Figure 4 (a and b)
- iii. From Table II (a) above the RS samples resisted more pull-out force compared with the normally vibrated sample (VIB), and this shows that its bond has an increased bonding strength than the normal vibrated reinforced concrete bond.
- iv. Crack widths for RS samples are ranging from 0.02 to 0.28mm and for VIB samples crack widths are ranging from 0.08 to 1.8mm.

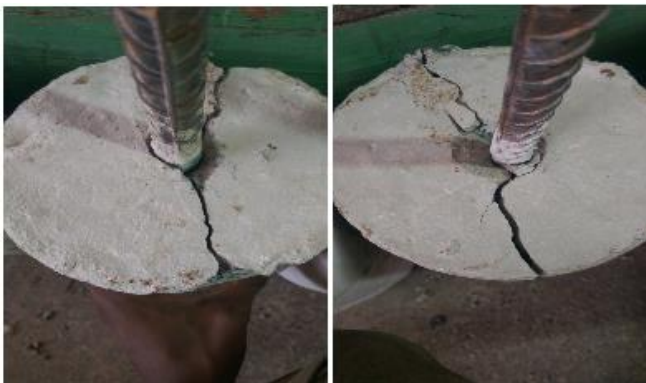
Figure 3: VIB concrete samples showing failure patterns and some visible cracks

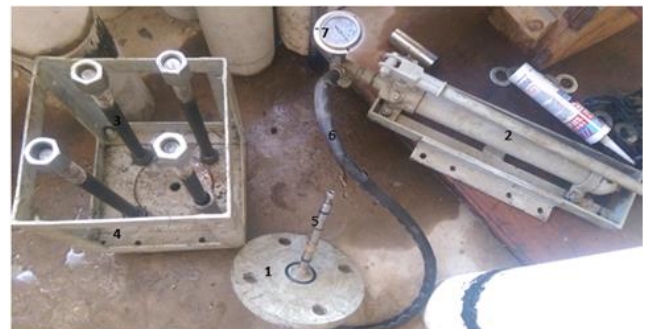
The machine operates under hydraulic laws. Hydraulic fluid is pumped into the concrete sample with the aid of the hand pump attached to the pressure gauge which records the amount of pressure conveyed. The machine contains different parts as listed below:

1. Top plate; 2. Hydraulic hand pump; 3. Vertical bolts; 4. Safety case; 5. Hydraulic delivering nozzle; 6. Hydraulic pipe; 7. Pressure gauge.

Figure 5: Hydraulic concrete cracking machine

The machine was used mainly to induce the internal lateral pressure to the inner concrete layer that forms the bond with the steel rebar, and also to induce stresses in concrete similar to effects created by the corrosion around the rebar (lateral expansion) hence causing cracks on the cover. The machine contains different parts such as the pressure gauge for measuring lateral pressure subjected to the concrete samples as shown in Figure 5.

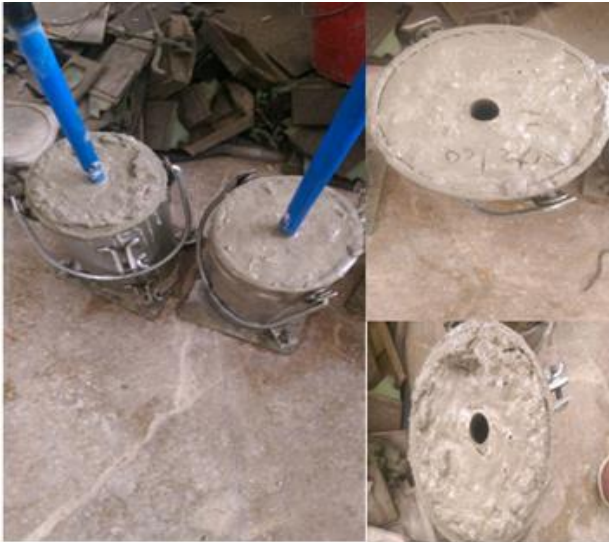
Figure 6: Samples with PVC immediately after preparation and without PVC pipe after setting.

Following the requirements of the machine, the samples were prepared by replacing the steel rebar with the PVC pipe which was later pulled out after concrete setting leaving the hollow space in the middle of the concrete cylinder and exposing the inner layer, as shown in Figure 6 and sample details are shown in Table III

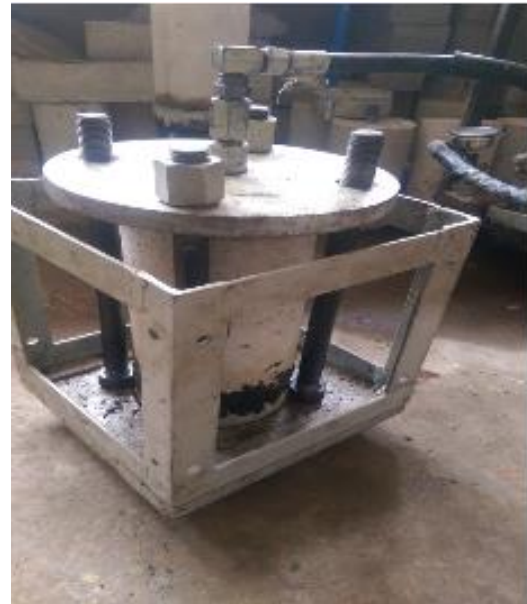
Figure 7: Sample under testing

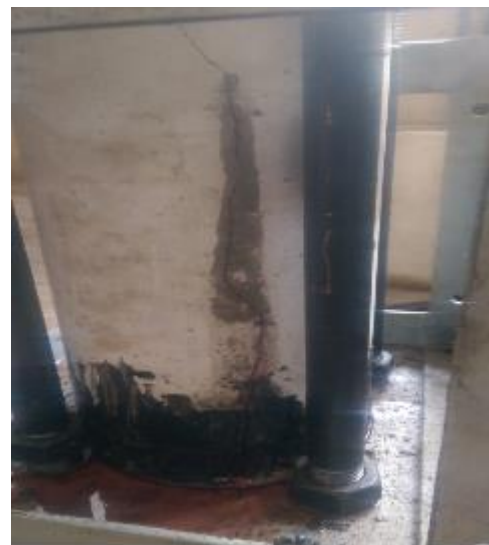
Figure 8: Cracked sample after testing.

After effective curing, the samples were removed and left to dry at room temperature for 72 hours and then put into the machine by inserting the hydraulic delivering nozzle in the hollow part of the sample. Then, the sample was secured on the machine by tightening the bolts and by using the hand pipe the hydraulic fluid was pumped into the sample hence creating the pressure inside the sample until failure was detected as shown in Figure 7. The failure was due to the development of cracks on the side(s) of the samples as well as the top, as shown in Figure 8

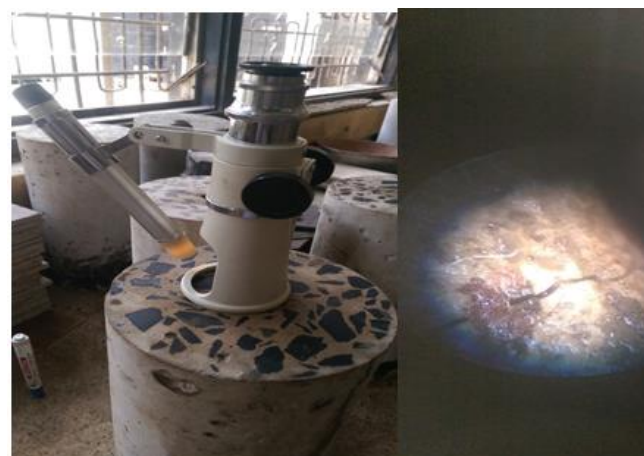
Figure 9: Observation of crack widths using crack meter

The Table IV (b) showed an increased pressure for the 28 days old cured samples with an average pressure of 152.5 kg/cm². By using the concrete crack meter (magnifier) as seen in the Figure 9 below the cracked samples where studied and observed as recorded in the Table V.

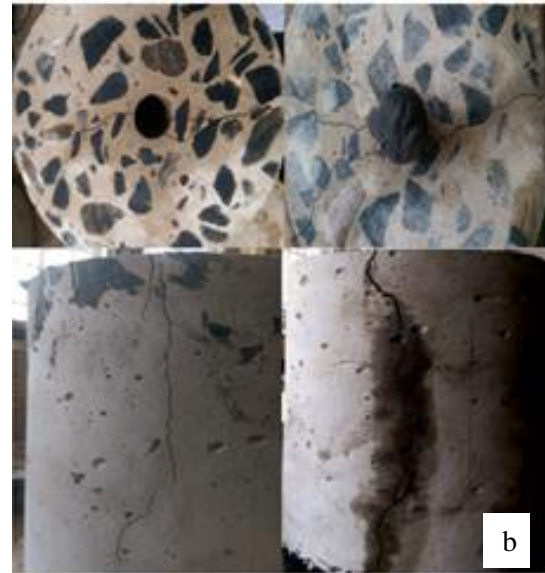
Figure 10: RS samples in (a) and VIB samples in (b) showing top surfaces and side cracks

Cracks observations for the samples shown in Figure 10 were done at the top, side surfaces and in the inner surfaces as shown in Figure 11

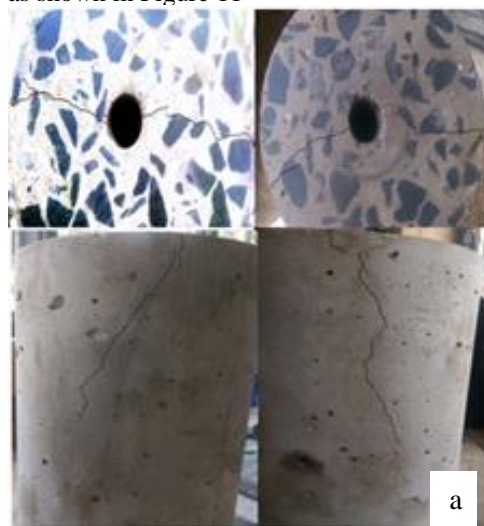
Figure 11: RS sample general pattern for both 7&28 days and VIB inner layer cracks

- i. Inner layer of the RS samples formed a single continuous cracks as shown in Figure 11(a), some short some long running vertically, to the outer sides (diagonally) cracks as seen in Fig 10(a)
- ii. The inner layer of the VIB samples displayed multiple vertical cracks extending the whole depth of the sample shown in Figure 11(b), which are straight on the outside with some branches of continuous cracks
- iii. Typical Micro-cracks patterns of RS sample in Figure 12(a) and VIB sample in Figure 12(b). The continuous longitudinal crack is visible

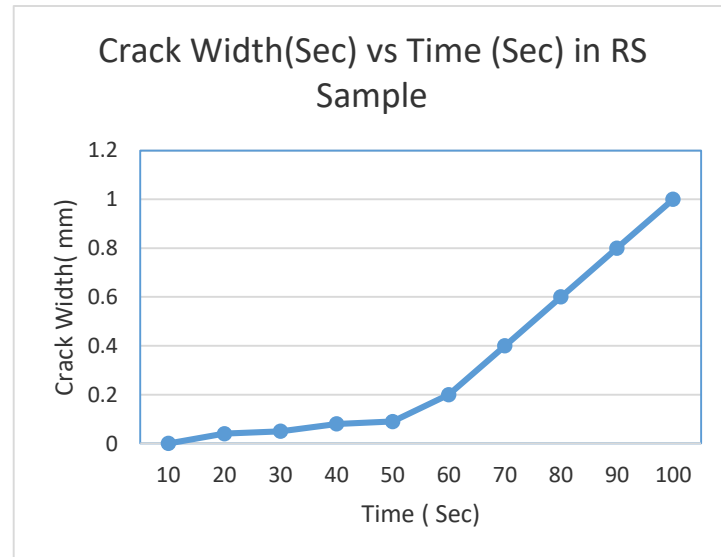
Figure 13: Crack widths vs. Time for RS samples

The maximum time from applying hydraulic pressure to the RS sample which has CPR until the occurrence of external crack is between 80 seconds to 120 seconds. Typical graph of Crack width versus Time is shown in Figure 13. It takes approximately 10 second for pressure to build-up until the first crack to appear. This nature of graphs is conforming to the results of Crack width versus Time that was done by Dimitri et al. (2009)
