Structural Health Monitoring of Japan Bangladesh Friendship Bridge

Keywords: SHM, Japan Bangladesh Friendship Bridge, local scouring, tiltmeter.

The objective of the present study is to monitor temperature variation through the pre-stressed concrete box girder of Japan Bangladesh Friendship Bridge. The threshold value of tiltmeter placed on top of pier and top of deck in order to monitor local scour monitoring around pier 8 has been studied using the technique implemented in US59 over Guadalupe River Bridge.

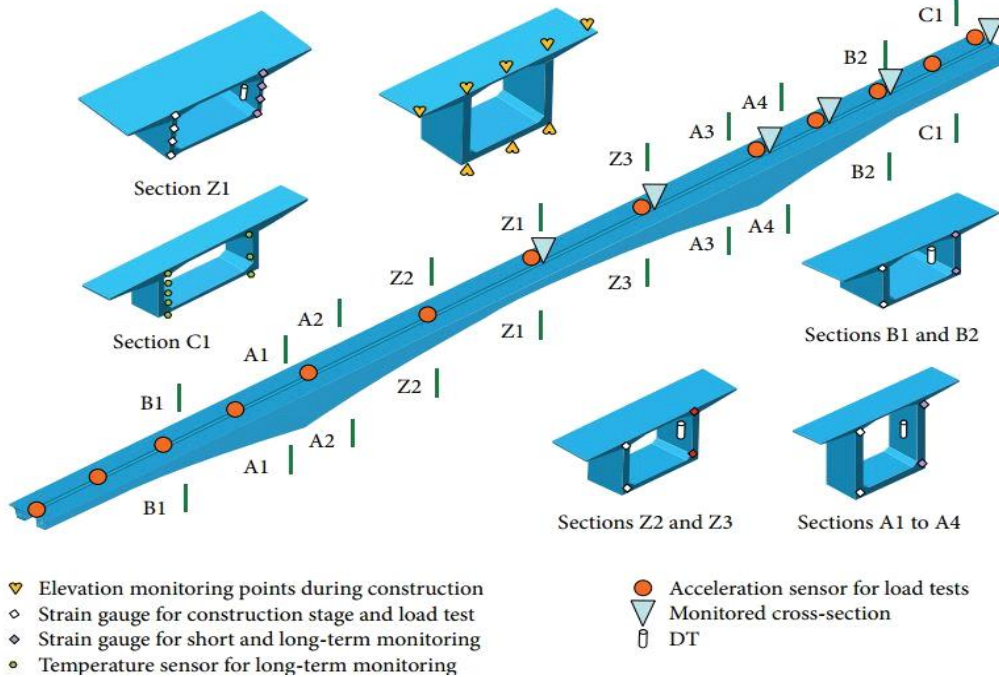
and B2. Each DT were installed on the inner surface of the web of the box girder. It is found that strain increment is insignificant at main span support indicating that concrete shrinkage or creep is not significant in that location. But at mid-span of main span the effect has been found significant. It has been found that the measured time dependent deflections are larger than the design values indicating that deflection at mid-span is one of the main problems of pre-stressed concrete bridge. The sensor layout for the monitoring in construction, completion test and service stages are shown in the Figure 2.

Figure 2. Sensor layout of Jinghang Canal Bridge (Chen et al. 2014)

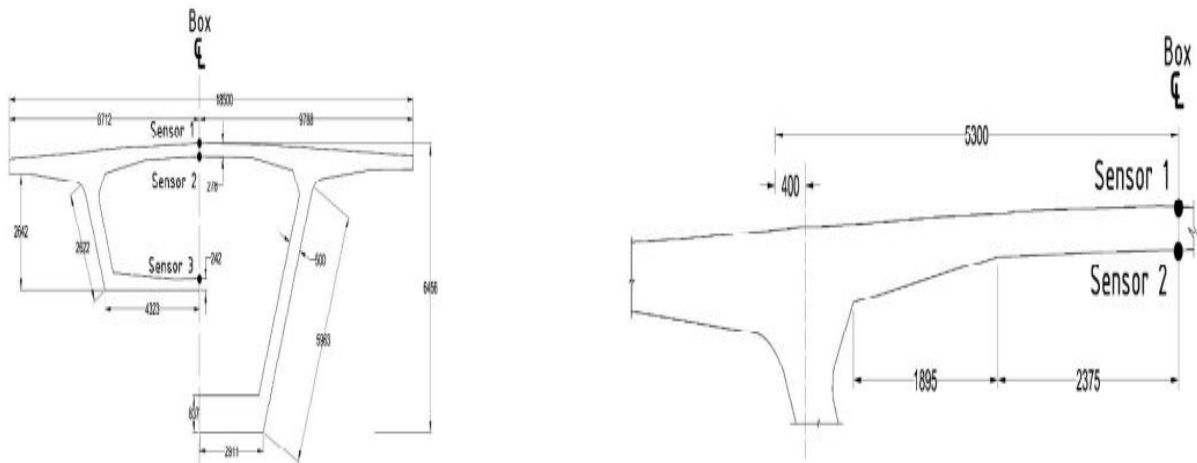
temperature variation of upper and bottom part, these cracks had been occurred (Amin et al.2014). To monitor temperature variation of upper and bottom part, temperature sensors had been used to get data periodically. The arrangement is shown in Figure 3.

Figure 3. Location of sensors to monitor temperature variation in box girder in Bangabandhu Bridge (Amin et al. 2015)
 Monitoring items of pre-stressed concrete box girder bridges all over the world is shown in the Table 3.

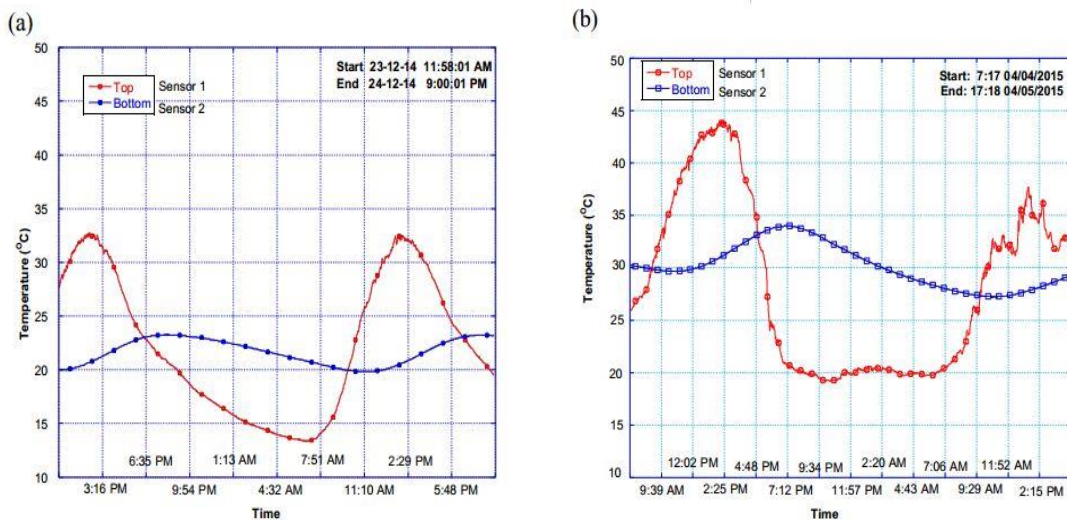
several bridges of Bangladesh i.e. Bangabandhu Bridge (total length 5.63 Km) and Gabkhan bridge (total length 918m) due to temperature variation. Figure 4 shows the temperature variation of Bangabandhu Bridge which is a box girder type at winter and summer.

Figure 4. Typical temperature measurement at (a) in winter, (b) in summer

From the above figure, it is clear to us that a thermal stress reversal occurs at day and night. The intensity of stress reversal is more prominent during summer days when the deck suddenly cools down due to raining creating a temperature gradient about 15°C. Moreover, hail storm occurs at the starting of summer season in Bangladesh which creates a big problem. During a hail storm, the deck even cools down more rapidly than the bottom part of it creating a worsen condition. It has been reported by Amin et al. (2015) that a hail storm can reduce the ambient temperature by about 12°C creating a temperature gradient of around 25°C. These temperature

It has been reported earlier that there is no temperature monitoring data available for Japan Bangladesh Friendship Bridge. So, the temperature monitoring data of Bangabandhu Bridge would be used for thermal stress analysis because Bangabandhu Bridge is located only 120 Kilometers from Dhaka and it could be assumed that temperature fluctuation is same for both regions. Table 4 is showing maximum and minimum temperature distribution along the box girder taken from Figure 4 for Japan Bangladesh Friendship Bridge.

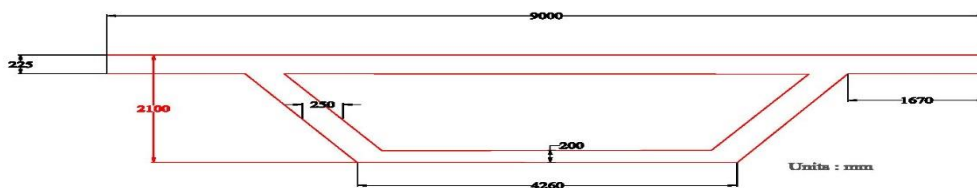
- Span length = 40 m = 40 000 mm
- Depth of box girder = 2100 mm
- Thickness of slab = 225 mm
- Deck width = 9000 mm
- Modulus of elasticity = 30 000 MPa

Figure 5. Cross-section of the model

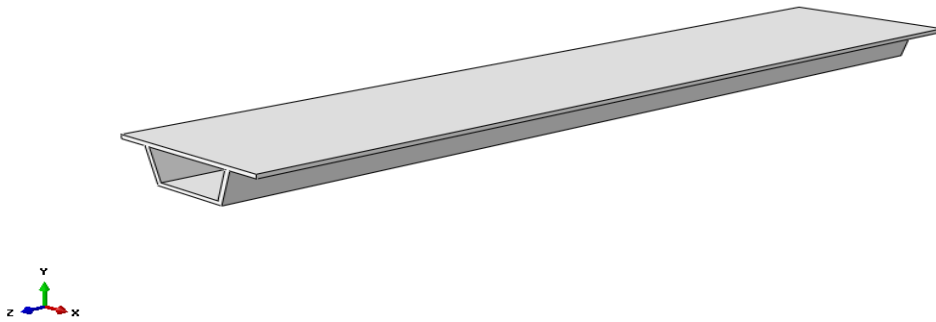
Figure 6. Longitudinal section of the model

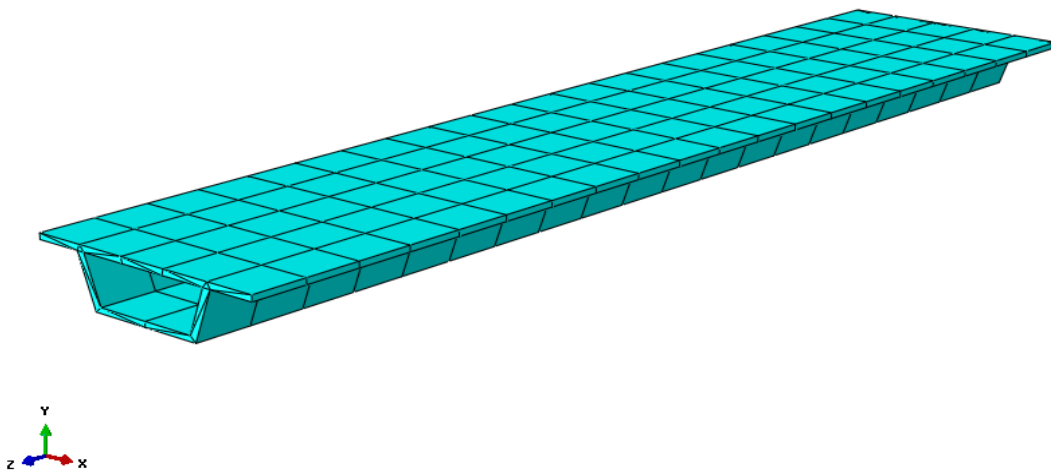
There are different finite element packages available but for thermal analysis, ABAQUS 6.13 software had been used. Solid deformable element and coupled temp - displacement procedure had been used for simulation. In order to reduce analysis time, a coarse mesh had been used. The 3-D mesh and boundary condition of the finite element problem is shown in Figure 7 and Figure 8 respectively.

Figure 7. 3-D mesh of the finite element model

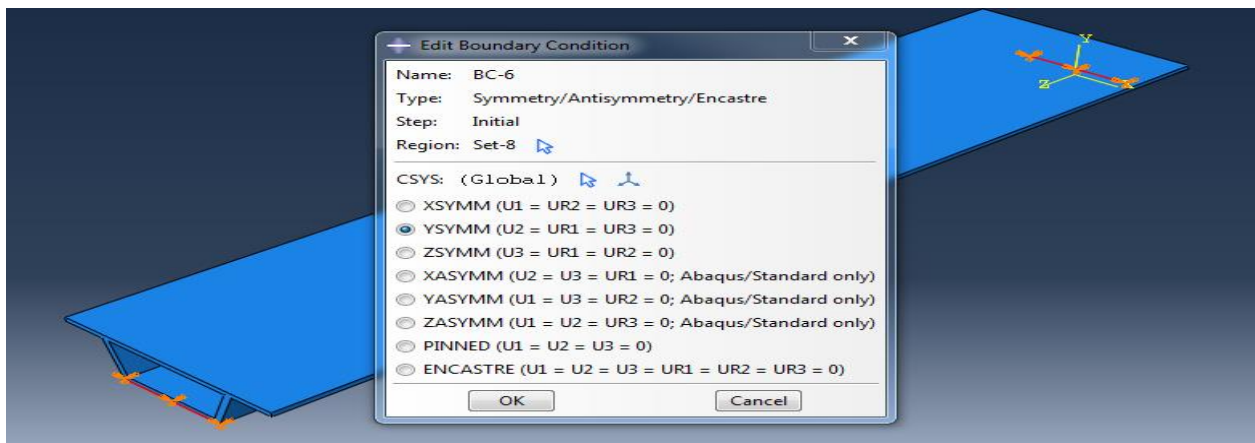
Figure 8. Boundary condition for the finite element model

- The pot bearing condition has been used in case of boundary conditions during performing analytical simulation because the bearing system in Japan Bangladesh Friendship Bridge is pot bearing. Other bearing systems can also be studied.

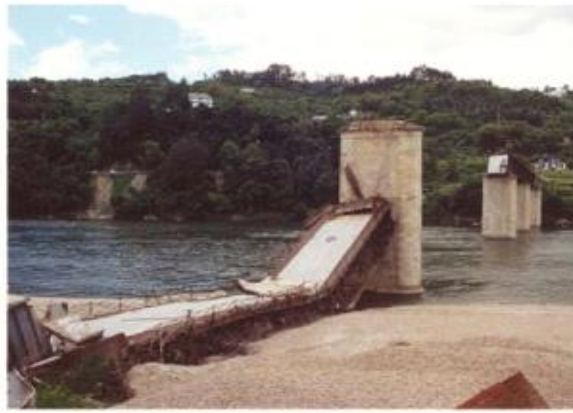
These loss of pier and loss of deck actually occur due to two mechanisms: settlement of pier and rotation of pier. When the pier settles down too much, then the deck tilts which can be captured by tiltmeter placed on the deck. That's why a dual gauge tiltmeter is placed on the deck near monitored pier of Japan Bangladesh Friendship Bridge. The deck loses its support and falls down due to excess settlement of pier. The deck may lose its support also if the pier rotates too much resulting loss of deck and loss of pier shown in the Figure 9 and Figure 10 respectively.

Figure 9. Loss of deck due to excess settlement of pier (Brioud et al. 2011)

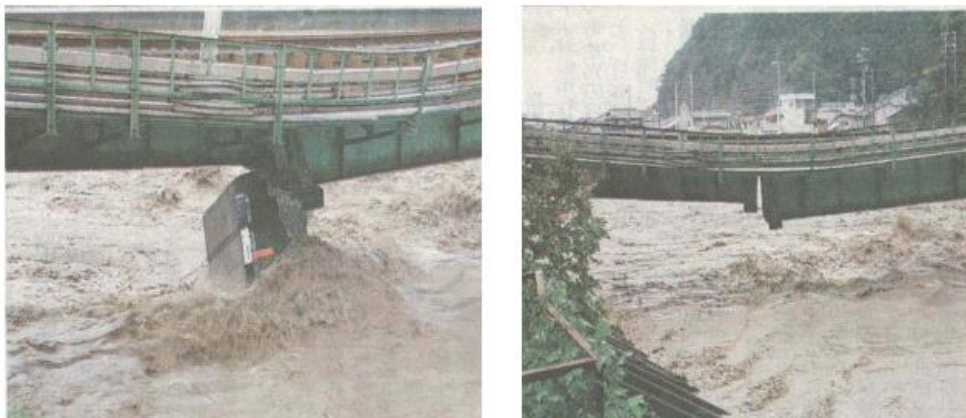
Figure 10. Loss of pier due to rotation of pier (Brioud et al. 2011)

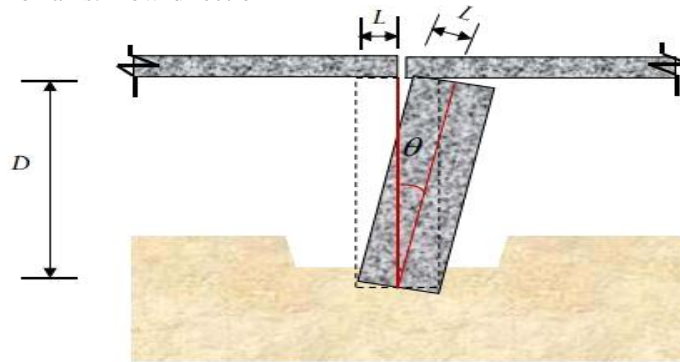
The dual gauge tiltmeter shown in Figure 11 placed on top of pier is capable to measure the rotation angle of pier around two direction of axis: flow direction

Figure 11. Tiltmeter threshold value calculation placed on top of pier 8 (Brioud et al 2011)

From Figure 11, it can be said that

$$\sin \Theta = \Theta = \frac{L}{D}, L = \text{Supporting width between deck and pier} = 3.2 \text{ m}, D = \text{depth of pier} = 40 \text{ m}$$

$$\Theta_{\text{check}} = \frac{L}{4*D} \text{ considering F.S.} = 4 \text{ and } \Theta_{\text{closure}} = \frac{L}{2*D} \text{ considering F.S.} = 2 \text{ (Formulas proposed by Briaud et. al.)}[8]$$

$$\Theta_{\text{check}} = 1.15^\circ$$

$$\Theta_{\text{closure}} = 2.29^\circ \text{ for Japan Bangladesh Friendship bridge}$$

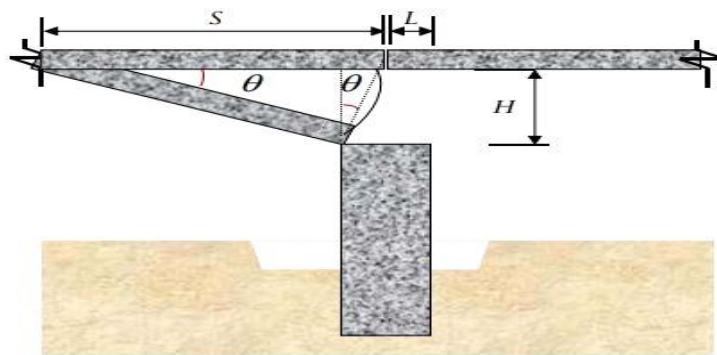
The dual gauge tiltmeter shown in Figure 12 placed on top of pier is capable to measure the rotation angle of pier around two direction of axis: flow direction

Figure 12. Tiltmeter threshold value calculation placed on deck near pier 8 (Brioud et al 2011)

From Figure 12, it can be said that

$$\sin \Theta = \Theta = \frac{H}{S}, S = \text{span of the bridge} = 40\text{m}, H = \text{settlement of the pier} = 0.6\text{m (Recommended)}$$

$$\Theta_{\text{check}} = \frac{H}{2*S} \text{ and } \Theta_{\text{closure}} = \frac{H}{S} \text{ (Formulas proposed by Briaud et. al.)}$$

$$\Theta_{\text{check}} = 0.1976^\circ$$

$$\Theta_{\text{closure}} = 0.395^\circ \text{ for Japan Bangladesh Friendship bridge}$$

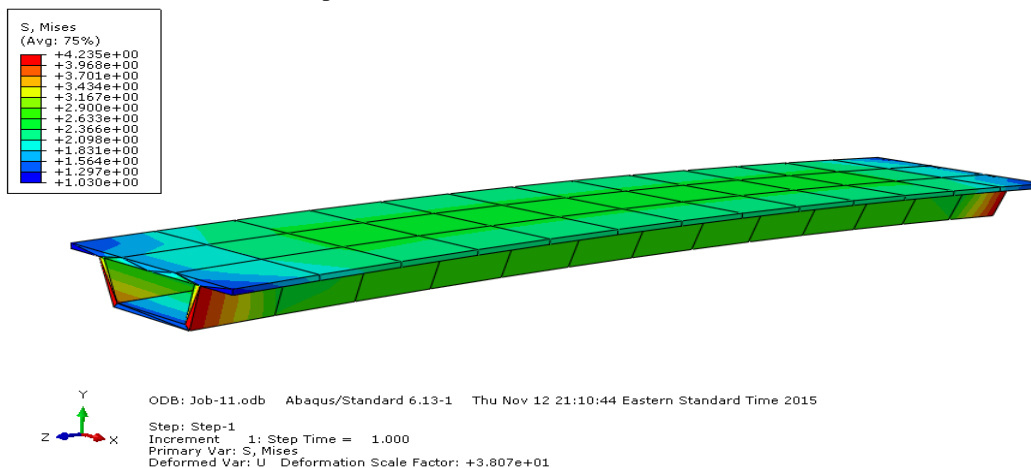
In case 1 (Figure 13), the top surface temperature was 317K and bottom surface temperature was 304K.

Since the top surface temperature is higher than bottom surface, therefore the top surface would tend to expand subjected to tension and the bottom surface would tend to contract subjected to compression which is found from ABAQUS finite element analysis.

Figure 13. Thermal stress found from case 1

Case	CHBDC (MPa)	Analytical Simulation (MPa)
Case 1	10.8	4.235
Case 2	11.16	4.561
Case 3	10.44	3.909
Case 4	9.00	2.606

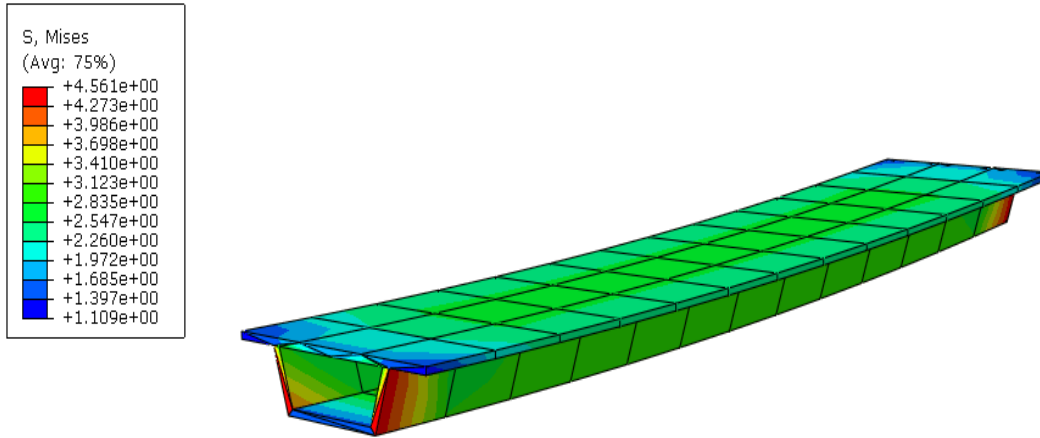
In case 2 (Figure 14), the top surface temperature was 292K and bottom surface temperature was 306K. Since the top surface temperature is lower than bottom

surface, so the top surface would tend to contract subjected to compression and the bottom surface would tend to expand subjected to tension which is found from ABAQUS finite element analysis.

Figure 14. Thermal stress found from case 2

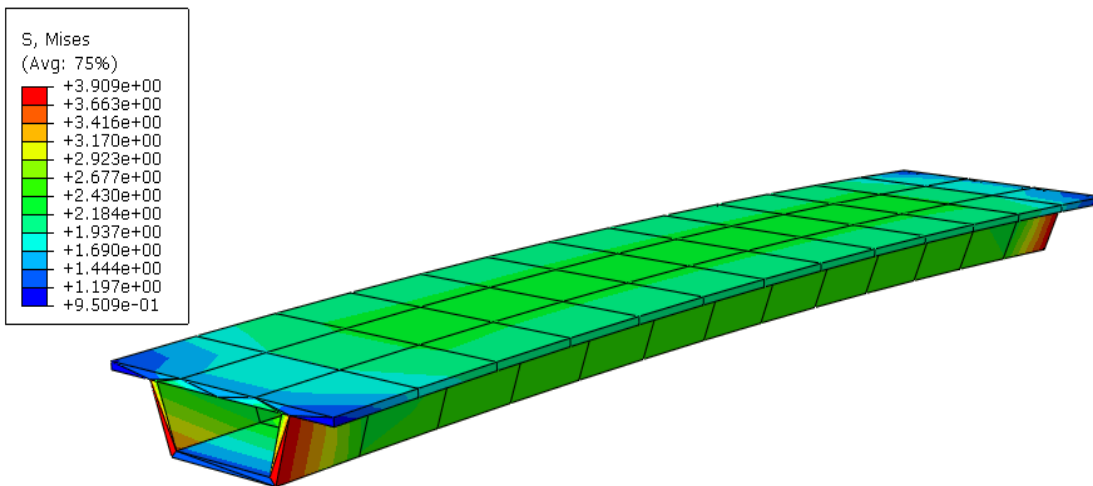
In case 3 (Figure 15), the top surface temperature was 306K and bottom surface temperature was 294K. Since the top surface temperature is higher than bottom

surface, therefore the top surface would tend to expand subjected to tension and the bottom surface would tend to contract subjected to compression which is found from ABAQUS finite element analysis.

Figure 15. Thermal Stress found from case 3

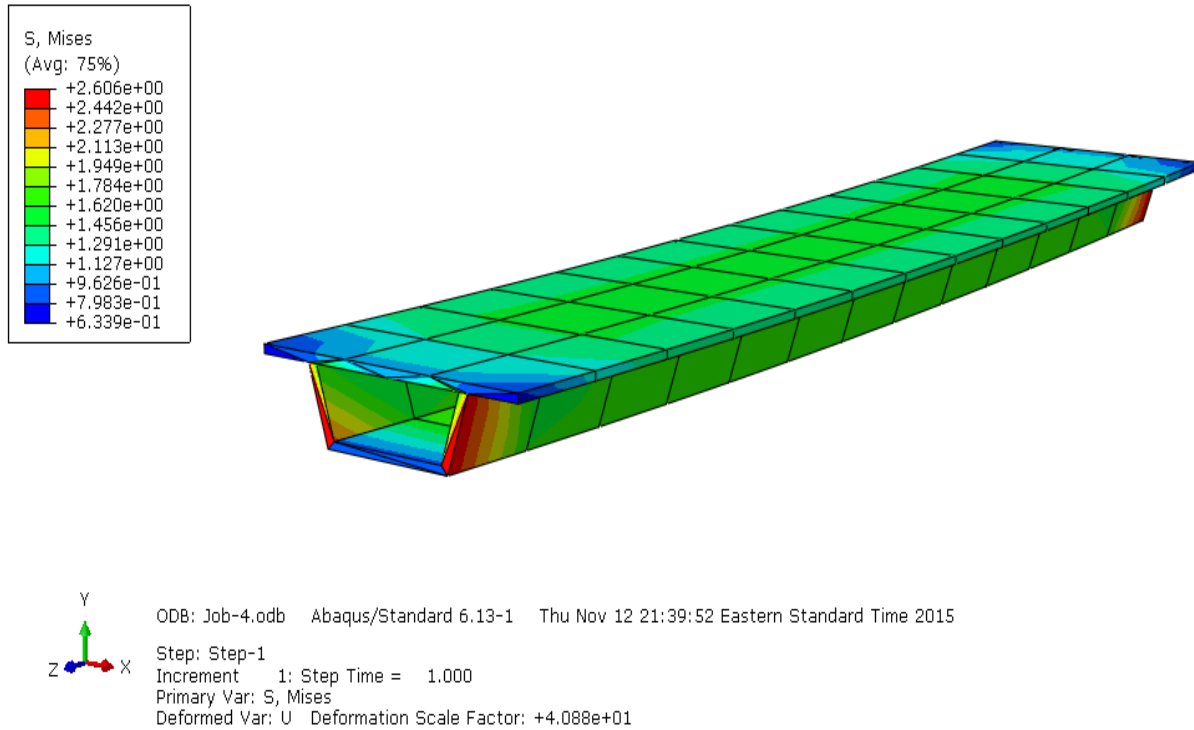
In case 4 (Figure 16), the top surface temperature was 286K and bottom surface temperature was 294K. Since the top surface temperature is lower than bottom

surface, so the top surface would tend to contract subjected to compression and the bottom surface would tend to expand subjected to tension which is found from ABAQUS finite element analysis.

Figure 16. Thermal stress found from case 4
