# Study on Retrofitting of Heritage Structure: Construction & Problems

**Abstract:-** India is the land of heritage structure. It contains variety of heritage monuments and structure which are need to be conserved. Since we all know that India is country which is at high risk of been subjected to natural disaster such as earthquake, floods, cyclones etc more often every year in past 2 decade evidently. This phenomenon is increasing day by day. This paper draws the attention towards general problems encountered in development plan of heritage conservation. Heritages conservation lacks in methodologies used to rehabilitate, understandability of structural as well as material aspects. Also the economical aspects are another major part which hinders the initiative taken towards retrofitting of heritage building. Looking in scenario government of India has already started taking initiatives by making laws and making authorities appointing tasks etc. This paper discusses briefly about Geometrical layout & Material understanding of Heritage structure.

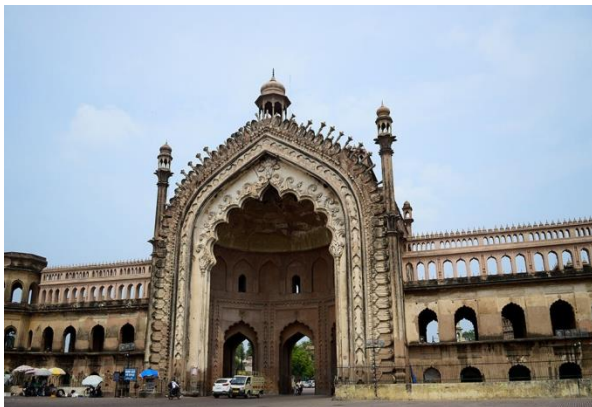
Fig No. 1 : Rumi Gate

So looking into the increase in damages and seismic activities many efforts had been made in past decades to restore the strength of heritages to make them capable to with stand seismic forces. Many cosmetic repairs run every day by the concerning authorities aiming to preserve the beauty of stones and material used in heritages (used in constructed by Kings).

These repairs have helped the structure very well but repairing technique could not stay for long. They deteriorated the original material. Reason behind this failure was repair could not form the efficient bond with existing masonry. In several places the originality of structure has been totally vanished.

The material which was used by ASI in the repairing of Rumi Darwaza in Lucknow was failed after some time of application. The repair material which was used in construction did not fit with the quality and basic property of original material. Due to which whatever repair was applied was damaged again. This damage was even poorer as it was compared earlier.

The main reason behind the damage of repair work was variation in water absorption property.

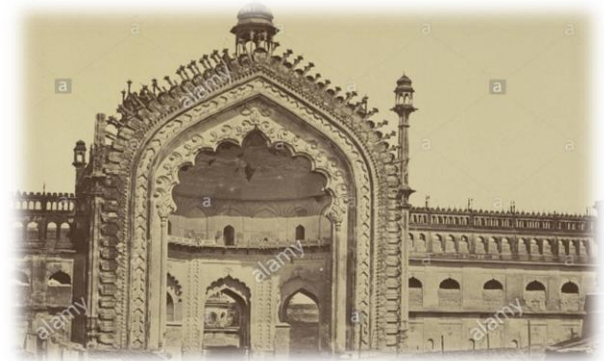
Fig No. 5 : File Pictures of Rumi Gate

Awadhi monument is made up of Lakhauri bricks and lime crushed brick aggregate. Mortar ratio is approximately 1:2 or 1:3 by volume.

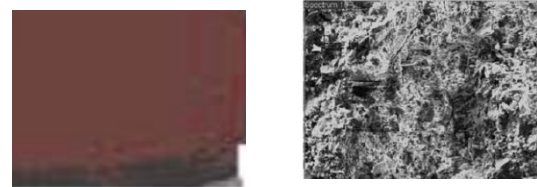
Fig No. 6 : Material

Compressive strength of bricks used is approximately lies between 15Mpa to 17Mpa. Modulus of elasticity was found to be 5.7Gpa. Water absorption is almost 11.4%. Porosity was calculated to be 19.9%.

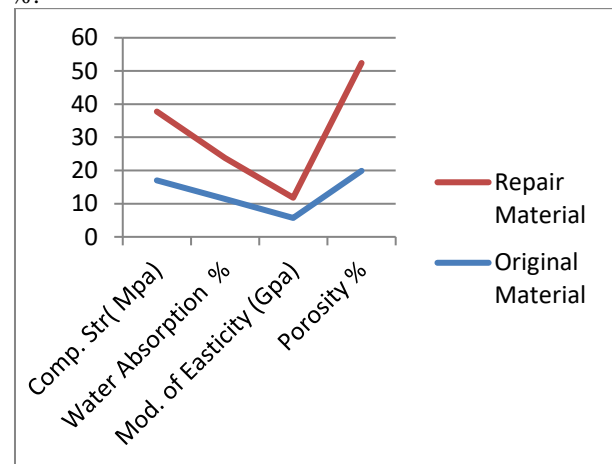
Fig no. 5 : Comparative Chart

Contemporary bricks compressive strength is approximately 20.8Mpa. Modulus of elasticity was determined to be close to 6.1GPa. Water absorption is 12.4 %.

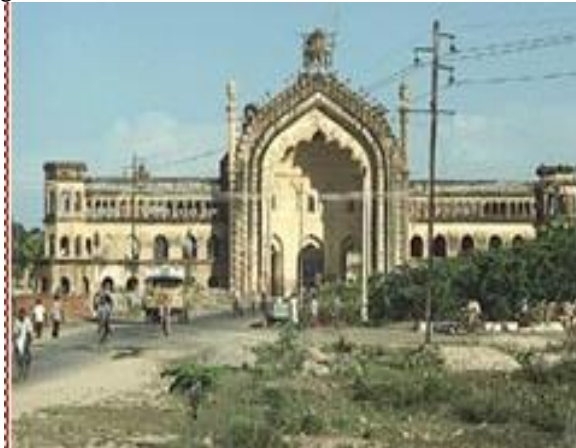
Fig No. 7 : File Pictures of Rumi Gate

Structural test of Rumi Darwaza was conducted by the researches in order to make it stronger to with stand the seismic ground motion. During this structural analysis understandability lead the engineers towards the parts of structure which may damage due to ground motion. The crown area which contains major arch and dome was more vulnerable to stresses and moments caused to due seismic

analysis test. The method of arch bracing was proposed to withstand the stresses which are likely to be developed by ground motion.

To make structure more seismically stronger the retrofitting of the structure was done using the modern technique of jacketing which has changed the original looks to drafted one.

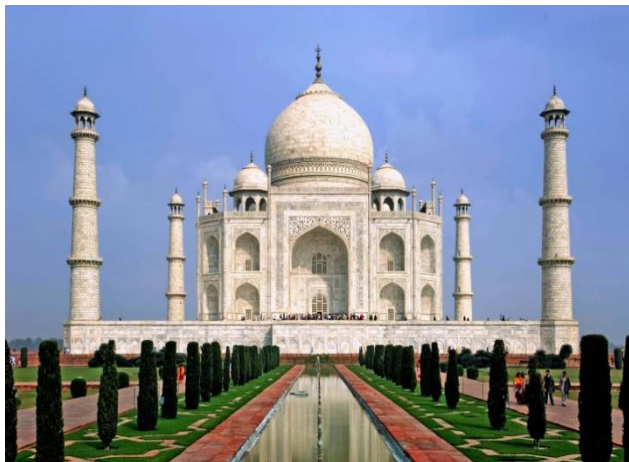
Figure No. 8 : File picture of Taj Mahal

Taj Mahal is the greatest architectural achievement of the whole range of Indo-Islamic architecture. It is situated at the bank of river YAMUNA. Taj Mahal structure contains double dome mausoleum and four Minnars. The whole monument rest over well type foundation filled with rubble masonry. The walls of mausoleum are made up of Lakhauri Bricks with mortar made of lime.

1. Decoloration
2. Crack formation
3. Marble bulging
4. Erosion of marble edges
5. Loss in shining

The thickness of mortar joint in this brick masonry was observed almost 2 times the size of brick.
