Study on the Material Properties of Chuihui (a Traditional Mortar) Used in the Leshan Giant Buddha

Abstract - As a World Cultural Heritage site, the Leshan Giant Buddha has long been affected by environmental factors, leading to deterioration issues such as cracking, hollow drumming, and damage in its restoration Chuihui materials. This study developed five distinct restoration materials tailored to the environmental conditions and repair requirements of different sections of the Leshan Giant Buddha. It systematically investigated their performance evolution under dry curing, pure water curing, and simulated permeating solution curing conditions. By measuring physical and mechanical properties and analyzing changes over curing periods, the study examined the degradation characteristics and adaptability of different materials in various environments. Results indicate: Sulfoaluminate cement Chuihui demonstrated the most significant enhancement under dry curing; In aqueous environments, while traditional Chuihui continued to deteriorate, the other materials initially declined then improved. Underwater cement Chuihui and Metakaolin Chuihui exhibited good water resistance. The comprehe

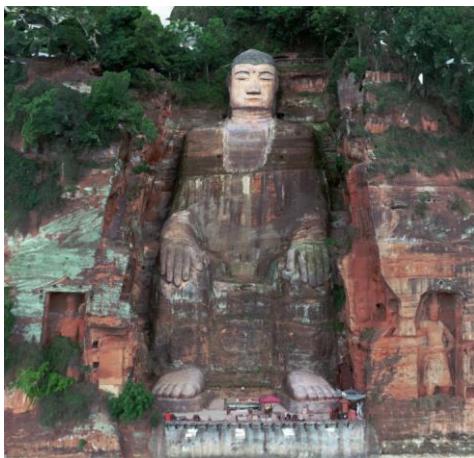
Fig 1 Schematic diagram of the Leshan Giant Buddha in Sichuan

The Leshan Giant Buddha, situated at the confluence of three rivers in Leshan City, Sichuan Province, China, stands 71 metres tall. As the largest extant stone-carved seated Maitreya Buddha statue, it was inscribed on the UNESCO World Heritage List as a dual natural and cultural site in 1996[1], as illustrated in Figure 1. However, prolonged environmental exposure has caused significant deterioration of the rock mass in which the Buddha is embedded, as illustrated in Figure 2. Over the past century, experts have undertaken seven restoration projects using Chuihui materials[2]. In the 1990s, Jiayu Ma [3] from the Sichuan Provincial Institute of Cultural Relics and Archaeology, building upon traditional Chuihui research, developed a Mixed Chuihui using cement, lime, carbon ash, and hemp fibre. Qiao Zhen [4] further enhanced the mechanical properties of the modified Chuihui by incorporating metakaolin into the Mixed Chuihui.

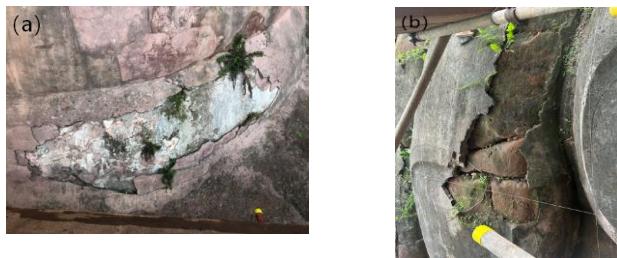
Fig 2 Deterioration status of Chuihui materials a. breast and abdominal reconstruction material failure,b. failure of hand repair materials

Near the fissures on the upper levels, the deterioration of the Leshan Giant Buddha's cave complex has become increasingly severe. This is due to the combined effects of soluble salts, the aquatic environment, and biological factors, compounded by recent intensified environmental pollution, water seepage erosion, and the washing and dissolution caused by acid rain. Regional cracking and damage are evident in the Buddha's hair bun, facial features, chest and abdomen, and hands, necessitating meticulous restoration using Chuihui materials [5]. Sun Bo [6] discovered that seepage at the interface between the rock substrate and the restoration layer causes cracking and delamination, presenting obstacles to

cultural heritage conservation; shear stress at this interface is the primary cause of cracking in the restoration layer. He Peng [7] investigated the failure mechanism of the Leshan Giant Buddha's hair bun, concluding that the primary causes of failure in the restoration material at this location were acid rain, water, CO_2 , and the restoration material itself.

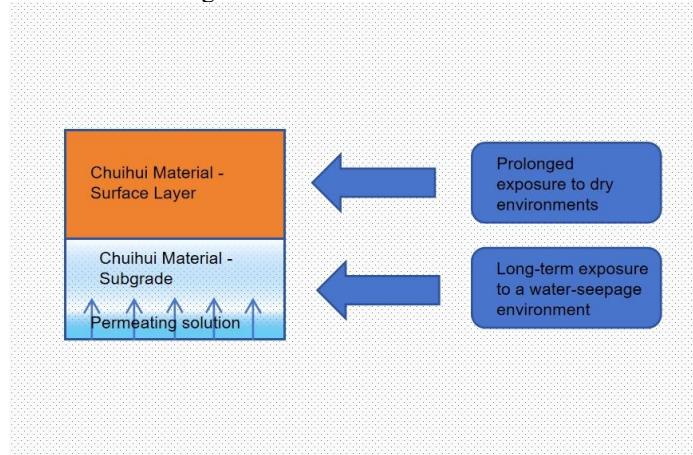
Fig 3 Schematic diagram of Chuihui

restoration of the Leshan Giant Buddha, construction personnel applied the Chuihui in layers from the interior outward, with a thickness ranging from approximately 10mm to 30mm. Surveys of the Buddha revealed significant variations in the environmental conditions of different sections due to its immense scale, primarily manifesting in two scenarios: Chuihui materials exposed on the surface of the cave structure have been subjected to prolonged dry conditions, but the chest and abdominal regions of the Leshan Giant Buddha have endured continuous erosion from seepage water. Certain internal layers (underlay) of the Chuihui materials have been persistently submerged in seepage solutions, isolated from air, as illustrated in Figure 3.

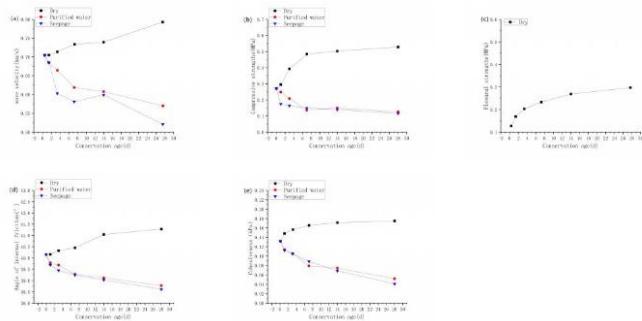
Fig 4 Variation curves of traditional Chuihui material properties under different conditions a. wave velocity variation curve, b. compressive strength variation curve, c. flexural strength variation curve, d. internal friction angle variation curve, e. cohesiveness variation curve.

According to Figure 4, the following can be obtained under dry curing conditions, the wave velocity, compressive strength, flexural strength, cohesiveness, and internal friction angle of traditional mortar exhibit an initial rapid followed by a gradual increase. Under permeating water and pure water conditions, all indicators exhibit a decline from rapid to gradual rates, with no significant distinction between the two. Taking compressive strength as an example, permeating water and pure water curing result in decreases of 0.14 MPa and 0.13 MPa respectively. This primarily stems from the continuous dissolution of lime in water, significantly weakening the cohesiveness between different materials. The progressive reduction in weathering indicators corroborates this observation. After 14 days of curing, pure water curing yielded slightly higher values than permeating water curing, with the overall sequence being dry curing > pure water curing > permeating water curing. This may stem from the loose structure of traditional lime mortar materials, where soluble salts in permeating solutions accumulate within rock pores. During testing, crystallisation formed during the drying process, leading to degradation.

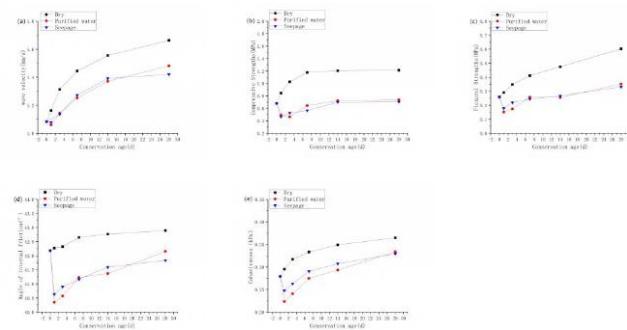
Fig 6 Variation curves of underwater cement Chuihui material properties under different conditions a. wave velocity variation curve, b. compressive strength variation curve, c. flexural strength variation curve, d. internal friction angle variation curve, e. cohesiveness variation curve.

According to Figure 6, the following can be obtained under dry curing conditions, wave velocity, compressive strength, and flexural strength also exhibited an initial rapid followed by a gradual increase. Under permeating water and pure water conditions, the overall trend showed a slight initial decrease followed by an increase, though the decrease was minimal. Through testing and literature review, it was found that underwater cement contains anti-dispersants, making it less prone to degradation in identical aquatic environments. Shear resistance parameters exhibited an initial rapid increase followed by a gradual slowdown in dry-cured specimens, whereas specimens cured in pure water and permeating water conditions first decreased before increasing. The shear resistance parameters of pure water and permeating water cured specimens showed no significant distinction, indicating that weathering induced by the "water" effect is the primary factor controlling specimen deterioration.

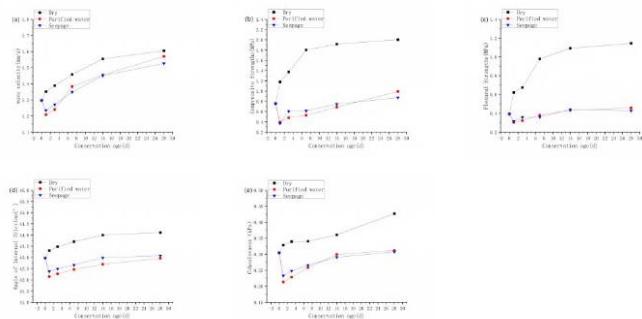
Fig 7 Variation curves of metakaolin Chuihui material properties under different conditions a. wave velocity variation curve, b. compressive strength variation curve, c. flexural strength variation curve, d. internal friction angle variation curve, e. cohesiveness variation curve.

According to Figure 7, the following can be obtained under dry curing conditions, both wave velocity and compressive and flexural strengths exhibit a trend of initially rapid increase before eventually stabilising. All three weathering indices exhibited a pronounced inflection point at 14 days. The compressive strength values at 0d, 1d, 3d, 7d, 14d, and 28d were 0.76 MPa, 1.18 MPa, 1.37 MPa, 1.81 MPa, 1.93 MPa, and 2.01 MPa respectively. This indicates that adding metakaolin reduces the time required for lime-based materials to achieve stable performance, thereby facilitating construction to some extent. Under permeating water and pure water conditions, the overall trend showed a decrease followed by an increase. Comparing weathering index values across the three curing conditions, dry-cured samples exhibited significantly higher values than water-cured samples, particularly evident in strength parameters. For instance, at 28 days, the flexural strength of dry-cured specimens reached 1.23 MPa, exceeding water-cured specimens by 0.75 MPa. Regarding shear properties, the internal friction angle and cohesion of dry-cured

specimens exhibited a non-linear growth pattern, accelerating initially before slowing. The internal friction angles at 0, 1, 3, 7, 14, and 28 days were 43° , 43.2° , 43.3° , 43.6° , 43.8° , and 44° , respectively, with overall variation not exceeding 1° . Cohesion, however, exhibited some variation between 7 and 28 days, potentially related to sample size, moisture content, and surface porosity. The trends and values of shear-related indicators for samples cured with pure water and seepage water were largely consistent, exhibiting a decrease followed by an increase. By 28 days, the internal friction angles and cohesion values for both pure water and seepage water-cured samples were approximately 43° and 0.31 kPa, respectively, similar to their initial values.

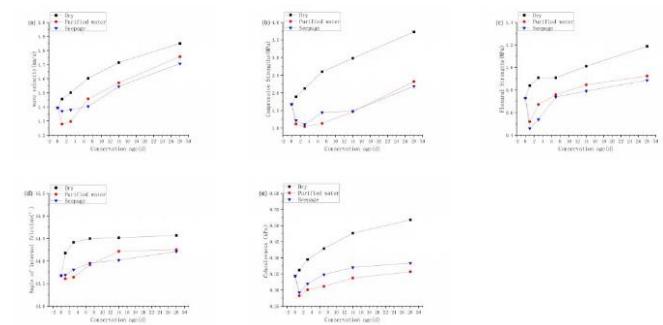
Fig 8 Variation curves of sulfoaluminate cement Chuihui material properties under different conditions a. wave velocity variation curve, b. compressive strength variation curve, c. flexural strength variation curve, d. internal friction angle variation curve, e. cohesiveness variation curve.

According to Figure 8, the following can be obtained under dry curing conditions, weathering indicators such as wave velocity, compressive strength, and flexural strength exhibit an almost linear upward trend with relatively rapid rates of change. At 0d, 1d, 3d, 7d, 14d, and 28d, wave velocities were 1.392 km/s, 1.451 km/s, 1.499 km/s, 1.603 km/s, 1.716 km/s, and 1.815 km/s respectively, with wave velocity increasing by merely 0.5 km/s. The internal density of the samples markedly enhanced, reducing pore and fissure dimensions, indicating thorough inter-material reactions. Compressive strength values reached 1.67 MPa, 1.89 MPa, 2.14 MPa, 2.59 MPa, 2.97 MPa, and 3.73 MPa, representing an increase of 2.06 MPa. Flexural strength also varied from 0.81 MPa to 1.35 MPa, indirectly indicating a correlation between the macroscopic indicators of the samples. Under water seepage and pure water conditions, the overall trend showed a decrease followed by an increase. The increase in strength parameters was modest, with compressive strength and flexural strength increasing by approximately 0.65 MPa and 0.21 MPa respectively. The internal friction angle of dry-cured specimens did not exceed 0.5° , while cohesiveness increased from 0.35 kPa to 0.52 kPa, representing an overall improvement of 0.17 kPa. The shear-related indicators for both pure water and permeating water-cured specimens exhibited largely consistent trends and values, showing a decrease followed by an increase. By day 28, the internal friction angle and cohesiveness for both pure water and permeating water-cured specimens were approximately 44° and 0.33 kPa respectively.

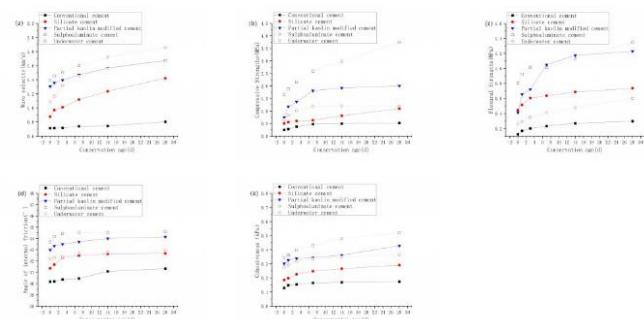
Fig 9 Variation curves of indicators for different types of Chuihui materials under dry curing conditions a. wave velocity variation curve, b. compressive strength variation curve, c. flexural strength variation curve, d. internal friction angle variation curve, e. cohesiveness variation curve.

Figure 9 indicates that under dry curing conditions, the weathering indices of various types of Chuihui materials all exhibit a non-linear upward trend, though differences exist in the magnitude of increase and rate of change. When considering physical properties such as wave velocity, compressive strength, and flexural strength, the overall sequence is: Sulphoaluminate cement Chuihui > Metakaolin Chuihui > Underwater cement Chuihui > Silicate cement Chuihui > Traditional Chuihui. Cementitious materials enhance the mechanical properties of Chuihui, with sulphoaluminate cement demonstrating the most pronounced effect. Variations were observed in weathering index test results, such as inconsistent compressive and flexural strength values for underwater cement. This may be closely linked to the homogeneity and microstructure of the Chuihui material. The internal friction angle of dry-cured specimens varied within approximately 1° , cohesiveness ranged between 0.2 kPa and 1.5 kPa.

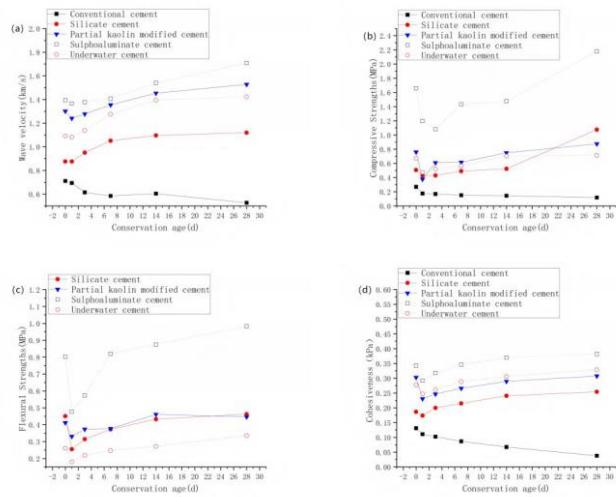
Fig 10 Variation curves of indicators for different types of Chuihui materials water-permeable curing conditions a. wave velocity variation curve, b. compressive strength variation curve, c. flexural strength variation curve, d. cohesiveness variation curve.

Figure 10 indicates that comprehensive comparison of Chuihui material indices: Sulfoaluminate cement Chuihui > Metakaolin Chuihui > Underwater cement Chuihui > Silicate cement Chuihui > Traditional Chuihui. Under permeation curing, traditional Chuihui exhibits a declining trend, while other mortar types show an initial decline followed by an increase in all indices. This outcome aligns with the lowest performance metrics of traditional Chuihui, indirectly highlighting cementitious materials' crucial role in restoration processes. Compared to other mortar types, sulfoaluminate cement-modified mortar exhibits the most pronounced initial susceptibility to aquatic environments, particularly demonstrating significant strength degradation. The microenvironment at the restoration site of the Leshan Giant Buddha significantly impacts the performance of Chuihui materials. Water and the resulting weathering effects substantially diminish the material's properties.
