Technique for Prevention of Surface Problem in Construction of RCC Chimney Shell by using of Galvanised Cold Rolled Color Coated Plain Sheet

Abstract— RCC chimney is one of the essential and important structure in Thermal power plant & the RCC shell of chimney is usually constructed by using slip form technique. But during construction of chimney shell by using slip form technique, surface damage of RCC chimney shell is one of most common problem in every chimney during construction. Such surface problem issue indicate doubt on concrete quality & workmanship, which leads to investigation of in situ concrete quality and repairing of the damage concrete. In addition to that because of such surface problem with slip form concrete finally durability of concrete get compromised of such important chimney structure. Thus such surface issues leads to uncertain period of time for investigation with subsequent repairing at site, and in some cases it was also experienced that part of the chimney shell required to dismantle due to bad remarks in investigation report. Hence the surface issue of RCC chimney shell will impact on many issues related to construction of chimney like unexpected dela

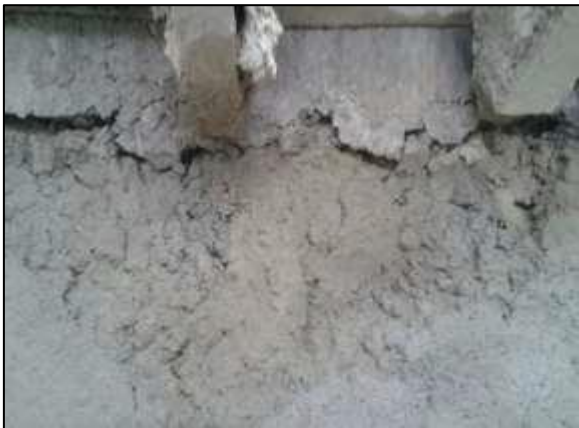
Fig-1: Lifting crack in RCC chimney shell construction by Slip form technique.

A. Lifting cracks

The lifting crack is usually occurred in chimney shell during slipping because of following reasons.

- Long interval between two successive layers of concrete.
- Restart of concrete over an old concrete surface after long gap of more than 3 days.
- Delay in lifting of slip form or long gap between two successive lift usually schedule lifting is in every 15-20 minute. So in any case if it exceed more than 30 minutes & concrete get set then such problem is very common.
- Pouring layer thickness is less than 200 mm over an old concrete surface.

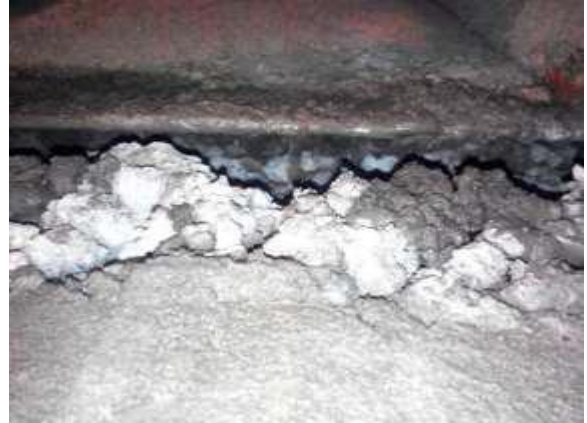
Fig-2: Delamination problem in RCC chimney shell construction by Slip form technique.

B. Delamination

The delamination is nothing but damage of cover concrete during slipping of slip form. The following are the reasons for occurrence of delamination during slipping of form.

- Geometrical changes like negative radius in any particular location.
- The level of slip form is not in a level plan mostly LVL in yoke legs get disturbed.
- Due to non-cleaning of slip form steel shutter plate continuously cement slurry is getting hydrated with already stick cement mortar splat & thus increasing its volume. So during lifting of slip form this stick mass

with shutter plate will damage the upper soft semi solid stage concrete & hence delamination occurred.

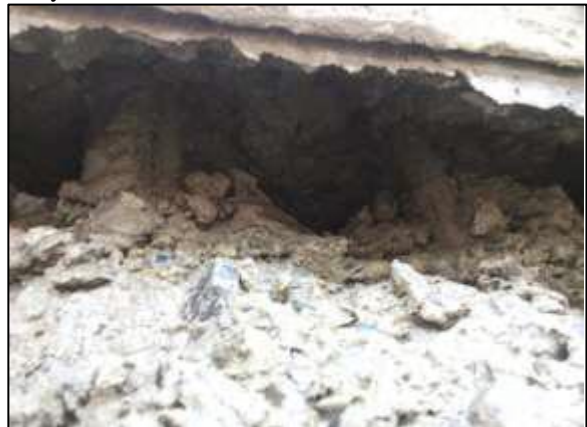
Fig-3: Concrete collapse problem in RCC chimney shell construction by Slip form technique.

C. Concrete collapse

The concrete collapse is usually occurred during slipping of form because of the following reasons.

- Lifting of slip form when concrete is not getting set.
- Rate of lifting is very high as comparison to the setting time of concrete i.e. lifting over non set concrete.
- Un-even layer pouring i.e. in some location height of of pouring is 300-400 mm while in some locations layer thickness is 150-200 mm.

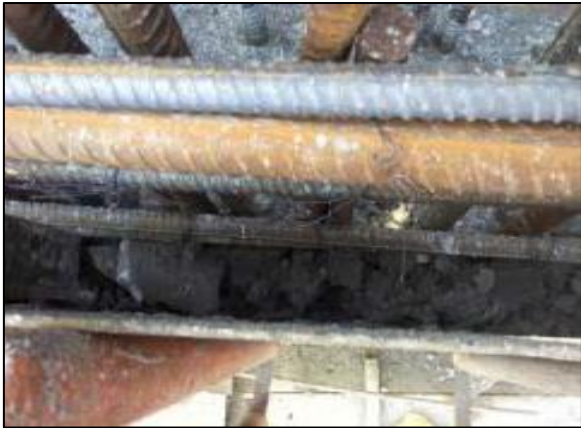
Fig-4: Lump formation problem in RCC chimney shell construction by Slip form technique.

D. Lump formation

The lump formation is usually occurred in slip form concrete because of the following reasons

- High ambient temperature.
- Low w/c ratio in the mix i.e. less than 0.40.
- Using of OPC 53-grade cement as per IS-12269 or CEM-I 52.5 class cement as per BSEN-197-1 more than 400 kg/cum in the mix having fineness of cement is more than 370 m²/kg.
- The Relative humidity of ambient air less than 60% with high ambient temperature.
- Very high wind speed with very high rate of evaporation loss of surface water.
- Low setting time of concrete i.e. less than 5 hrs

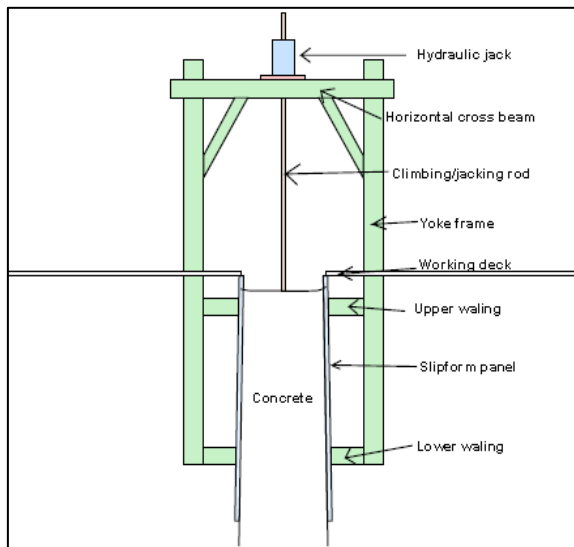
Fig-5: Slip form arrangement for RCC-chimney shell construction.

Considering all the above cause of surface damage during slipping of form, the primary cause is very high static friction between semi solid concrete surface & slip form shutter plate because of roughness of shutter plate. Hence it is felt that if we placed a smooth surfaced material will placed between concrete & steel plate then such high static friction can be minimized & subsequently we can eliminate most of the causes which can cause surface damage during slipping of form.

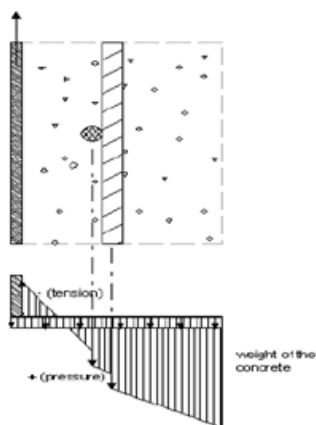
Fig-6: Stress distribution during lifting of slip form.

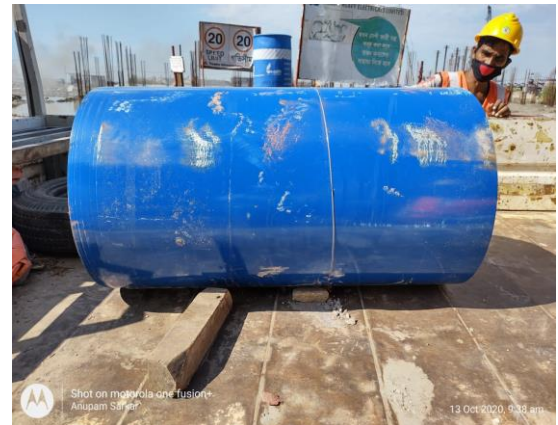
Fig-7: Sample of 0.47 mm thick galvanized cold rolled color coated sheet.

The experiment was conducted with 0.47 mm thick galvanized cold rolled color coated plain sheet application along normal MS plate used as a slip form shutter plate. The fixing arrangement of the sheet shall be done in such a way so that the sheet can be slide along with steel shutter plate during diameter adjustment of shell. The fixing arrangement of sheet is shown in Fig-8, Fig-9, and Fig-10.

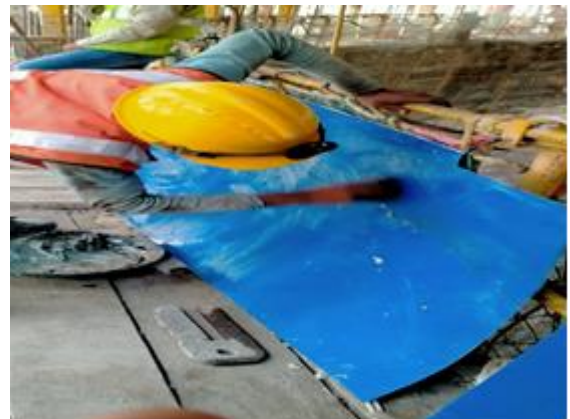
Fig-8: Making of sheet as per the size of plate used as a slip form shutter plate.

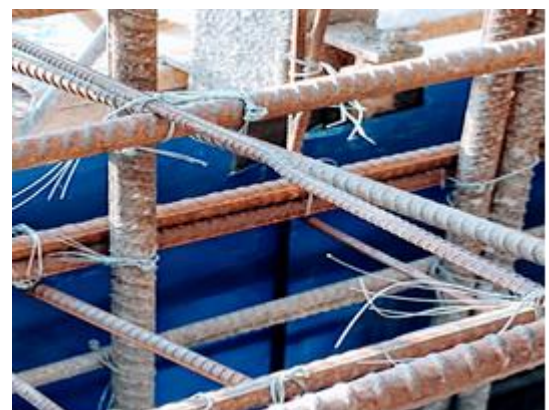
Fig-9: Fixing of sheet as per the size of plate used & considering the provision of slipping horizontally along with shutter plate.

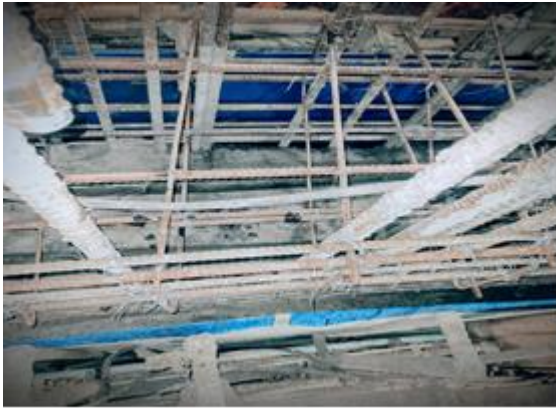
Fig-10: Fixing of sheet along with both inner & outer shutter plate considering the provision for making horizontal sliding.

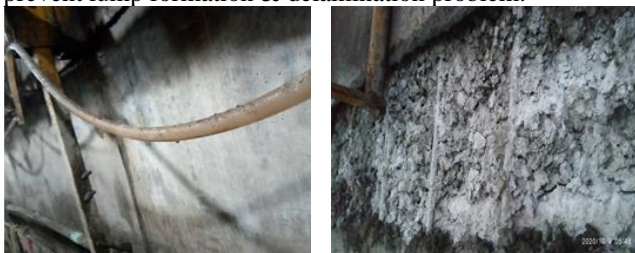
Fig-11: Concrete surface with (Left) or without (Left) using of 0.47 mm thick galvanized cold rolled color coated sheet in inner surface of shell concrete.

There is always a possibilities of adhesion of cement mortar slurry along with normal mild steel plate of slip form shutter during concreting of RCC shell & it results smoothness of plate will lost. As the smoothness of the got reduced subsequently the friction between concrete surface & steel plate get increased & such increased friction resulting damage of surface or cover concrete while slipping. In addition to that surface attached cement mortar will gradually increasing its size by volume due to continuous hydration with newly poured concrete & thus formed lump of concrete along with shutter plate. When shutter plate will start slipping vertically it will break the upper layer of soft concrete & resulting delamination of cover concrete. On the pretext of using 0.47 mm thick cold rolled color coated galvanized sheet, it act as a smooth protective surface between steel plate & concrete surface which helps to reduce frictional force between steel plate & concrete surface and also it prevent adhesion of cement mortar to steel plate & thus helps to prevent lump formation & delamination problem.

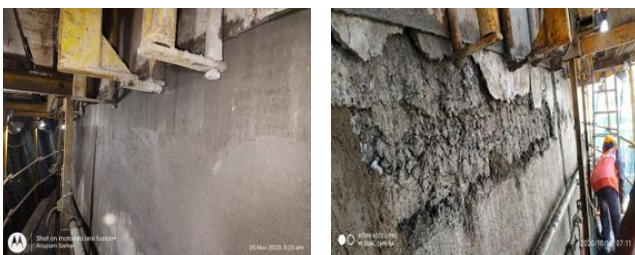
Fig-12: Concrete surface with (Left) or without (Left) using of 0.47 mm thick galvanized cold rolled color coated sheet in outer surface of shell concrete.

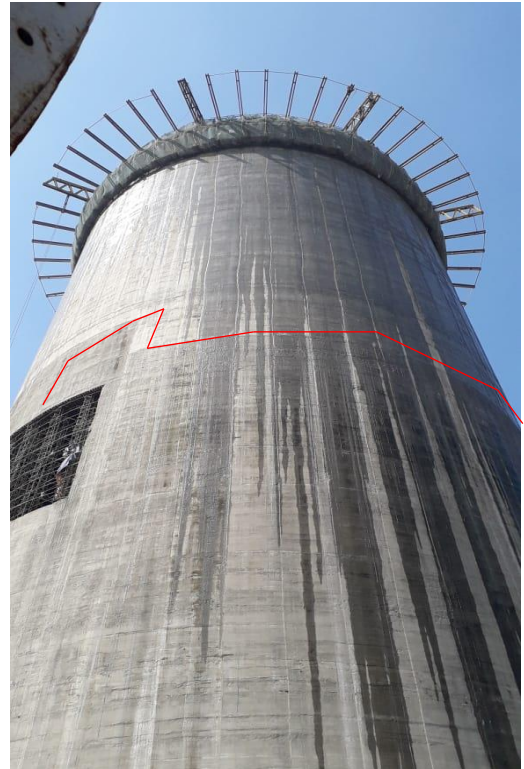
Fig-13: Concrete surface of RCC Chimney shell by using of 0.47 mm thick color coated galvanized sheet along with steel shutter plate for Upper part of chimney shell or without using of sheet Bottom part of shell.

6. It helps to prevent any delay in construction time cycle due to unexpected surface problem during construction stage.
7. It helps to produce good surface appearance as compared to concrete surface without using such sheet as per Fig-13.
