Use of vibration Monitoring and Analysis for Fault Diagnosis of Rotating Machines - Some Case Studies

The present paper deals with the application vibration monitoring and analysis for fault diagnosis of some critical machines in process industries. Steps involved in vibration monitoring and analysis are discussed as well as three case studies are presented.

Case 1: I.D. Fan of Boiler, Sahyadri starch and Auxiliary Chem. Industries Pvt. Ltd. Miraj.

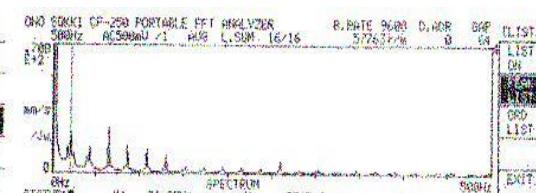
Figure 2: Frequency Spectrum at Bearing 'A'

In the course of the trial it was observed that even on 'NO LOAD' the vibration level on both the bearings of the fan were very high which are shown in the Table 1. As the vibrations levels were severe at both bearings of I.D. Fan, it was decided to carry out frequency spectrum analysis. Frequency spectrum taken on bearings shown in Figure 2 and 3. Vibration analysis with IRD 350 Av revealed that the predominant frequency was at 1x RPM. A little marked vibration was also observed at 2x RPM. The vibration at 1x RPM with steady phase occurs due to unbalance. So it was concluded that there was unbalance.

It was decided to carry out single plane In-situ balancing of fan. As usual procedure, initial vibration level was tuned condition at 1x RPM and phase were measured they were found to 500 microns and 250 degrees respectively. Trial weight of 95 gms was added on shroud plate of the fan. With this trial weight vibration level and phase were observed and they found to be 420 microns and 260 degrees respectively. Vector diagram was drawn and value of balance weight to be added with respect to trial weight, location was calculated. They were 120 gms, and 95 degrees with respect to the position of trial weight in opposite direction of rotation.

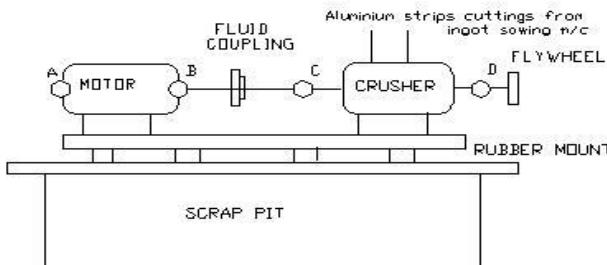
Figure 5: layout of scalper machine

When machine was running in the load condition it was observed that there were very high axial readings on A and B bearings (motor side) also very high vertical reading on C and D (Crusher side) as shown in Table 3. As the vibration level were severe, it was decided to carry out frequency spectrum analysis. Figure 4 shows the frequency spectrum at A axial, in that 1x, 2x, 3x rpm and 1x rpm was predominant and so it was concluded that there might be unbalance. At B vertical and axial, got almost same frequency spectrum (Figure 6). Also at C and D vertical from frequency spectrum (Figure 7) it was found that 1x rpm was dominant and so concluded that there was an unbalance on rotor side.

After thinking so much and with carefully observation it was seen that the anti-vibration pads were worn out and so there was uneven deflection of anti-vibration pads this leads to misalignment of crusher and motor also creates oscillation because of this axial vibration on motor side are more therefore it was advisable to check anti-vibration pads for loading in such a way that deflection of all pads was same, which helps to keep level of machine horizontal

This showed that characteristics of rotating hammer changes angular distribution of weights in each run as such satisfactory results in balancing could be achieved. The main cause of vibration was eccentric mounting of rotor with respect to shaft and loss of damping properties of anti-vibration pads. Rotors were thoroughly checked for eccentric fitment was dynamically balanced, without hammers and with flywheel especially on balancing machine. (Off-site).

Then hammers were mounting with equal weight distribution uniformly to attain better results. Also shaft was rubbed out and so it was materialized and then it was assembled with rotors also anti-vibration pads change. After that the vibrations were reduced drastically as shown in Table 4.

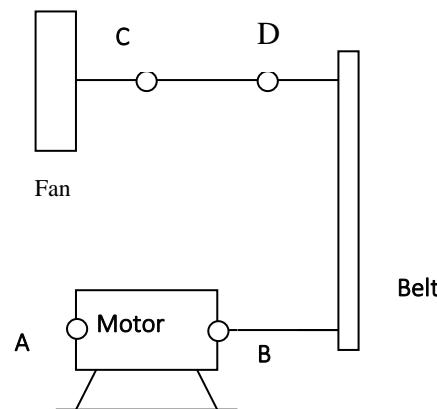
Figure 9: Layout of Dryer Circulation Fan

From the readings shown in Table 5 found that vibration levels were much higher than the permissible value as per ISO 10816-1 STD. So it was decided to carry out the frequency spectrum analysis. From the frequency spectrum (Figure 9 to Figure 11) it was seen that there were high radial vibration and 1x rpm is predominant, so there might be eccentric pulley also there might be misalign.

Because of flexible motor mounting causes high motor vibration due to that resonating type of condition occurred, therefore it was recommended to change the motor mounting structure and make it more stiffened. Also at 'D' observed the bearings frequencies and therefore bearing might be deteriorating, so it was recommended also to check the fan shaft surface for scoring marks at the bearings mounting area.

At bearings 'C' and 'D' show the increased clearances and so recommended to replace the bearings. After rectification in alignment again we had taken readings and frequency spectrum it was observed that there was minor misalignment between both pulleys, also there was no proper fitment of both the pulleys.

After realign we observed that there was drastically reduction in vibration as shown in Table 6. After realigning of pulleys, the overall vibration levels were acceptable.
