Vibration Analysis of CFRP Cantilever Beams due to Different Types of Notches Closed to Fixed End

Abstract - The aim of experiment is to analyze the vibration of undamaged and damaged Carbon Fiber Reinforced Polymer (CFRP) beams. Experimental free vibration of CFRP cantilever beam will be investigated by dynamic tests. Total three different types of notches are made artificially on the beams closed to fixed end. A comparison will be made of the experimentally extracted frequencies at each damage level and in relation to the single positions of the accelerometer. A comparison between natural frequencies due to different types notches have been investigated. The present experiment illustrates the envelope of Frequency Response Functions (FRFs) obtained by the experimental dynamic tests and the changes of natural frequency values correlated to the damage degree of CFRP beam. Numerical data is found out and discussed in comparison to the experimental results.

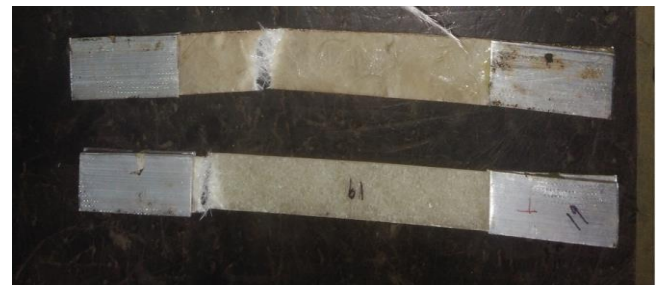
Fig. 1 Experimental setup for tensile test of a CFRP cantilever beam

Experimental tensile tests on specimens were carried out in the laboratory in order to evaluate the strength of CFRP laminas and Young's modulus before vibration tests aimed at determining the frequency values of undamaged and damaged CFRP cantilever beam elements. Tensile test beam element dimensions are 250mm*20mm*2mm (thick) and 55mm aluminum pads for gripping purpose while testing at the end of the beams. Table 1 shows the tensile test results of CFRP Cantilever beam. Fig. 1 shows the test setup of CFRP cantilever beam. Fig. 2 shows the tensile test result of CFRP cantilever beam.

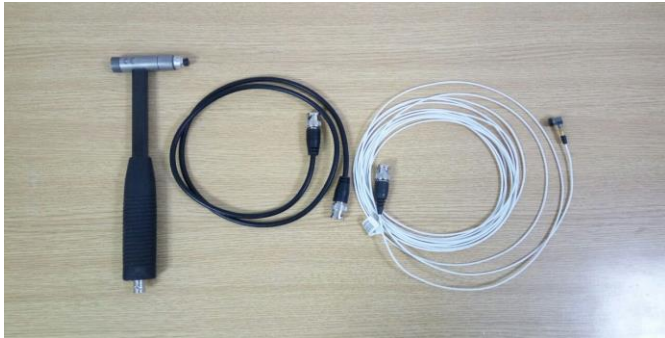
Fig. 4 Impact Hammer and P20 sensor

The Instrument used for determining the frequency values are crystal instruments Coco 80x, Impact Hammer and its Property is 0.9944mv/lbf, Sensor name is P20, weight is 3 grams, and its property is 10 mv/lbf. Fig. 3 shows the FFT analyzer. Fig. 4 shows the impact hammer and the sensor.

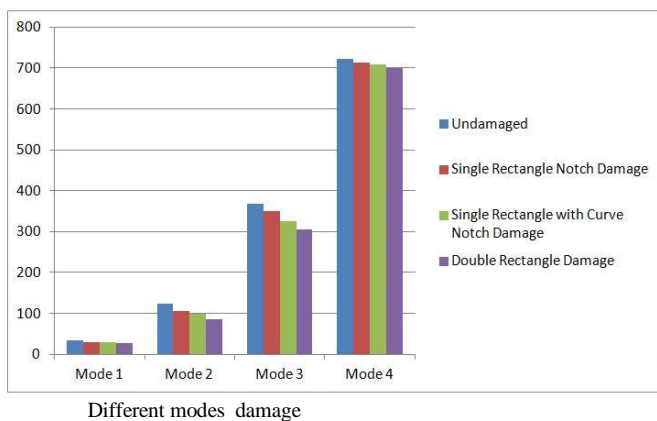
Fig. 14 Variation of natural frequencies for experimental investigations

A series of experiments are conducted to determine the natural frequencies of a CFRP cantilever beam. The frequency near to the notch at accelerometer position (a₁) for undamaged condition is 33.1875, for single rectangular notch damage condition is 30.0000, for single rectangle with curve notch condition is 29.9375, and for double rectangle notch condition is 26.7500. As a result of conducting two types of analysis, it can be found that the frequency decreases with the increase in damage condition.

Tables 7 and 8 shows the experimental and theoretical natural frequencies. Fig.14 shows the variation of natural frequencies by experimental investigations.
