Water Quality Assessment of Lakes in Mysuru, India - A Case Study

Keywords: Kukkarahalli Lake, Karanji Lake, Dalvoy Lake, Mysuru city, Physico-chemical variables, water quality.

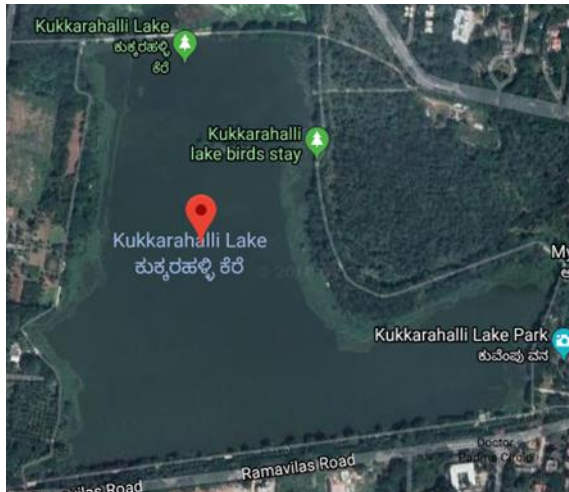
Fig 2: Location map of kukkarahalli Lake

The sampling sites were selected by keeping in mind the locations of inflow and outflow. The location map of Kukkarahalli Lake, Dalvoy Lake and Karanji Lake is as shown in Figs 2, 3, and 4 respectively. Water samples were collected from the surface and few meters below water level to find out the varying characteristics, if any, of surface and bottom waters, by using specially designed airtight sampler, using clean and sterile polythene bottles.
